James A. FitzPatrick
Nuclear Power Plant
P.O. Box 41
Lycoming, New York 13093
315-342-3840

Subject: Docket No. 50-333
LICENSEE EVENT REPORT: LER-96-015

Design Error Allows Bypass Flow Path Around Offgas
Isolation Valve

TITLE (4)
 Design Error Allows Bypass Flow Path Around Offgas Isolation Valve

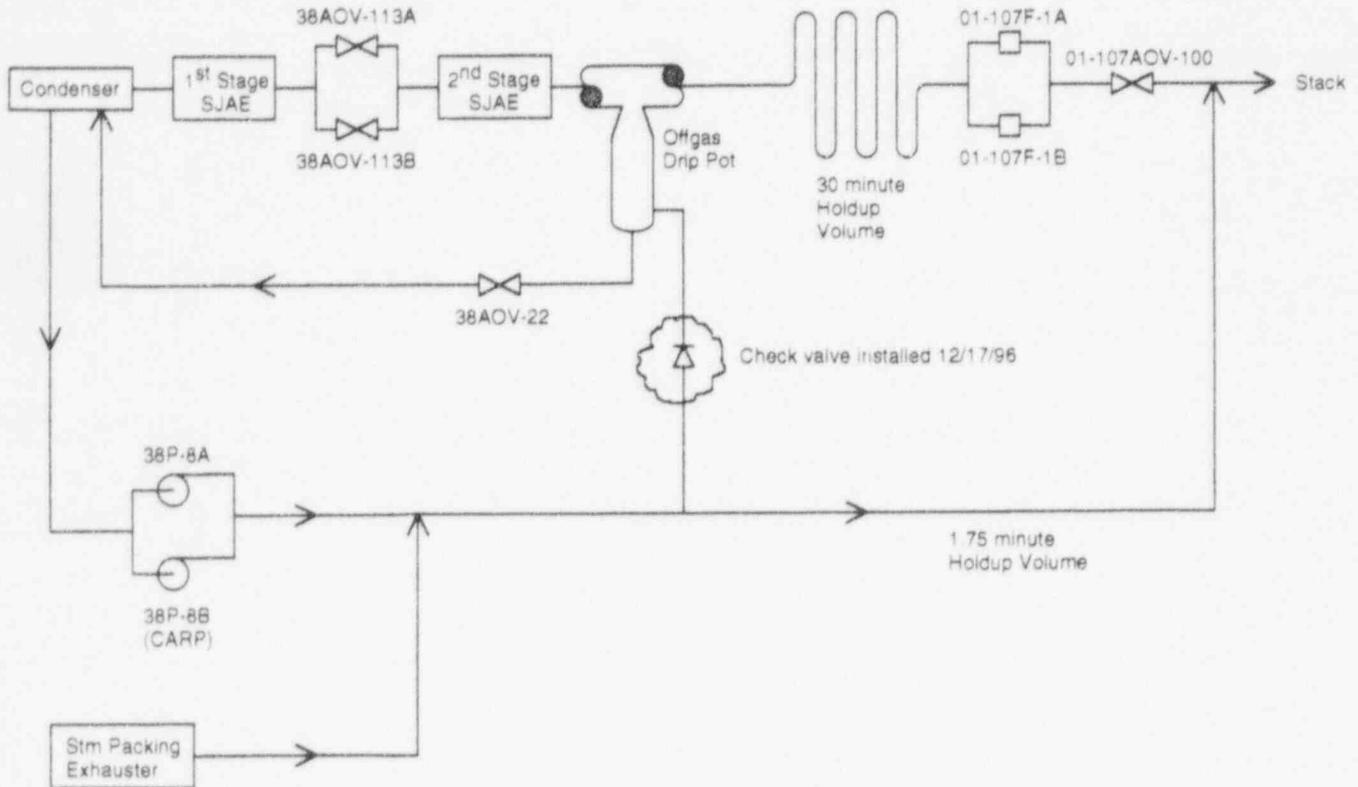
FIGURE 1

At 12:00 on December 18, 1996, it was determined that the original design of an interconnection between the condenser air removal system [SH] and the offgas system [WF] could have prevented the fulfillment of the safety function of a system required to control the release of radioactive material or mitigate the consequences of an accident. This determination was based on the observation that pressurization of the offgas 30 minute holdup volume would have cleared the water which effectively seals the condenser air removal pump / steam packing exhauster (CARP/SPE) discharge line from the offgas system by maintenance of level in the offgas drip pot and CARP/SPE discharge common drain from the drip pot and drain line, providing a flow path for offgas to bypass the offgas HEPA filters, 01-107F-1A/B, 30 minute holdup volume and offgas outlet isolation valve, 01-107AOV-100.

The offgas system is isolated by closure of 01-107AOV-100 in response to high radiation in the effluent. Closure of this valve will result in pressurization of the 30 minute holdup volume due to continued steam jet air ejector operation removing non-condensibles from the condenser [SG]. Pressurization of the 30 minute holdup volume may have resulted in offgas flow bypassing the 30 minute holdup volume and offgas HEPA filters (01-107F-1A/B) through the flowpath described above.

The cause of the event was an error in the original plant design (cause code B) which created a potential discharge path from the offgas drip pot to the main stack through the common drain line from the steam packing exhauster and condenser air removal discharge pipe (1.75 minute holdup volume) to the drip pot. As designed, this line had no provision to prevent offgas backflow if the drip pot was pressurized sufficiently to clear the loop seal in the drip pot / drain line.

Simplified Offgas System Flow Diagram

The offgas piping design error was corrected by installation of a permanent modification which installed a check valve in the common drain line to prevent reverse flow from the steam jet air ejector discharge.

1. Modification M1-96-103 was installed on December 17, 1996 and tested satisfactorily on December 18, 1996. This modification installed a check valve in the drain line from the common steam packing exhauster / condenser air removal pump discharge line to the offgas drip pot which will prevent reverse flow of the steam jet air ejector effluent in the event the thirty minute holdup volume is pressurized.
2. A calculation will be performed to evaluate the consequences of a control rod drop accident given the original configuration of the offgas system by March 19, 1997 (Corporate Radiological Engineering).
3. A revision to this LER documenting the results of corrective action 2 will be prepared, if necessary, by April 15, 1997 (Licensing).
