RADIOLOGIC AND ENGINEERING ASSESSMENT

DOE ID NO.: GJ-01390-RS
ADDRESS: 2025 NORTH 21ST STREET

AUGUST 1985

URANIUM MILL TAILINGS REMEDIAL ACTION PROJECT OFFICE

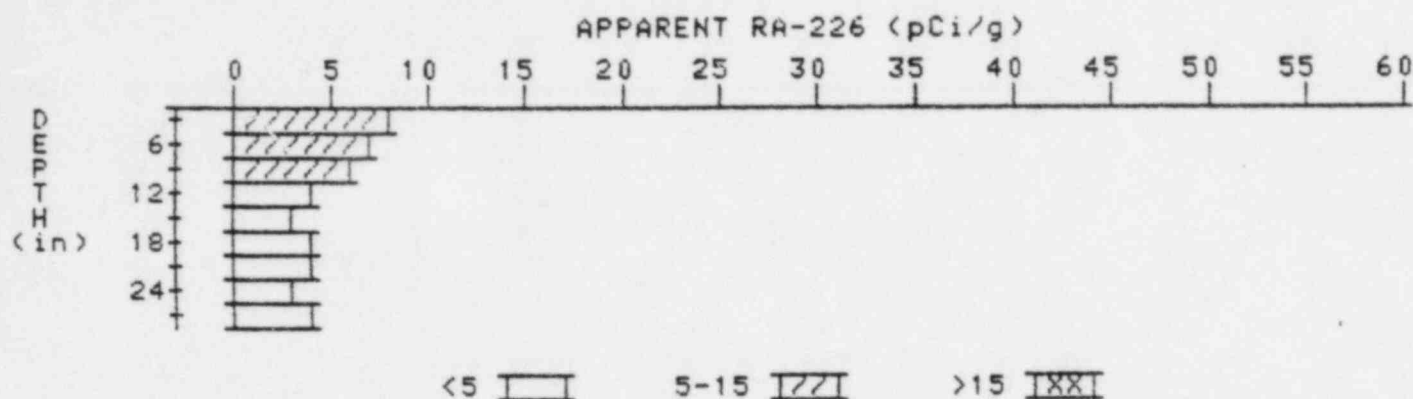
APPARENT RADIUM-226 CONCENTRATION DECONVOLUTION GRAPH

Depth (in)	Apparent Radium-226 (pCi/g) Undeconvolved	Apparent Radium-226 (pCi/g) Deconvolved
3	7.5	7.5
6	6.7	7.1
9	5.7	5.5
12	4.8	4.4
15	4.1	3.2
18	3.9	3.7
21	3.8	3.6
24	3.8	3.4
27	4.0	4.0

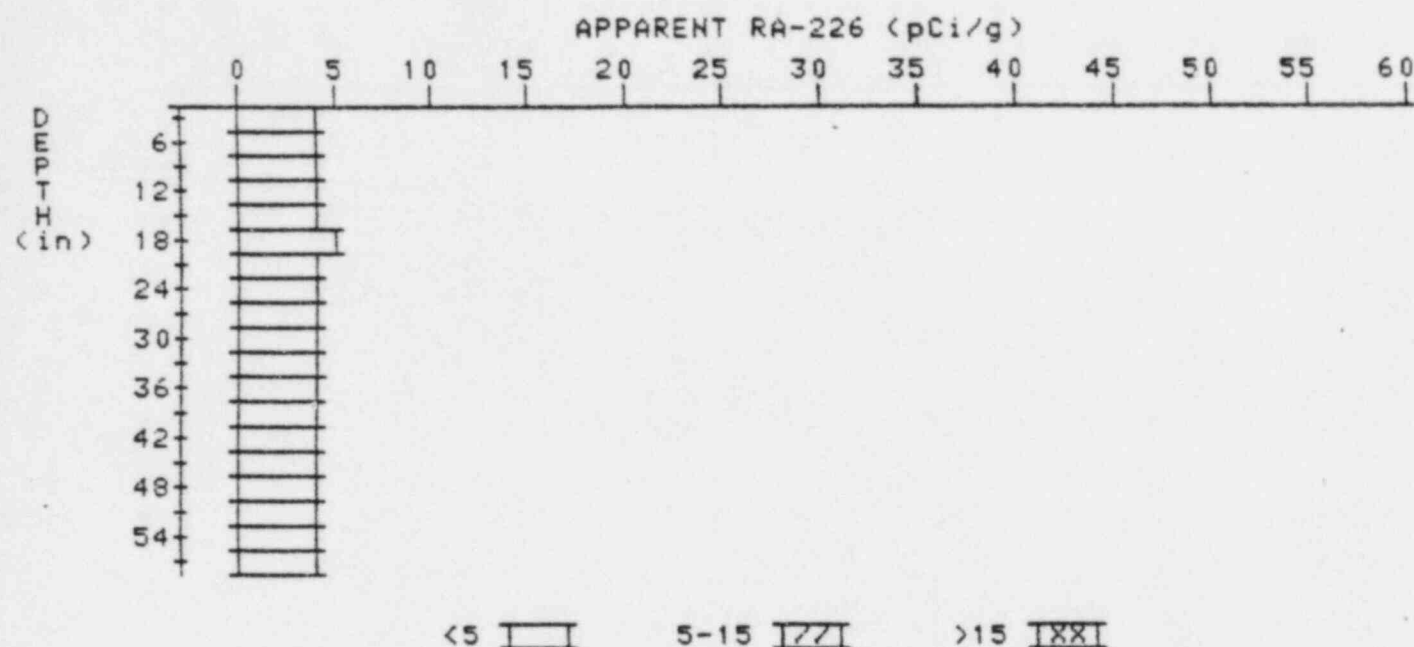
APPARENT RADIUM-226 CONCENTRATION 11 DECONVOLUTION GRAPH

11	205262	03	TC	3.6		*	Sewer line West of primary structure DC = 0 inches
		06	TC	3.8		*	
		09	TC	4.0		*	
		12	TC	4.1		*

Depth (in)	Apparent Radium-226 (pCi/g) Undeconvolved	Apparent Radium-226 (pCi/g) Deconvolved
3	3.6	3.6
6	3.8	3.8
9	4.0	4.2
12	4.1	4.3
15	4.1	3.9
18	4.2	4.6
21	4.1	3.9
24	4.1	4.1
27	4.1	4.1
30	4.1	4.1
33	4.1	4.3
36	4.0	3.8
39	4.0	4.0
42	4.0	4.0
45	4.0	3.8
48	4.1	4.3
51	4.1	4.3
54	4.0	3.8

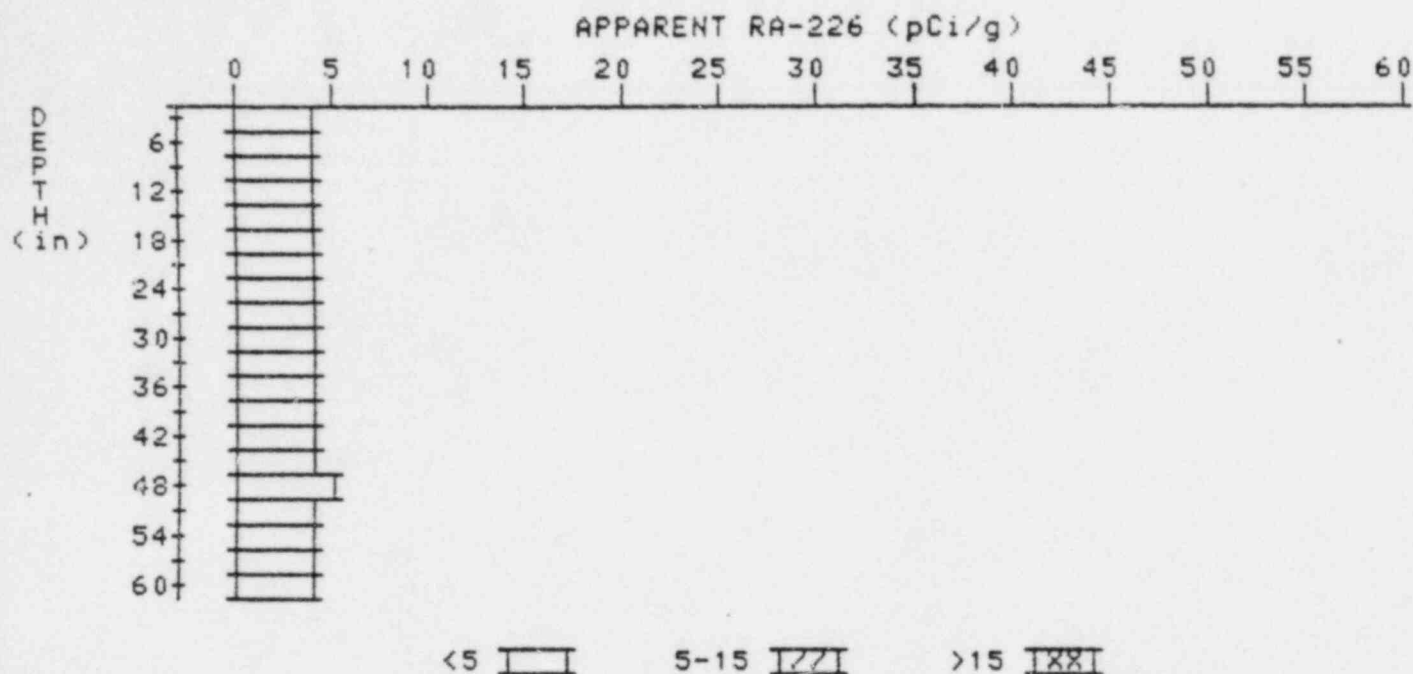
APPARENT RADIUM-226 CONCENTRATION 13 DECONVOLUTION GRAPH

Depth (in)	Apparent Radium-226 (pCi/g) Undeconvolved	Apparent Radium-226 (pCi/g) Deconvolved
3	3.9	3.9
6	4.0	4.2
9	4.0	4.0
12	4.0	3.8
15	4.1	4.5
18	4.0	3.6
21	4.1	4.5
24	4.0	3.8
27	4.0	4.0
30	4.0	4.0
33	4.0	4.0
36	4.0	4.0
39	4.0	3.8
42	4.1	4.3
45	4.1	3.9
48	4.2	4.6
51	4.1	3.9
54	4.1	4.3

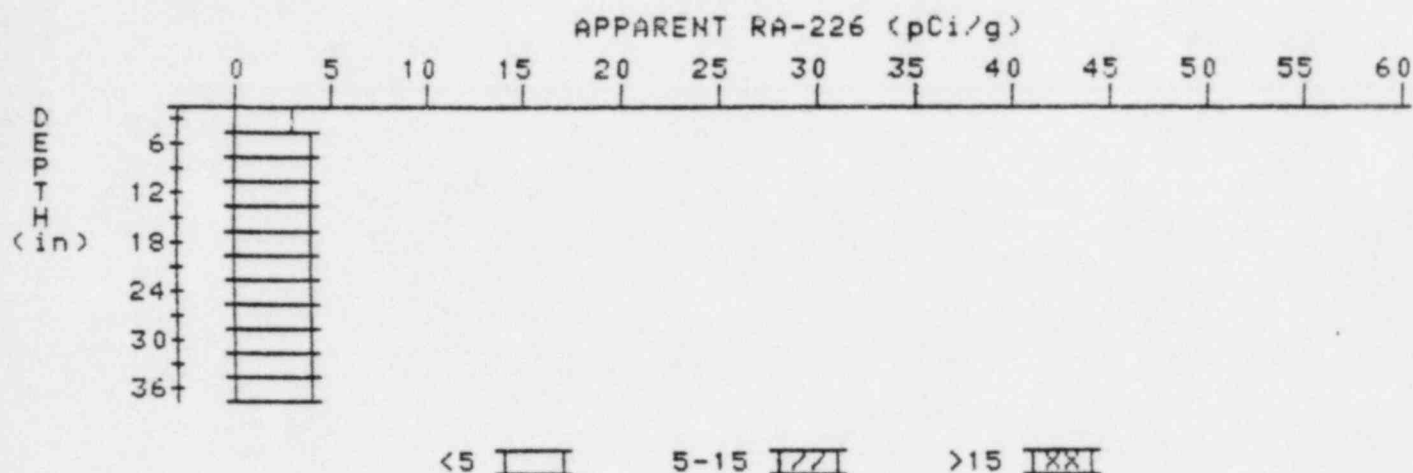
APPARENT RADIUM-226 CONCENTRATION 16 DECONVOLUTION GRAPH

Depth (in)	Apparent Radium-226 (pCi/g) Undeconvolved	Apparent Radium-226 (pCi/g) Deconvolved
3	3.3	3.3
6	3.7	4.1
9	3.9	3.9
12	4.1	4.5
15	4.1	4.1
18	4.1	4.1
21	4.1	4.3
24	4.0	3.6
27	4.1	4.3
30	4.1	4.1
33	4.1	4.1
36	4.1	4.1

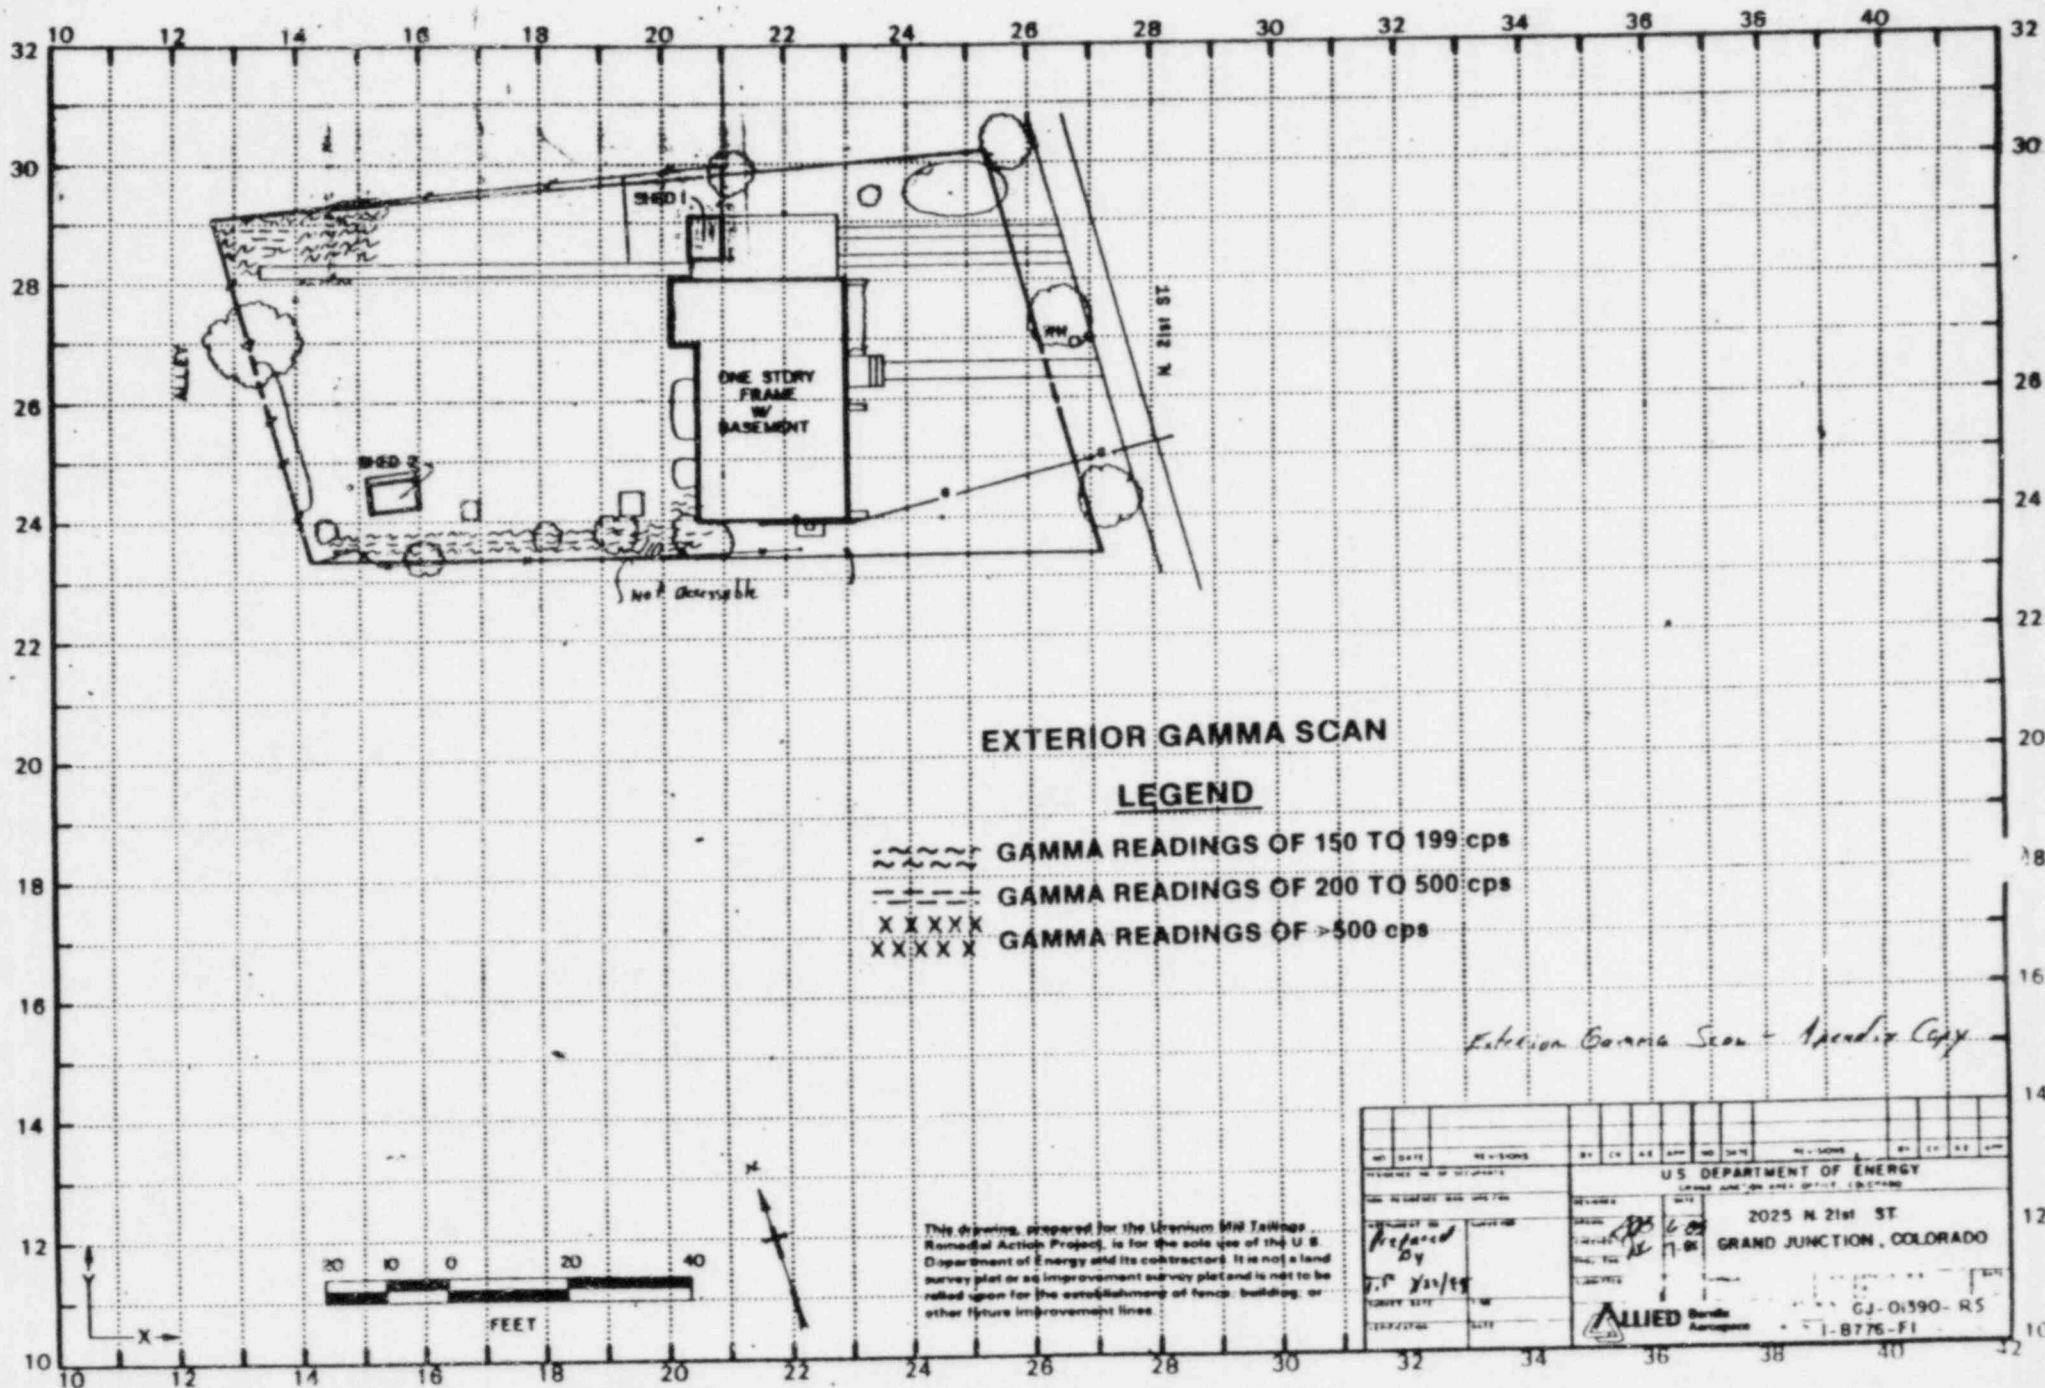
Exterior Gamma Scan Map

The survey crew arrived on the property at 7:30 AM. After performing an exterior scan and grid point survey, we noted elevated readings along the north and south fence lines. Deltas and boreholes were performed in these areas.
