RADIOLOGIC AND ENGINEERING ASSESSMENT

DOE ID NO.: GJ-00712-RS  
ADDRESS: 1522 ELM AVENUE

URANIUM MILL TAILINGS REMEDIAL ACTION PROJECT OFFICE

BENDIX FIELD ENGINEERING CORPORATION  
P.O. Box 1569  
Grand Junction, Colorado 81502

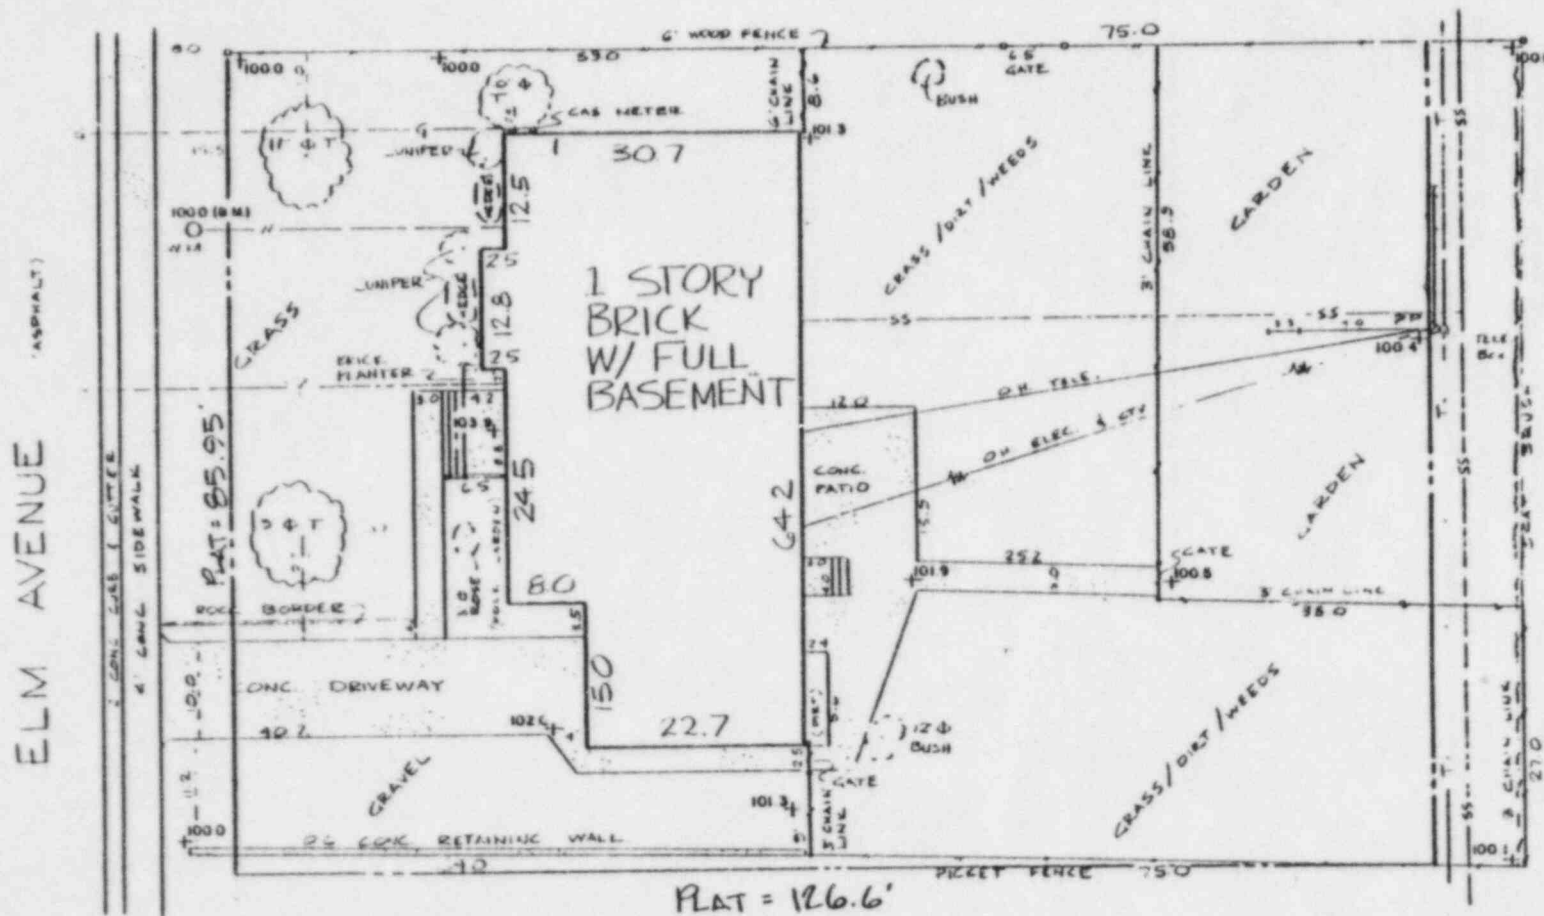
FIGURE 2.2  
SITE PLAN

Tailings are extensive under landscaped areas. Structures, utilities, landscaping, and other special features of this property are included in Appendix Figure 2.2.
