Loss of Main and Auxiliary Feedwater Event at the Davis-Besse Plant on June 9, 1985

U.S. Nuclear Regulatory
Commission

Manuscript Completed: July 1985
Date Published: July 1985

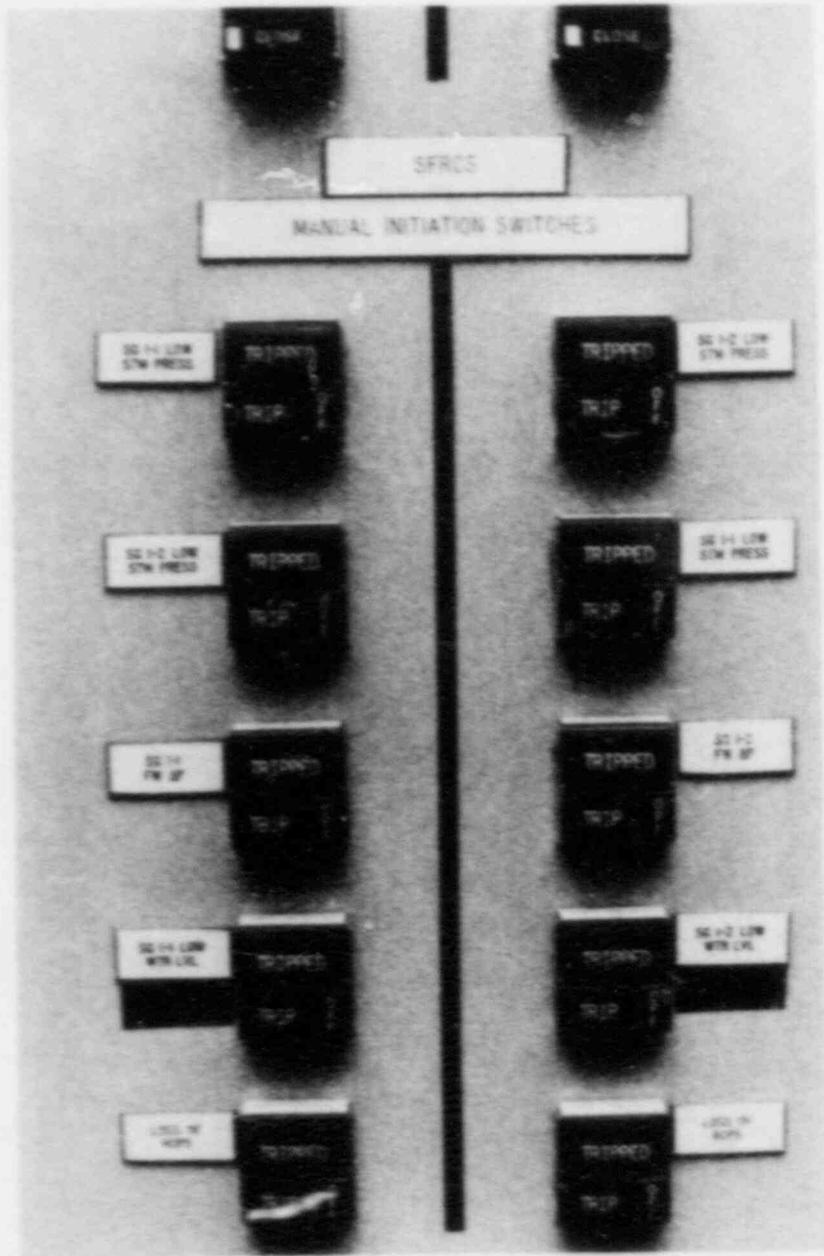
Figure 3.6 Manual Initiation Switches for SFRCS

He went to the manual initiation switches at the back panel and pushed two buttons to trip the SFRCS. (The SFRCS control panel is shown in Figure 3.6.) He inadvertently pushed the wrong two buttons and, as a result, both steam generators were isolated from the emergency feedwater supply. He had activated the SFRCS on low pressure (the top pair of buttons in Figure 3.6) for each steam generator instead of on low level (the fourth pair of buttons from the top). By manually actuating the SFRCS on low pressure, the SFRCS was signalled that both generators had experienced a steamline break or leak and the system responded, as designed, to isolate both steam generators. The operator's anticipatory action defeated the safety function of the auxiliary feedwater system--a common-mode failure and the third abnormality to occur within 6 minutes after the reactor trip.

The operator returned to the auxiliary feedwater station expecting the AFWS to actuate and provide the much-needed feedwater to the steam generators that were boiling dry. Instead, he first saw the No. 1 AFW pump, followed by the No. 2 AFW pump trip on overspeed--a second common-mode failure of the auxiliary feedwater system and abnormalities four and five. He returned to the SFRCS panel to find that he had pushed the wrong two buttons.

The shift supervisor quickly determined that the valves in the AFWS were improperly aligned. He reset the SFRCS, tripped it on low level, and corrected the operator's error about one minute after it occurred. This action commanded the SFRCS to realign itself such that each AFW pump delivered flow to its associated steam generator. Thus, had both systems (the AFWS and SFRCS) operated properly, the operator's mistake would have had no significant consequences on plant safety.
