Re: Reportable Occurrence: Tech Spec Violation  
License R-2, Docket No. 50-005, letter of December 20, 1996

## Addendum to Reportable Event Letter of December 20, 1996

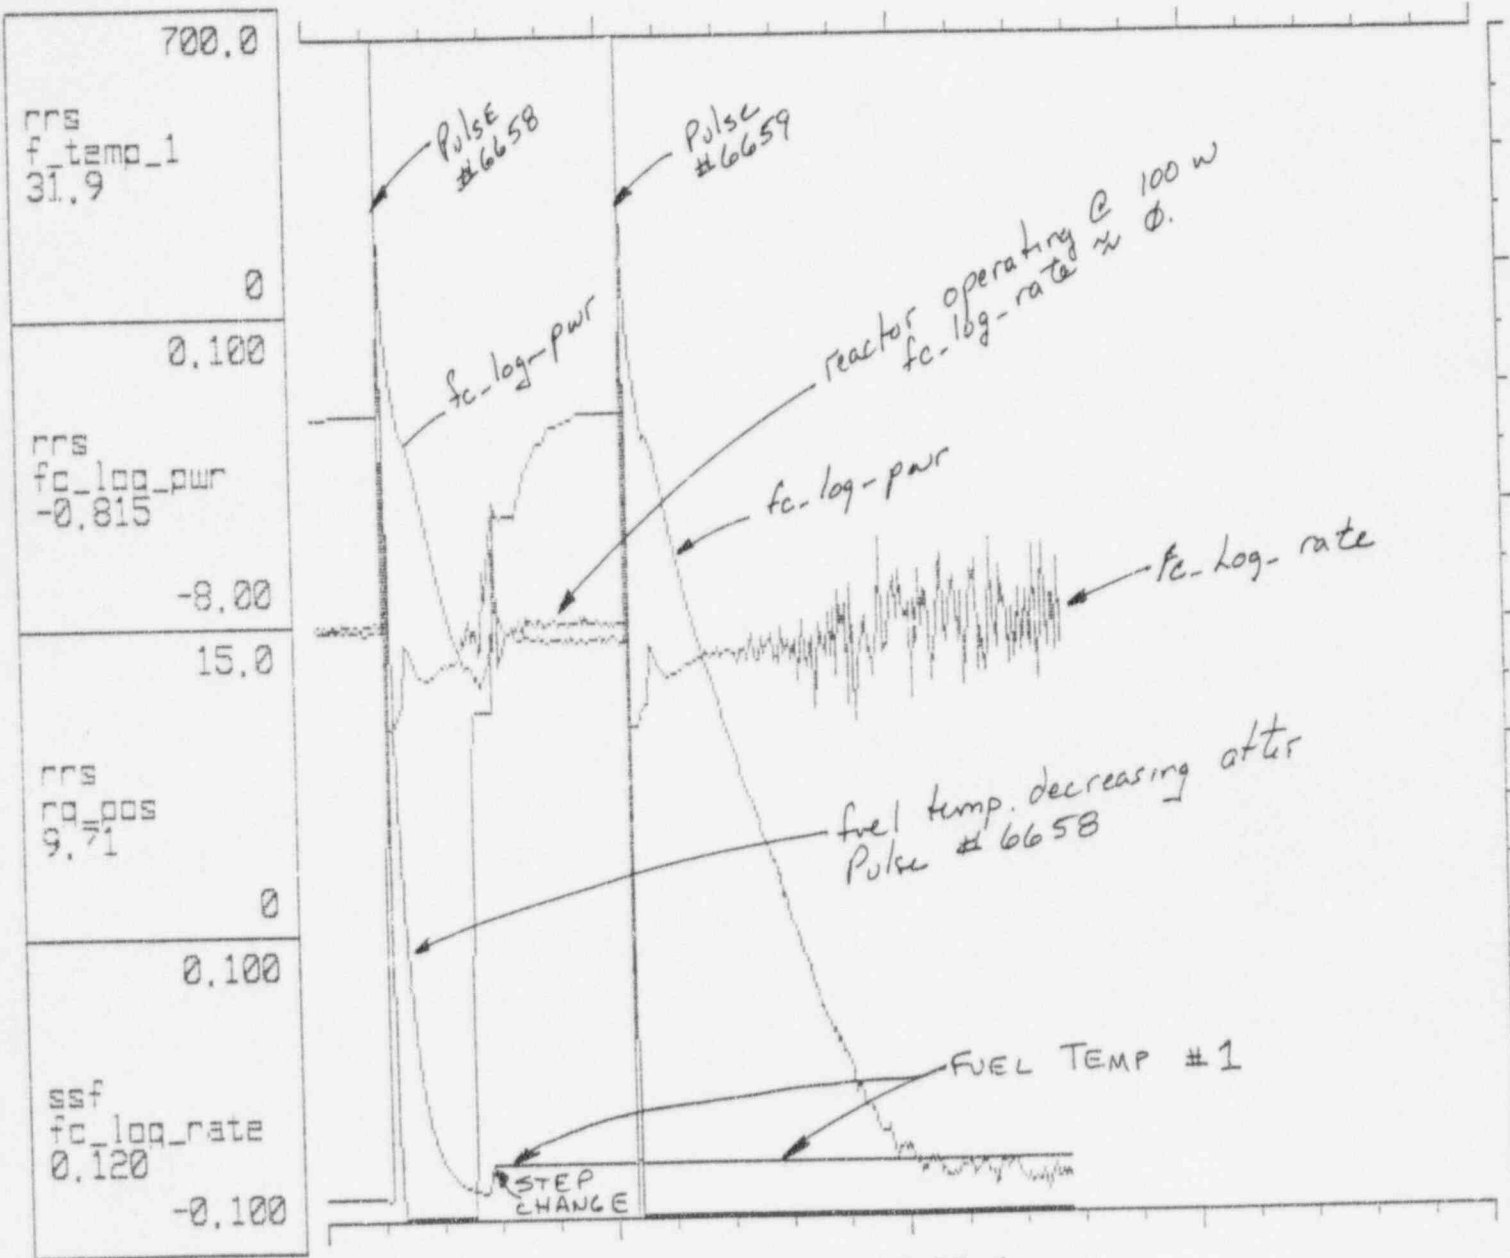
Data 96 Dec 16 19:57:29.13 Set name =neg\_temp Update Period = 9.64 sec

Immediately a comprehensive evaluation of this event was undertaken. Attachment 1 documents the fuel temperature before, during and after pulse #6659. This trend clearly shows the fuel temperature step change just prior to operating the reactor at 100 watts and returning to normal some 53 minutes later. Attachment's 2 and 3 show the data acquired during pulses #6658 and #6659. After reviewing data from the Local Area Network (LAN) system, the DCC-Z message log, the trends printed by the staff immediately after the event, and reviewing the event with the experimenter, we were able to reconstruct the timetable above. Between pulses #6658 and #6659 the experimenter increased the experimental probe excitation from +15 volts to +20 volts, this caused the initial step change in the fuel temperatures. After the event had taken place and the reactor was secured, the experimenter turned his equipment off for the night. This resulted in the fuel temperatures returning to their normal readings. During the investigation the following key steps were completed:

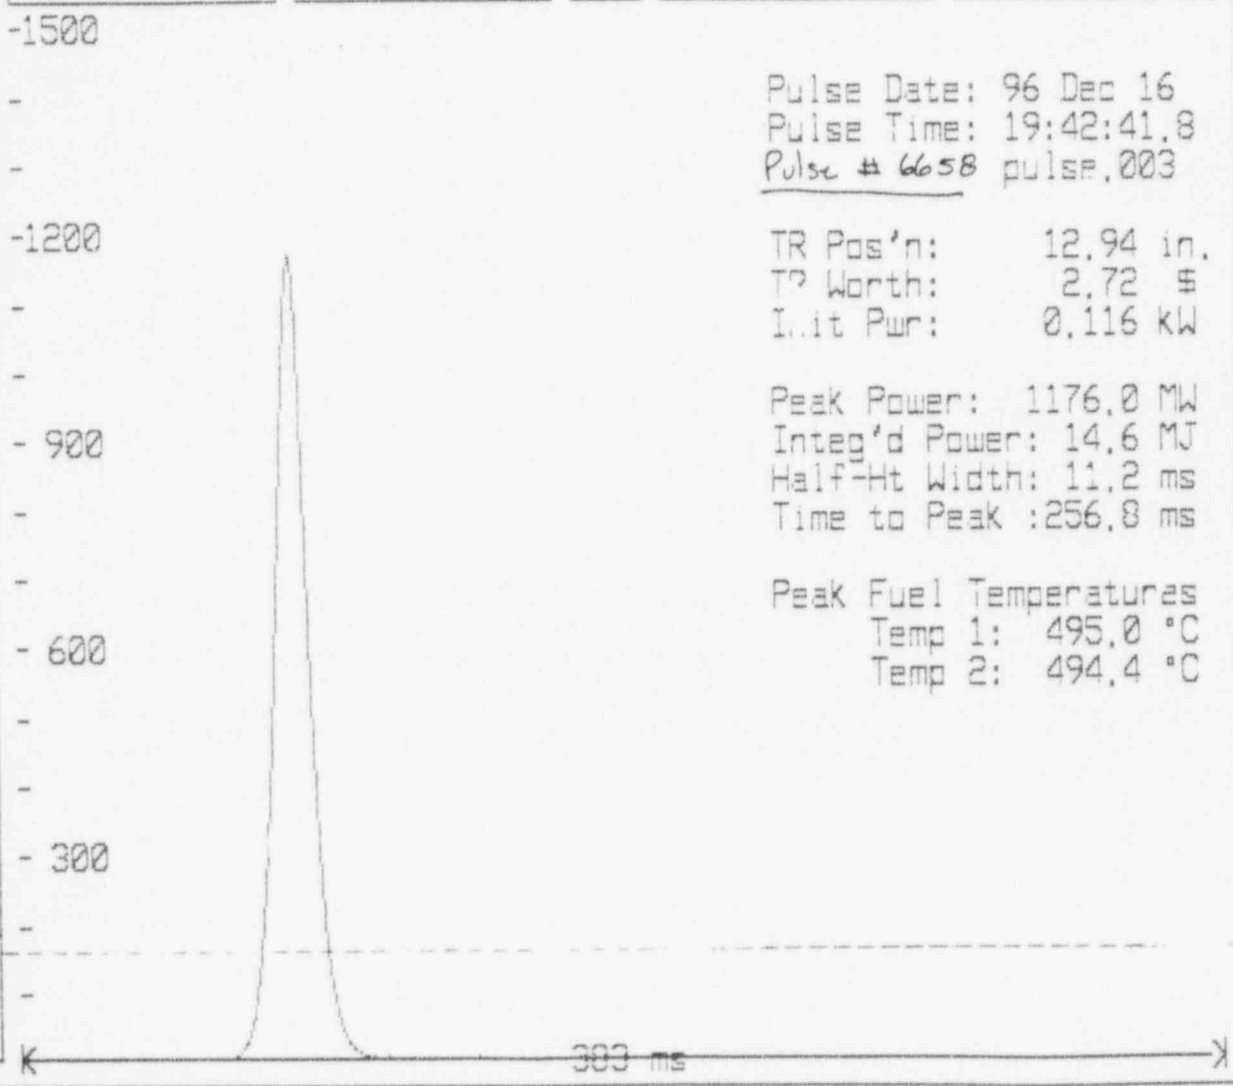
Pulse Date: 96 Dec 16  
 Pulse Time: 19:42:41.8  
 Pulse # 6658 pulse.003

Peak Fuel Temperatures  
 Temp 1: 495.0 °C  
 Temp 2: 494.4 °C

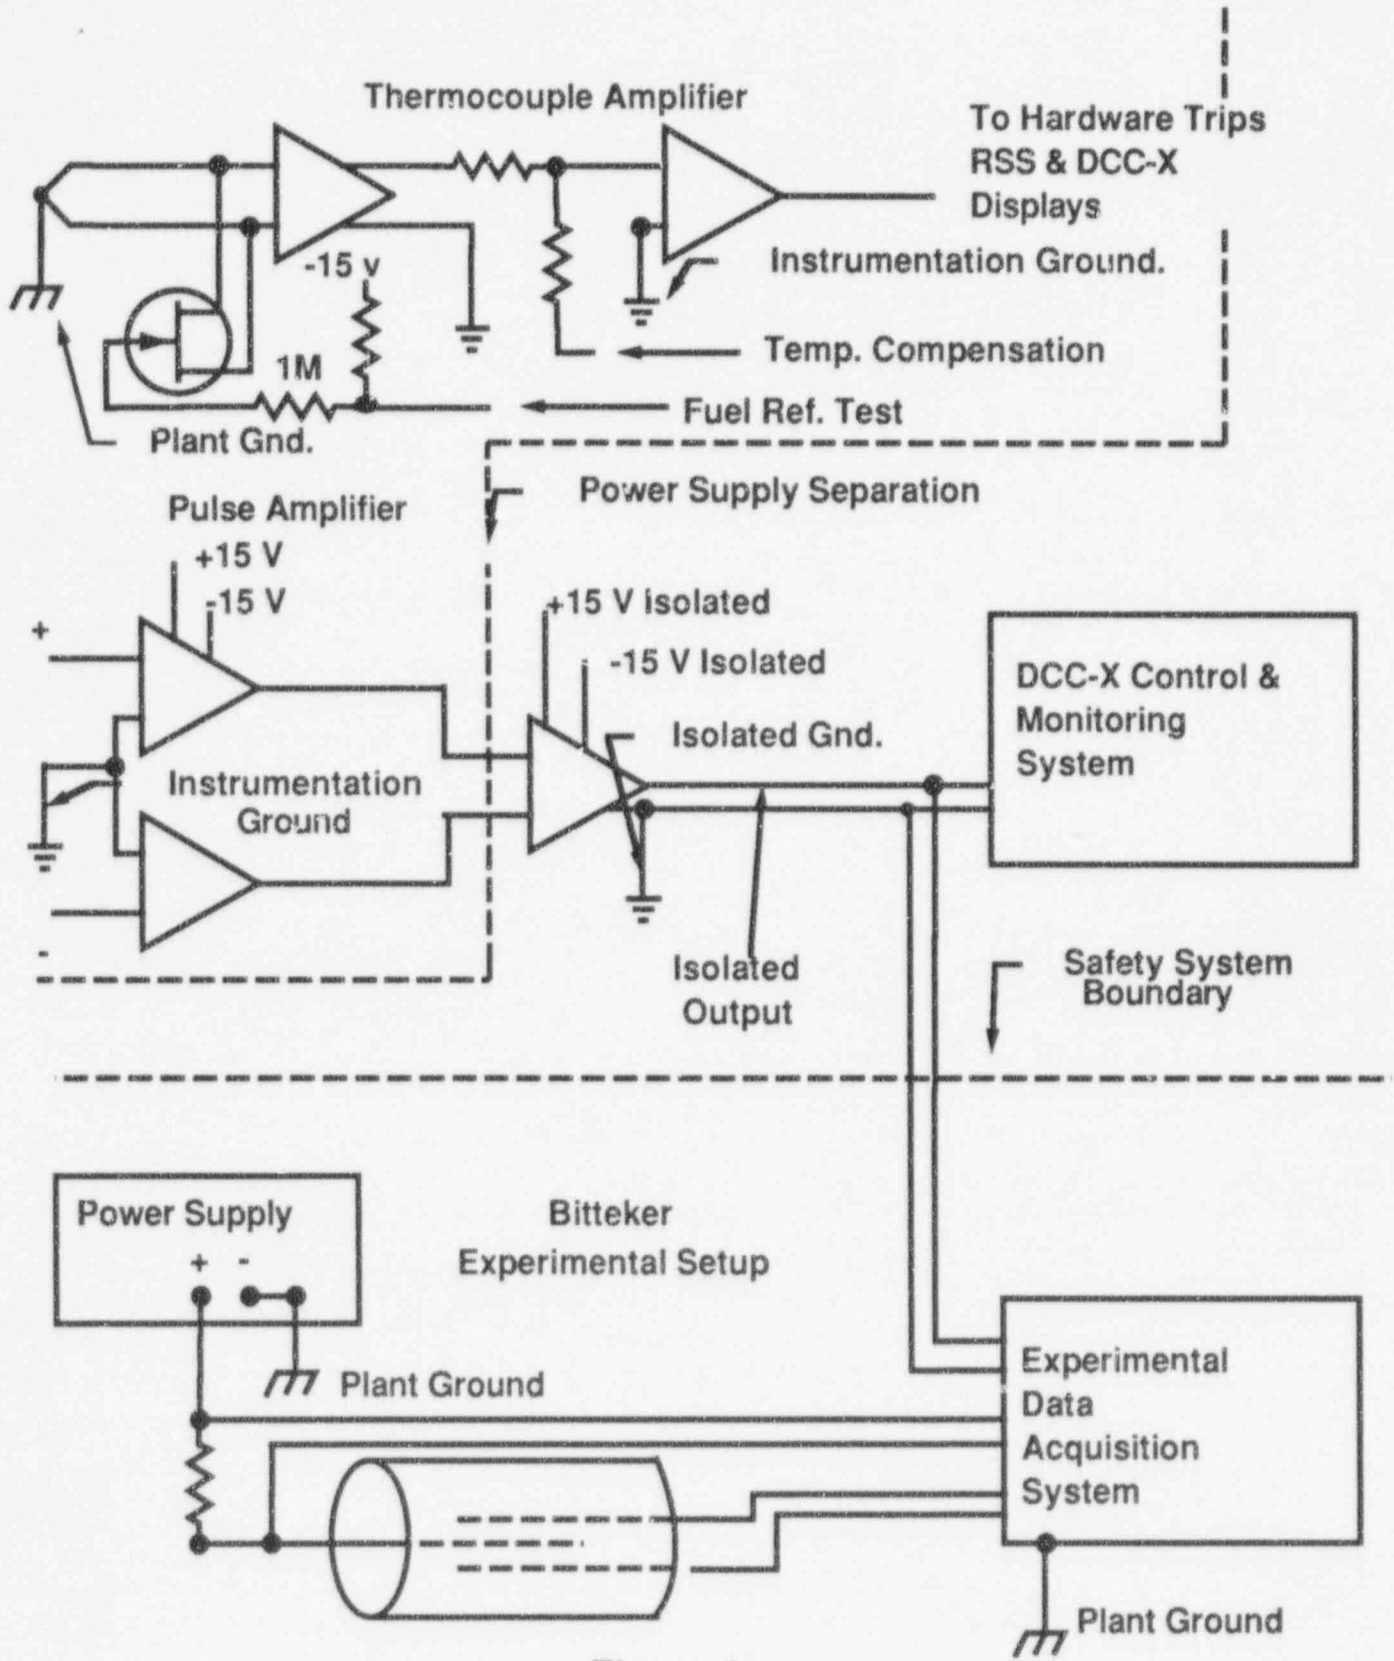
Figure 1

The -10 volt potential measured on both sides of the thermocouples with respect to instrument ground is key to the analysis of why the thermocouples were non-operative during the steady state operation and did not respond to the pulse. Referring to Figure 1, the main components of the thermocouple amplifier circuit are the thermocouple, diode protection, JFET, instrumentation amplifier and the temperature compensation. The thermocouple input is connected between R1 and R2 and R6 and R7 which provides bias current for the amplifier and a substitute voltage if the thermocouple opens or is disconnected. This substitute voltage provides an input to the amplifier that generates an output indication of greater than 1200° C. Zener diodes CR1- CR4, provide over voltage protection for the input of the amplifier. The JFET is normally held off by holding the gate to source differential voltage to approximately -13 volts. When the gate is pulled to ground by a test switch, the differential gate to source voltage becomes approximately 0 volts turning the JFET on. This shorts the thermocouple inputs together; activating the test switch Fuel 1 Ref. or Fuel 2 Ref. also generates a non-operate condition which causes a reactor trip. When the thermocouple inputs are shorted the output of the thermocouple amplifier indicates the temperature of the compensation circuit. Due to the -10 volt potential being applied to the thermocouple junction the JFET was turned on. It was turned on by decreasing the gate to source voltage to approximately -3 volts. Turning on the JFET shorted the thermocouple inputs together. This does not generate a non-operate condition because the test switch was not activated and therefore did not trip the reactor. Shorting the inputs together forced the output of the amplifier to approximately 30 °C, which was the temperature indication of the temperature compensation circuit. Additionally when these inputs are shorted, they cannot respond to any temperature change in the fuel. This resulted in a non-operative thermocouple during the steady state operation and pulse #6659 since the circuit could not respond to the temperature of the instrumented element. Therefore the fuel temperature safety circuit was inoperative.
