Commonwealth Edison Company
LaSalle Generating Station
2601 North 21st Road
Marseilles, IL 61341-9757
Tel 815-357-6761

LICENSEE EVENT REPORT (LER)

FACILITY NAME (1): LaSalle County Station Unit Two	DOCKET NUMBER (2) 05000374	PAGE (3) 1 of 11
--	--------------------------------------	----------------------------

TITLE (4) Failure to Follow Procedures Results in Technical Specification Violation of the Core Standby Cooling System Pond Surveillance

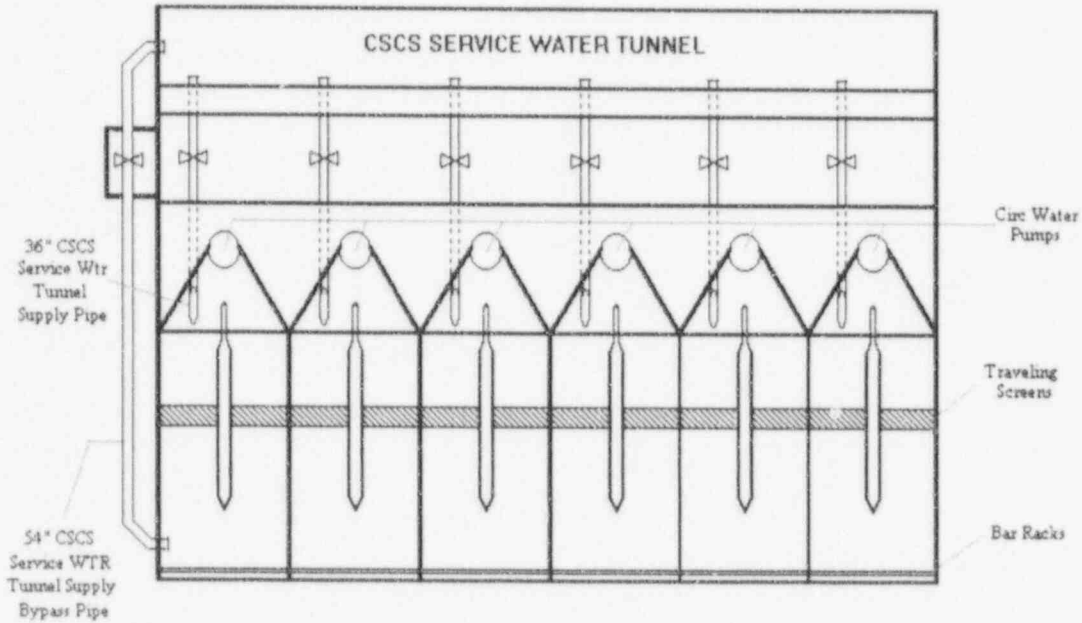
LAKE SCREEN HOUSE

There are 6 36-inch pipes supplying the Core Standby Cooling System (CSCS) [VF] tunnel, one from each of the 6 Circulating Water (CW) [KE] pump bays, located inside the bar grills and Traveling Screens. There is also a 54 inch CSCS inlet bypass pipe that can supply the CSCS tunnel from the Unit 1 CW Pump bay area located inside the bar grills and outside the Traveling Screens to provide a suction for the CSCS pumps in the unlikely event that the Traveling Screens would become completely blocked. (See Attachments A and B). Technical Specification 3.7.1.3 states the surveillance requirement that the sediment deposition anywhere within the Lake Screen House behind the bar racks is not greater than one foot in thickness. The basis of the one foot limit is to ensure that any sediment buildup would be below the bottom of the 7 CSCS tunnel inlet pipes. These pipes are 18 inches above the CW pump bay floor.

The operability of the Ultimate Heat Sink ensures that sufficient cooling capacity is available for continued operation of the safety-related equipment during normal and accident conditions. There are 6 36-inch pipes supplying the Core Standby Cooling System (CSCS) tunnel, one from each of the 6 Circulating Water pump bays, which are inside the bar grills and the Traveling Screens. There is also a 54 inch CSCS inlet bypass pipe that can supply the CSCS tunnel from the Unit 1 CW Pump bay area located inside the bar grills and outside the Traveling Screens to provide a suction for the CSCS pumps in the unlikely event that the Traveling Screens would become completely blocked. The basis of the one foot maximum limit on sediment anywhere in the Lake Screen House inside the Bar Racks is to ensure that any sediment buildup would be below the bottom of the 7 CSCS tunnel inlet pipes. This one foot limit is conservative as the bottom of the 7 CSCS tunnel inlet pipes are 18 inches above the CW pump bay floor.

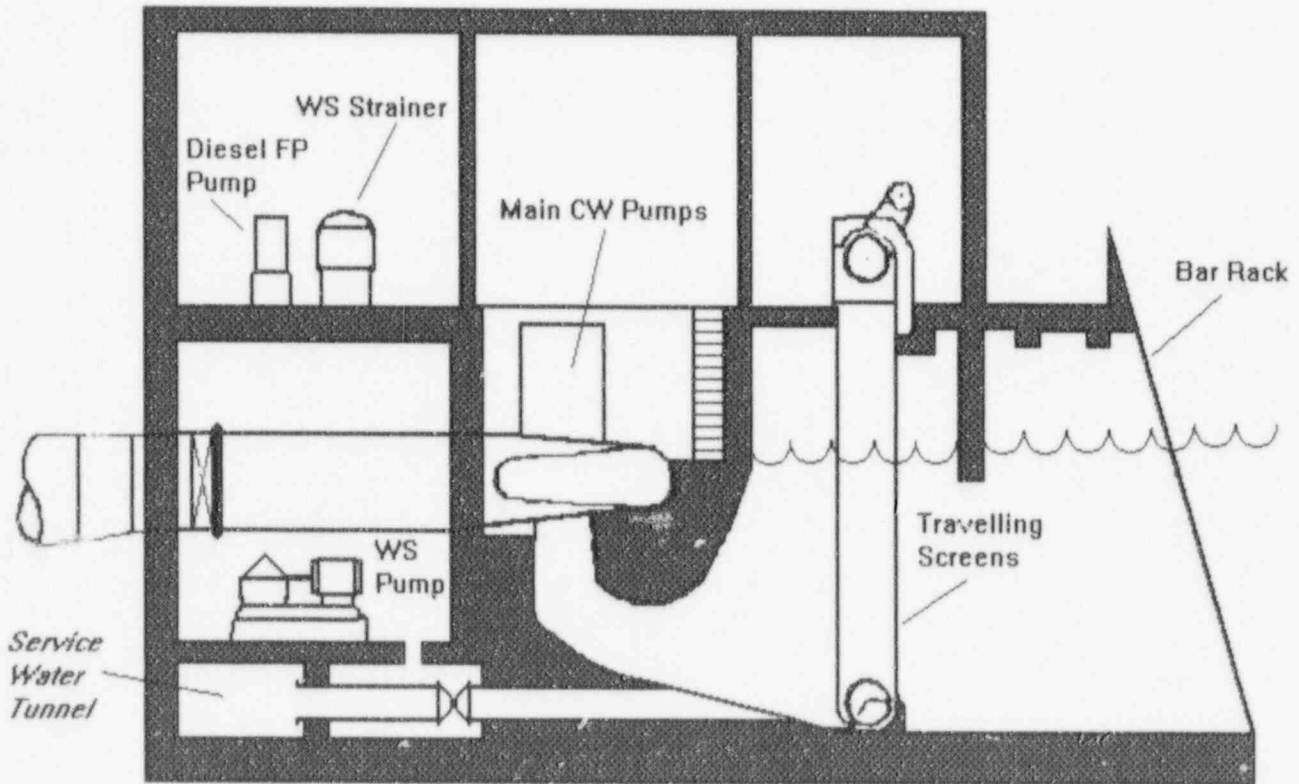
LAKE SCREEN HOUSE (Section)

The Safety Significance of this event is minimal as the bottom of the each of the 7 pipes that supply a suction path to the CSCS pumps is 18 inches above the CW pump bay floor. The depth of sediment in the area after the bar grills and after the traveling screens for the three Unit 1 CW pump bays was measured from 2 to 16 inches. This is below the bottom of the three normal CSCS tunnel inlet pipes in these bays. The depth of the sediment in the area after the bar grills and before the traveling screens was 0 inches with some small, 1 to 3 inch piles of light gravel which is well below the CSCS inlet bypass pipe.
