U.S. NUCLEAR REGULATORY COMMISSION  
REGION I  
MEETING REPORT

Docket/Report No.: 50-336/85-26

Facility Name: Millstone Nuclear Power Station, Unit 2

## Reversed Wiring of Pressurizer Spray Valves

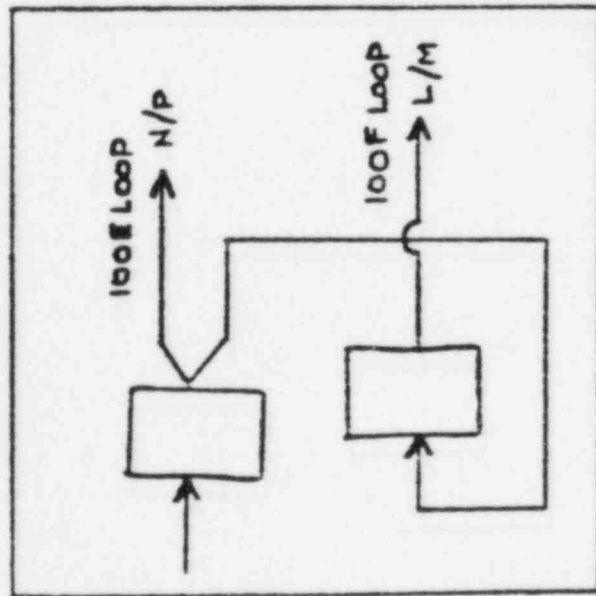
25203-28500  
SHEET 50D

As indicated on the simplified sketch, three of the drawings included in the plant design change request contained the discrepancy which resulted in the wiring reversal. Sheet 50D identified wires N/P as carrying loop E signals while wires L/M carry the loop F signal. However, sheet 50E reversed the wires such that wires N/P supply the F loop and wires L/M supply the E loop. This reversal was repeated on sheet 50F in that output wires Q/R and S/T switched from F to E and E to F respectively.

When the wiring error was discovered an addendum was initiated to the plant design change request to correct the discrepancy. The change consisted of reversing the wires on the CO3 controllers and reversing the nameplates on the C21 controllers. To understand why the corrective actions are different the design of the control boards must be considered. On C21, facility separation is by a metal divider which splits the back panel in half. On CO3, three feet of space provides the separation.

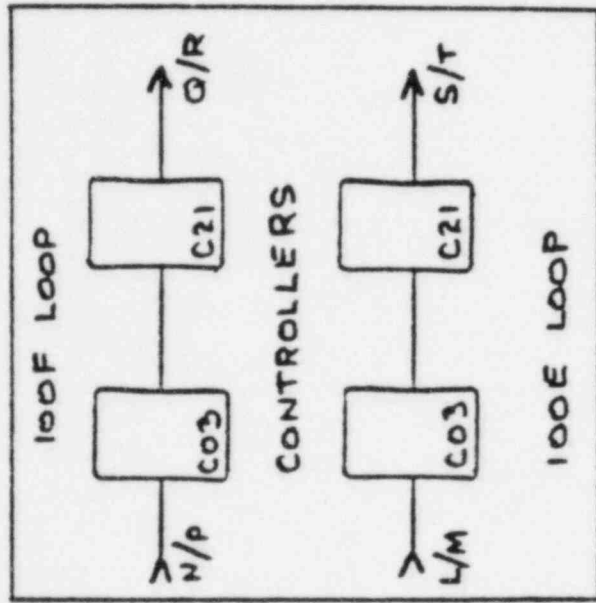
25203-28500  
SHEET 50E

As a result of these wire reversals, the CO3 and C21 controllers, which were reflected on sheet 50E, were wired such that the E controller operated the F valve and the F controller operated the E valve. This discrepancy was not discovered during testing since valve operation was not verified. Rather, test meter deflections were observed. These meter deflections were observed at test points identified on the same prints which resulted in the reversal.

Concerning the original modification to CO3, identical controllers were placed in a new section of control board for the two valves. The labeling of these controllers was consistent with the design layout drawing which maintained the system mimic on the remainder of the panel. However, the design layout drawing reflected the mistake made on sheet 50E and the wrong wires were connected to the controllers. Therefore, the corrective action is to reverse the wires.

The modification on C21 consisted of identical controllers being placed in two holes in the control board. One of the holes was on each side of the divider plate. Since one hole was on each side of the divider plate and one cable was pulled to each side of the plate, the connections were made without reference to the layout drawings or connection drawings which were in error. The layout drawing was used for labeling, however, and the controllers were mislabeled. Thus, the C21 corrective action is to reverse the labels.
