# PERRY NUCLEAR POWER PLANT DEVIATION ANALYSIS REPORT

ITEM Ruskin Fire Dampers	LOCATION Perry Nuclear Power Plant	QUANTITY 85
ORIGINATOR <i>MAB</i> M. A. Brown <i>RLV</i> <i>WJK</i>	ORGANIZATION Construction Quality Engineering	DATE 8/8/80
RESPONSIBLE ORGANIZATION Ruskin Manufacturing Company	SPECIFICATION SP-49/91	REFERENCE DOCUMENTS See Attached

Subject: Ruskin's Vertical Spring Close IBD Fire Dampers

Subject: Modification of Vertical Fire Dampers

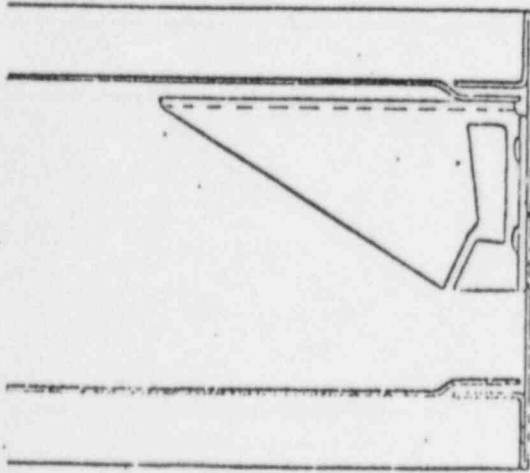
Vertical IBD type Fire Dampers with spring closure built by Ruskin after June 1979, have spring brackets installed with two rivets through the bottom of the frame and a tackweld holding the top of the bracket to the blade guide. Previous to this date, brackets had not been tackwelded to the blade guide. Addition of the tackweld came about after noting that repeated closings of the blade package during air test at our laboratory caused some bending in the brackets. Fastening of the bracket to the blade guide was to provide extra support for the bracket; however, it also alters the shape of the spring holding slot. This was discovered recently when we recieved a report from one job site of some springs coming out of brackets while the damper were being cycled. The engineering firm for this job has advised Ruskin that this problem is reportable under 10CFR part 21. Ruskin has reported it accordingly.

ORIGINAL INSTALLATION  
(VERTICAL FIRE DAMPERS  
WITH SPRING CLOSURE)

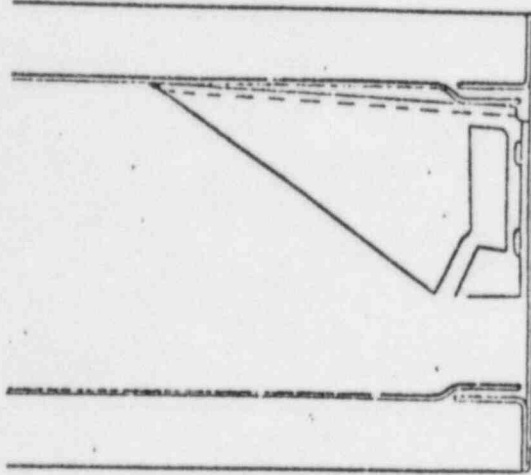
TOP EDGE OF BRACKET  
TACKWELDED TO PROVIDE  
EXTRA SUPPORT FOR  
BRACKET & RESULTING  
ALTERATION OF SPRING  
SLOT

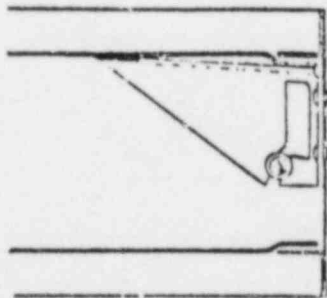
Although it appears that this method should have eliminated the problem, an engineering firm has indicated to us that some of the screws worked loose during shipment. This raises the possibility that the use of screws as a fix is questionable. We therefore request that you stop any activity relative to the installation of this fix.

INSTALLATION OF  
PROPOSED BRACKET  
CLAMP (SEE DETAIL  
PAGE ALSO)

ORIGINAL FIX USING  
#6 SCREW, WASHER, NUT  
LOCKWASHER & NUT

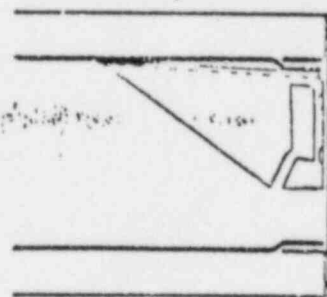
TOP EDGE OF BRACKET  
TACKWELDED TO PROVIDE  
EXTRA SUPPORT FOR  
BRACKET & RESULTING  
ALTERATION OF SPRING  
SLOT

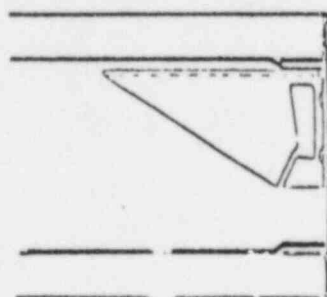
ORIGINAL INSTALLATION  
(VERTICAL FIRE DAMPERS  
WITH SPRING CLOSURE)

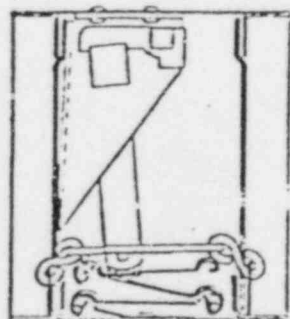
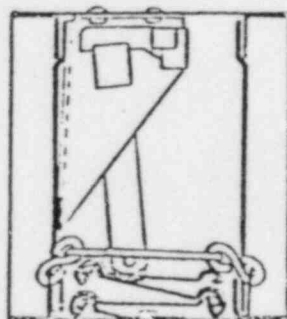
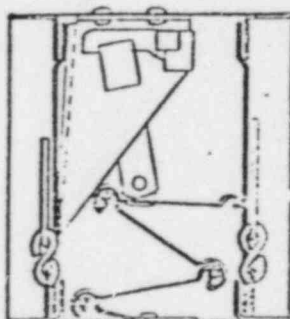
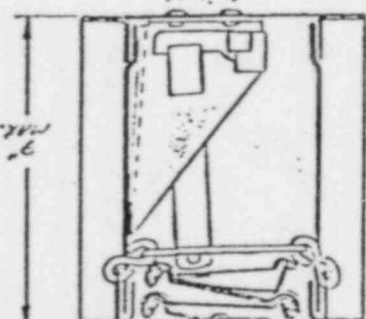
A second problem has also been brought to our attention. If the blade package in vertical units less than 9" high is shifted such that the leading edge of the bottom blade rests higher than the trailing edge, the blades may jam when released.

VERTICAL DIBOZ  
AS SHOWN, THE ORIFER  
WILL CLOSE COMPLETELY  
AND CONSISTENTLY WHEN  
THE FUSE LINK MELTS

ABOVE THE GLASS PICKUP  
HAS BEEN SHIFTED PLACED  
THE LEADING EDGE OF  
THE BOTTOM BLADE TO BE  
ABOVE THE TRAILING  
EDGE - IF THE FUSE  
LINK MELTS WITH THE  
BLADES IN THIS POSITION,  
THEY WILL JAM AS IN  
THE NEXT DETAIL

BLADE PICKUP JAMMED

Ruskin has developed a snap-in strip which when installed will hold the bottom blade in the proper orientation and insure complete and consistent closure (see drawing 5565).

CAMPER WITH SLIP IN  
STRIP (SHOWN AT RIGHT)  
INSTALLED, SIDE LEADING  
EDGE IS HELD BELOW  
TRAILING EDGE OF BOTTOM  
BLADE, UNIT CLOSSES  
COMPLETELY & CONSISTENTLY
