DUKE POWER COMPANY

August 23, 1985

Regarding: Catawba Nuclear Station
Docket No. 50-413 and 50-414
Resolution of Outstanding Items on Diesel Generators

The purpose of this letter is to inform you of action that Duke Power Company is taking on cylinder heads for the Catawba diesel generators.

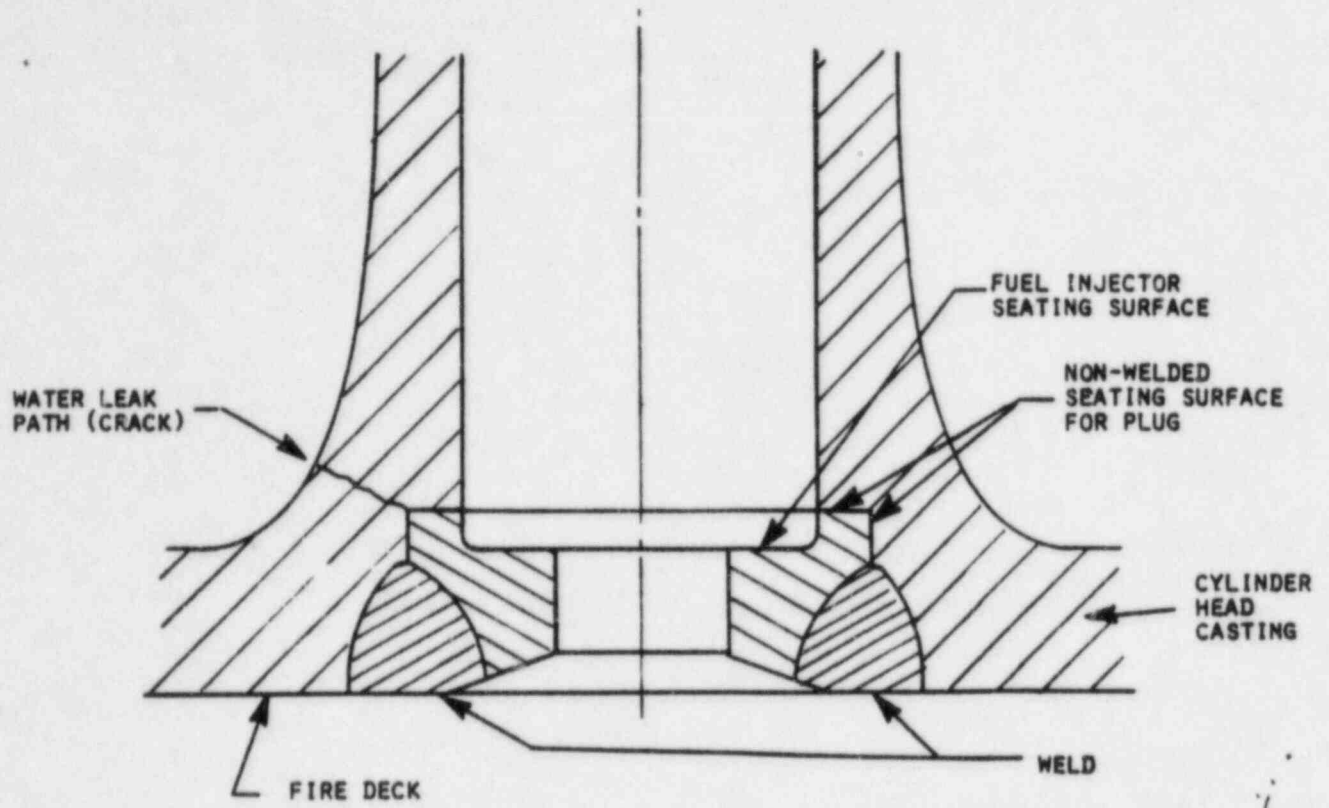
A. OLD HEAD REPAIR

Four cylinder heads at Catawba, one on engine 1A and three on engine 1B, developed small jacket water leaks into the fuel injection cavity. The 1A cylinder head has been examined by FaAA. This investigation (reference 3) revealed that the leak was caused by a crack initiating from the corner of a welded-in plug where it was seated in the cylinder head as shown in Figure 1A. This welded-in plug is reported by TDI to have been used to repair the casting around the fuel injector hole. This head as well as the three heads on engine 1B were replaced. Reference 2, forwarded by reference 1, requested that Duke Power Company replace another head on diesel 1A (head 6L) where it was suspected, based on visual examination, that this head had the same welded-in plug. This head was subsequently replaced on diesel 1A. The remaining heads on both engines were inspected and we therefore believe that none of the cylinderheads on the Catawba Unit 1 diesels have weld repairs.
