LICENSEE EVENT REPORT (LER)

Facility Name (1) Quad Cities Unit Two	Docket Number (2) 0 5 0 0 0 2 6 5	Page (3) 1 of 0 6
---	--	----------------------------

Title (4)
High Pressure Coolant Injection Inoperable Due to Inadequate Venting.

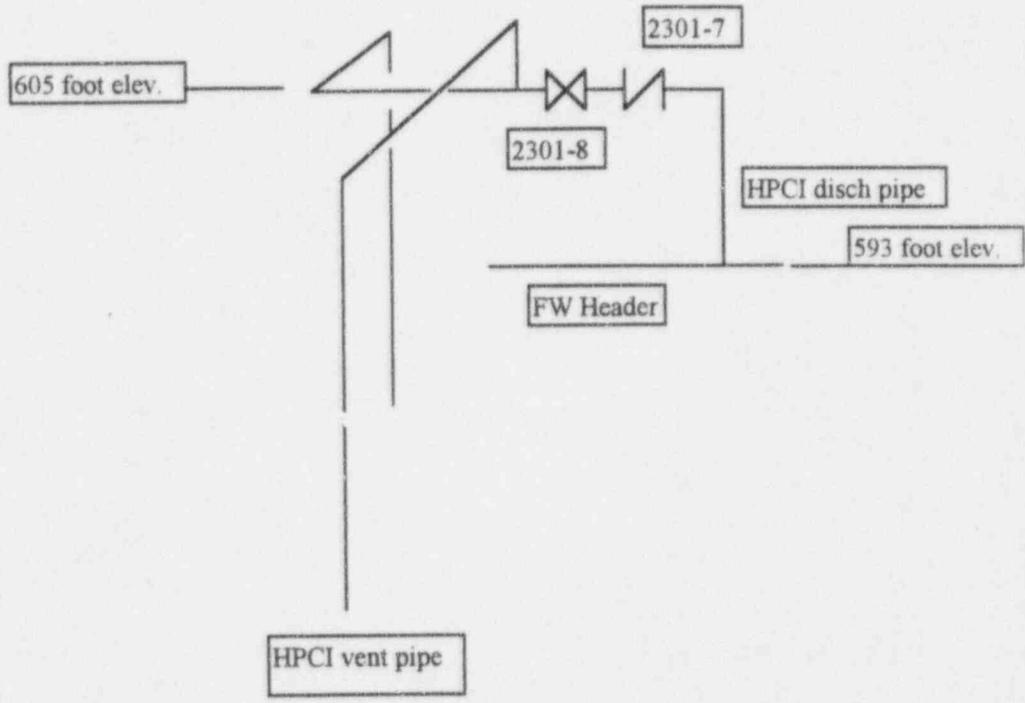
The apparent cause of this event was a failure to properly vent the HPCI injection piping downstream of the system isolation valve (2-2301-8) after maintenance in August 1996 on the system injection check valve (2-2301-7). Refer to Figure 1 for a layout of the HPCI discharge piping high point.

Since these vents are located below the high point of the HPCI discharge piping, the discharge piping was not completely filled. This improper venting left air in the piping downstream of the system isolation valve.

The system isolation valve, 2-2301-8, is opened on a quarterly frequency. The first time that it was opened after this improper venting was on October 8, 1996 per QCOS 2300-6, "Quarterly HPCI System Power Operated Valve Test." When the system isolation valve was opened, the air trapped in the piping migrated to the upstream side of the 2-2301-8 system isolation valve since the upstream piping section was at a lower pressure than the downstream side. Subsequently, on October 9, 1996 when QCOS 2300-09 was attempted, this trapped air prevented the system from venting properly even though there was a static head of water above the high point of the discharge piping.

The U-2 HPCI vent piping is hard piped to a six foot loop seal located about forty feet below the HPCI high point piping. With this vent piping full of the air that was trapped in the HPCI discharge piping, six feet of static head could not be developed at the loop seal and water flow could not be established. When the HPCI discharge piping was completely evacuated of air during the cooling water pump run at about 1900 hours on October 9, 1996, continuous water flow was established through the vent piping. This scenario was verified through conversations with hydraulic systems experts at General Electric Company.

1. The U-2 HPCI discharge piping has been verified to be full of water to the system isolation valve (M02-2301-8).
2. QCOS 2300-9, was completed following performance of QCOS 2300-6, thereby verifying no additional trapped air present in the HPCI piping downstream of the system isolation valve.
3. It was verified that a similar problem did not exist on Unit 1 by ensuring that QCOS 2300-9, had been successfully completed following the performance of QCOS 2300-6.
4. The root cause team report has been distributed to the Operating Department to ensure they understand the cause of this event.
5. An engineering letter has been written to the Operating Department instructing them on the proper vent location for system venting. Additionally, this letter included instructions on how to ensure that piping is completely filled if there is not a high point vent available.

1. Revise QCOP 2300-1, to ensure that the piping downstream of the system isolation valve is filled and vented after maintenance (that drains the piping). This will be completed by December 15, 1996. (NTS# 2651809600201, OP)
