Edwin I. Hatch Nuclear Plant
Reply to a Notice of Violation

Edwin I. Hatch Nuclear Plant
Violation 96-14-03 and GPC Response

VIOLATION 96-14-03

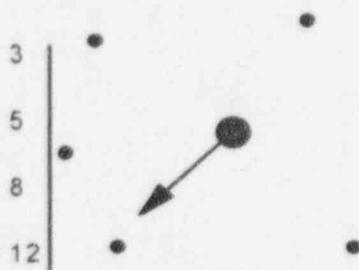
The fourth example of the Notice of Violation was caused by an inadequate breaker trip device label. Specifically, the manufacturer-installed labels on the face of the breaker trip device selector switch are misleading. An individual setting the trip device to point to the numeral 12 on the face of the selector switch would actually be setting it to a dot corresponding to an incorrect trip setpoint of 8X instead of the desired setpoint of 12X. (Comparing Figure 1 with Figure 2 shows the labeling problem which led to the breaker trip device being set incorrectly.) The inadequate label resulted in the installed overcurrent trip device for the normal supply breaker to Motor Control Center 1R24-S026 having a setting which differed from the electrical single line diagram and from procedure 52PM-R24-002-0S, "Air Circuit Breaker, Type LA-600, Maintenance," both of which required a trip setpoint of 12X.

Figure 1
Actual Appearance of
Selector Switch Face

For the fourth example, a temporary modification was implemented on 11/10/96 in which a 150-amp, non-safety related load was removed from Unit 1 Motor Control Center 1R24-S026 and powered from another bus. The incorrectly set trip device installed on the

600V feeder breaker in Motor Control Center 1R24-S026 then was disabled and the appropriate breakers set to accommodate the remaining loads on the bus. These actions were taken in response to potential concerns regarding proper breaker coordination with the instantaneous overcurrent trip device installed and resulted in the "B" Emergency Diesel Generator being returned to operable status. Breaker settings for similar breakers in the plant have been checked by the system engineer; they were found to be correct.

5. A permanent design change will be made to Unit 1 Motor Control Center 1R24-S026 to remove the existing trip devices from the primary and alternate feeder breakers on this bus. Thereafter, circuit protection will be provided for this 600V bus by upstream 4160V breakers. The load which was removed from this 600V bus will be returned to the bus. These actions will be completed by 6/15/97.

For the fourth example, full compliance was achieved on 11/10/96 when the breaker trip device on Unit 1 Motor Control Center 1R24-S026 was disabled and documented per an approved temporary design configuration.

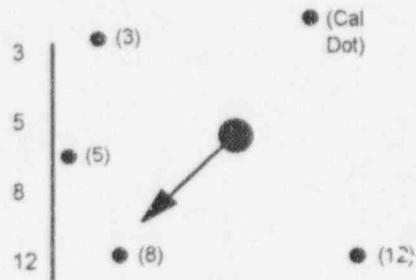
Figure 2
Selector Switch Face With
(Numbers) Added to Show
What Each Dot Represents
