POWER REACTOR EVENTS

United States Nuclear Regulatory Commission

Date Published: December 1985

Period Covered: May-June 1985

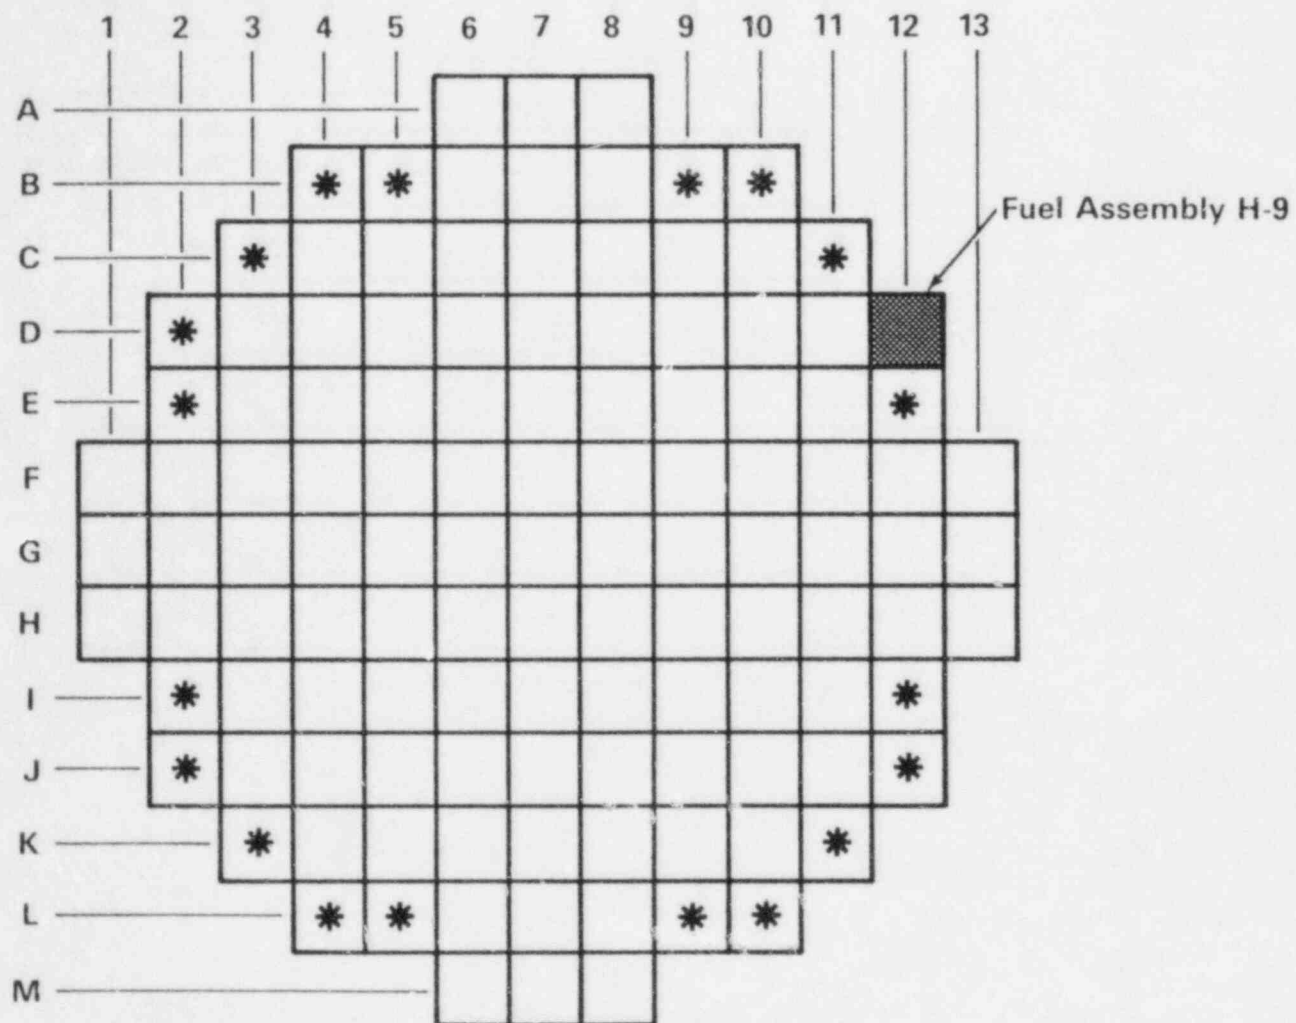
Figure 1. Location of Failed Fuel Assembly at Point Beach

During the April 27, 1985 routine inspection of discharged fuel during refueling at Point Beach Unit 1,* failed fuel rod cladding in assembly H9 was discovered. The fuel rod cladding appears to have failed due to vibration of the rod against the grid and grid springs. This vibration is believed to have been caused by water impingement through a joint gap in the core baffle discovered on May 15, 1985. Assembly H9 was located in position D12, an outside position of the core next to a core baffle plate corner. No fuel pellets escaped from the fuel rod. The event is detailed below.

On April 27 and 30, 1985, visual inspections of fuel assembly H9 noted that a section of cladding on rod No. 14 (the outside corner rod next to the baffle joint) immediately behind grid No. 2 (the second grid from the top of the assembly) had failed. (See Figure 1.) The fuel was visible inside the rod. The same rod was found to have a torn grid spring at grid No. 3 and another cladding failure with the grid spring showing at grid No. 1. Rod No. 14 was touching the bottom nozzle. All other rods were in their normal off-the-bottom position. Fuel assembly H9 was placed in the reactor in location D12 such that rod No. 14 was located in the southwest corner of the fuel assembly during Cycle 12.

The inspection of the joint revealed indications of a possible 4 to 7 mil gap in the baffle plate joint between the rows of cap screws indicating the second and third, and third and fourth baffle radial supports. These indication locations correspond to the location of the fuel damage on assembly H9.

The probable cause of the fuel clad failure in assembly H9 is water impingement through the baffle plate joint during Cycle 12. Fuel clad failure was experienced earlier at Point Beach during Unit 1 Cycle 2 at location H1 (Licensee Event Report 50-266/75-018). However, the joint at location H1 is of a different design than that at position D12. The counterflow design of the Point Beach reactor results in a higher pressure outside the baffle plate than inside the plate. This can and apparently has, in this case, resulted in flow through the plate joint (baffle jetting) if any opening occurs. In this case, the opening was wide enough and flow strong enough to allow the fuel rod to vibrate and the grid and spring assemblies to cause clad damage. In the case of assembly H9, this damage caused the cladding to fail and expose the fuel to the primary coolant. The chemical and volume control system was designed to, and did, maintain the allowable levels of primary coolant activity with the failed fuel clad during Cycle 12.

There is a potential for failure of fuel rods in the same location. However, this failure does not appear to happen quickly. The fuel assembly which will be installed into position D12 has been inspected thoroughly prior to installation. This inspection has established a baseline of data for the inspection which will take place after the completion of Cycle 13. Monitoring of primary coolant activity during startup and subsequent operation will also provide

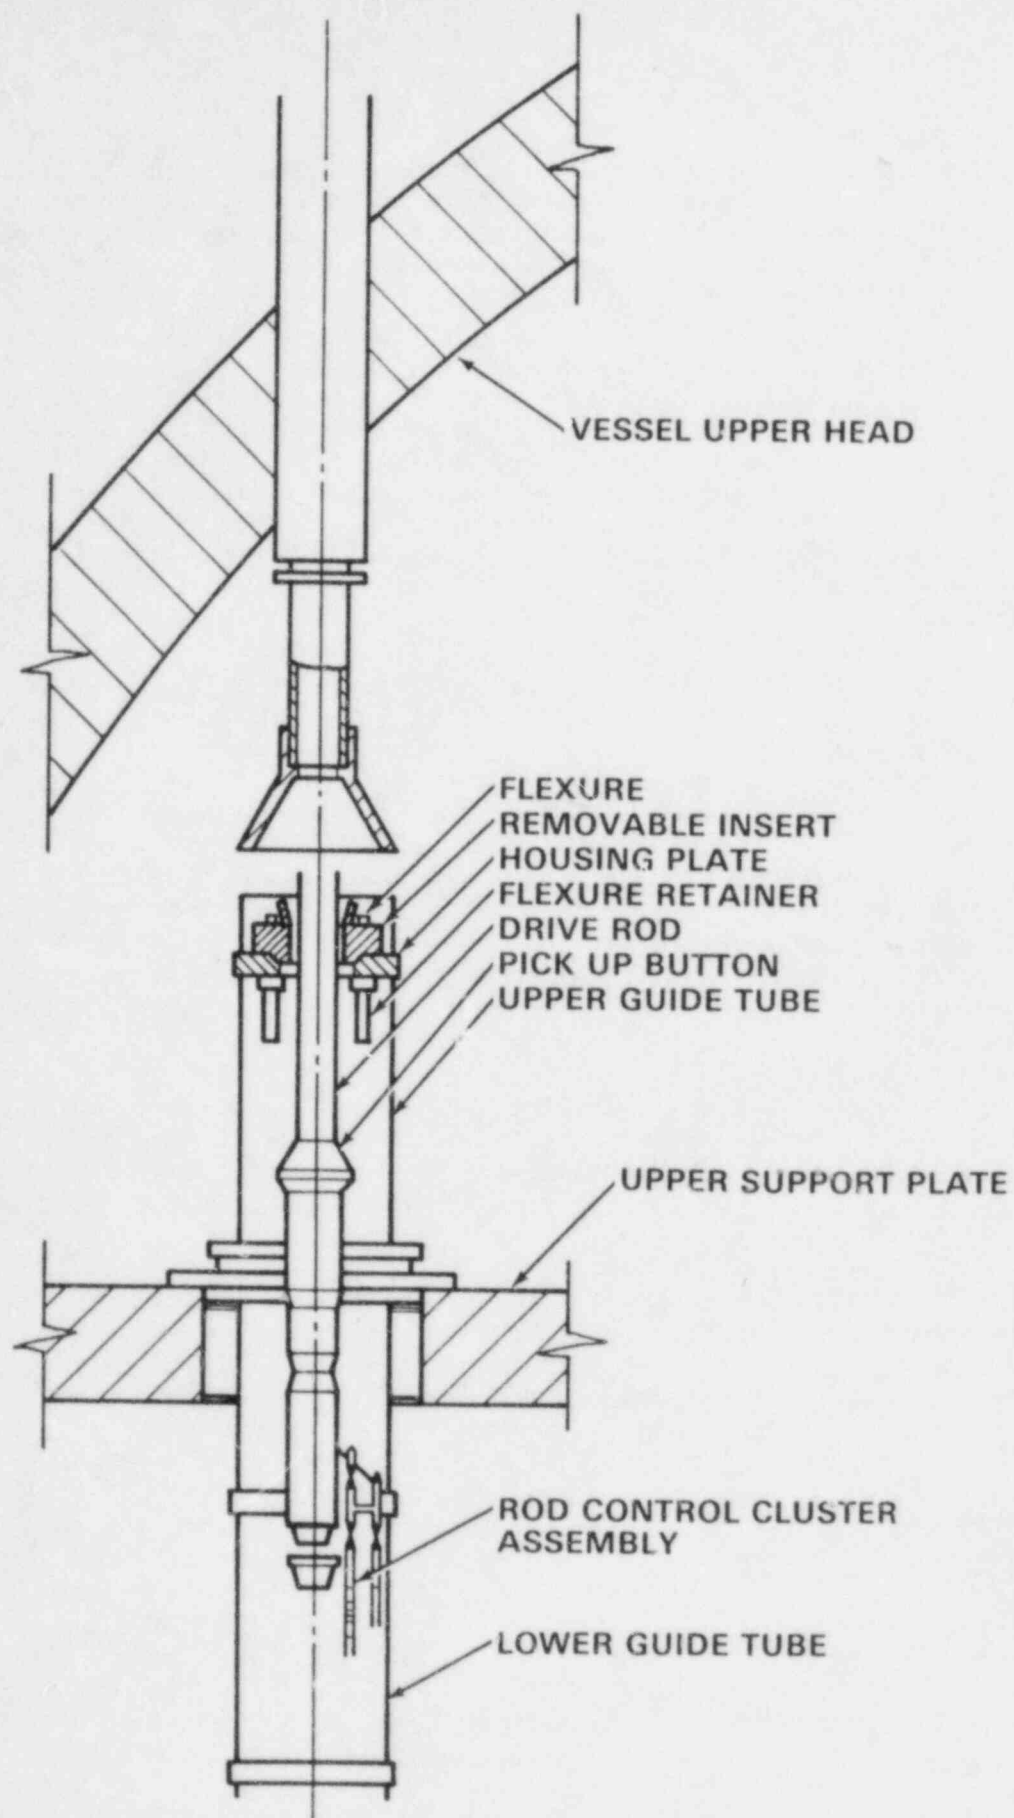
Figure 2. FLEXURES WITH ROD CONTROL CLUSTER ASSEMBLY FULLY WITHDRAWN

Inspection of the flexureless insert removed from the J-4 guide tube disclosed that a piece of the skirt section was missing. The skirt section is slotted, forming eight tabs. Four of the tabs are in contact with the latching pawls which hold the flexureless insert in place at the top of the guide tube. The slots were cut in the skirt during manufacturing to allow for forcible removal of the flexureless inserts in the event of a failure of the internal spring. The missing tab was one of the four not in contact with the latching pawl. After removal of the guide tube top hats at positions F-12 and J-4, a visual inspection of the control rod spider assemblies was performed. This inspection provided no further information.

(1) the missing piece of flexureless insert skirt was found in the J-4 guide tube on a guide tube card corresponding to the elevation at which rod J-4 had stuck, and (2) a flexure pin was found in the F-12 guide tube on a guide tube card corresponding to the elevation at which rod F-12 had stuck. These loose parts were determined to have resulted from control rod guide tube (CRGT) flow insert replacement conducted during the refueling outage. The piece of the insert skirt was part of a new "flexure pinless" flow insert which had broken, and the loose flexure pin had been removed from the control rod guide tube during the outage. Four flexure pins had been used to hold down the previous flow inserts, and had been removed during his outage in conjunction with flow insert replacement due to their susceptibility to stress induced cracking.

The licensee performed a complete visual inspection of all of the guide tube internals. The flexure pin and piece of flexureless insert were removed and no other debris was found. All flexureless inserts were removed and inspected. Three were found to have bent tabs. These three and the one from location J-4 with the broken tab were replaced from spares. It is believed that the cause of the damaged flexureless inserts was due to the installation procedure. This procedure was revised and all flexureless inserts were reinstalled with no problems. The control rods from positions F-12 and J-4 were replaced and the control rod drive shaft from position F-12 was replaced due to damage noted during visual inspections.
