10 CFR 50.59 SAFETY EVALUATION

**EVALUATION OF TEMPORARY OPERATING CONFIGURATION
WITH 1B MAIN TRANSFORMER OUT OF SERVICE**

ST. LUCIE NUCLEAR PLANT

JPN-PSL-SEES-96-068

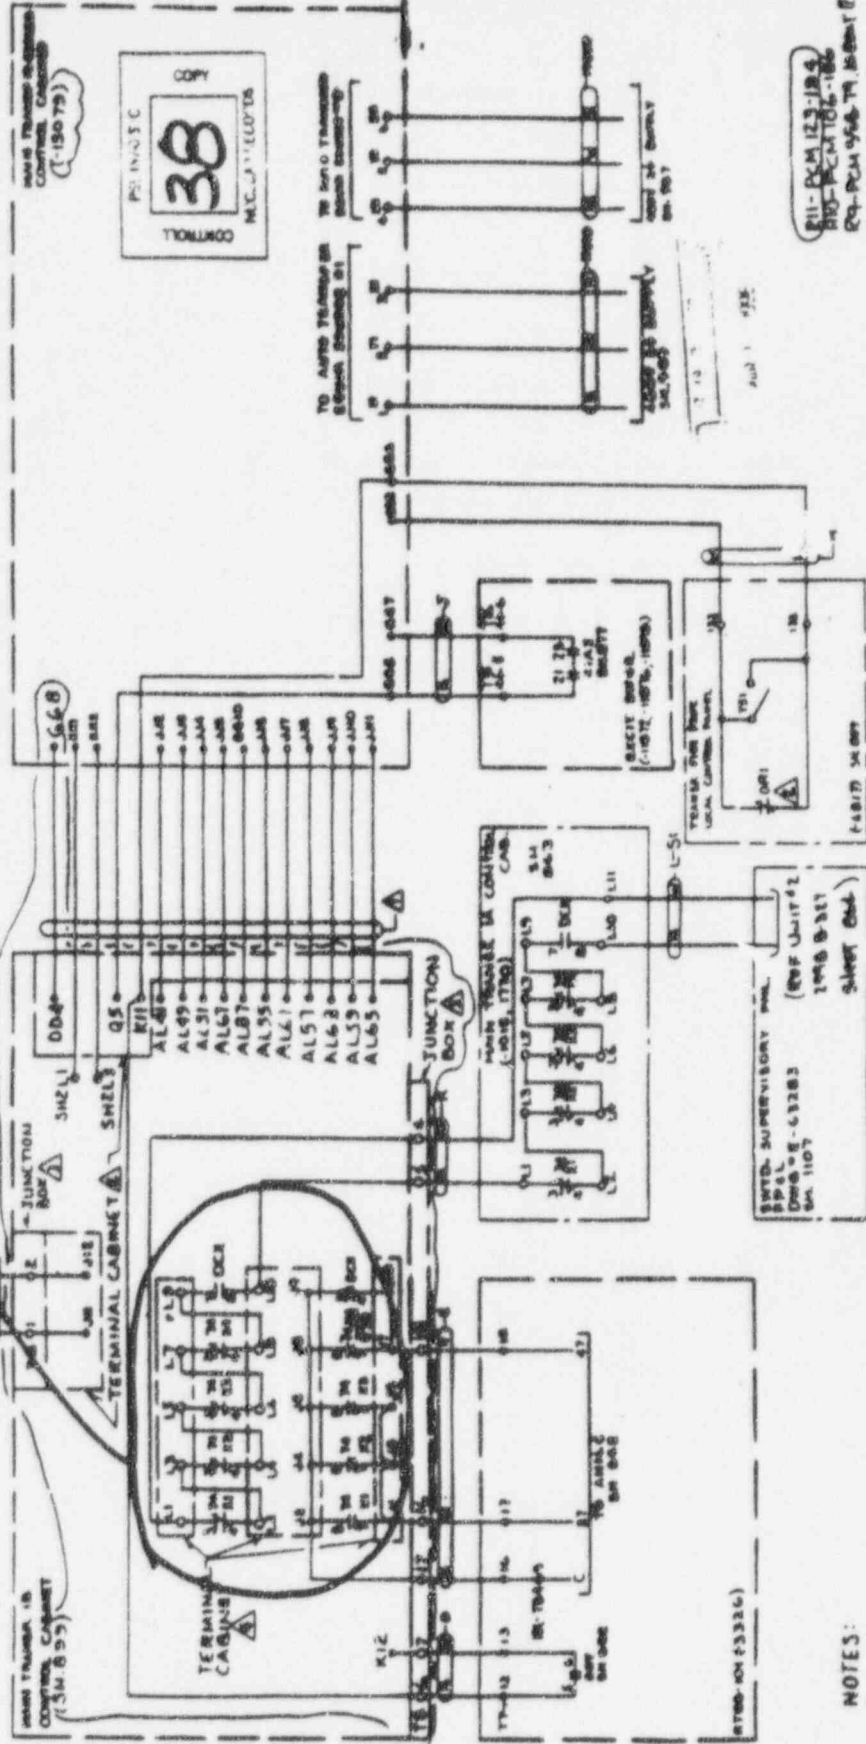
FLORIDA POWER & LIGHT CO.
 HUTCHINSON ISLAND PLANT-UNIT NO. 1
 CONTROL WIRING DIAGRAM
 MARCH TRANSFORMER 1B
 SHEET 384

TURN OFF ALL ANNUNCIATOR SWITCHES
 (May be turned on for testing purposes)

- 1) Isolate the 87TB/878 phase A, phase B and phase C BDD differential relays for Main Transformer 1B by removing the relay paddles.
- 2) Isolate the 51TNB/878 IAC neutral overcurrent relay by removing the relay paddle.
- 3) Install shorts for the C1, C2 and C3 current transformers for differential "s1" in Main Transformer 1B. Install isolation strips in the BC isolation device points 1-12 (six isolation strips).
- 4) Turn off all annunciator points in Main Transformer 1B. These may be turned on for testing purposes if required.

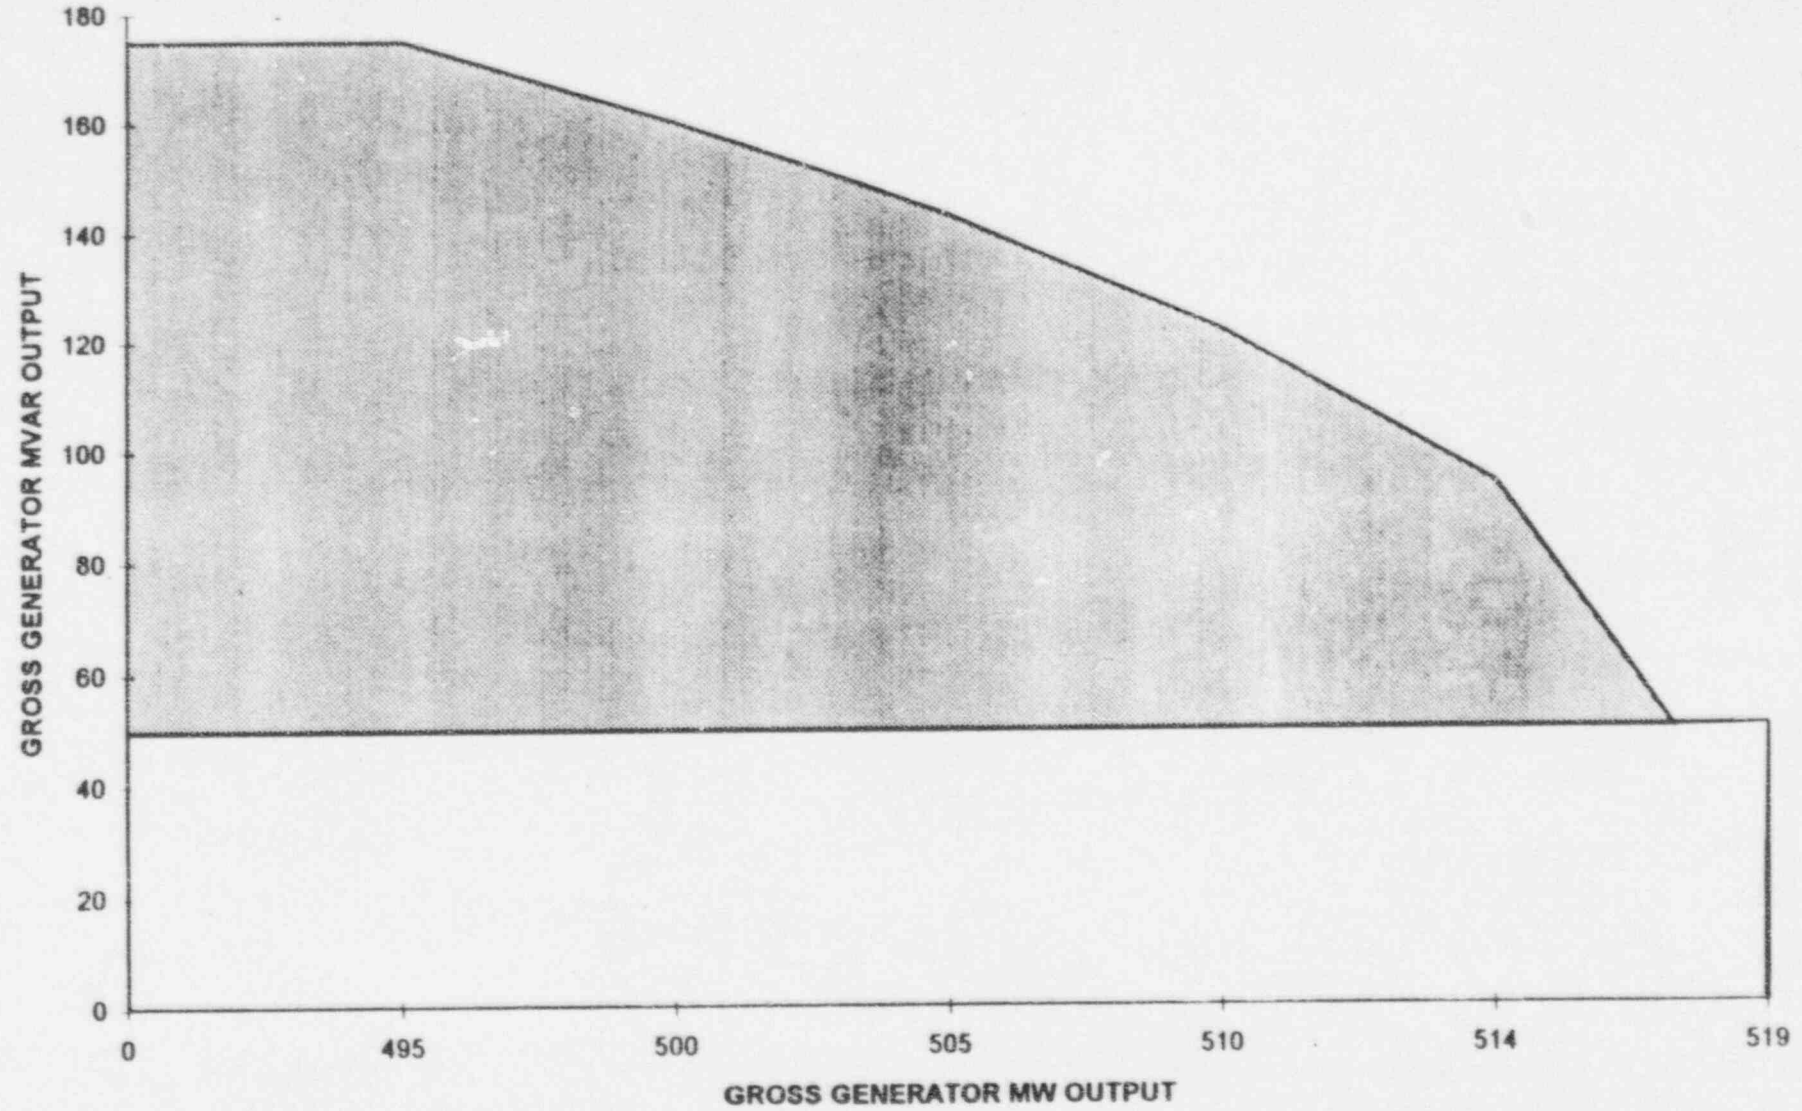
UNIT GENERATOR GROSS OUTPUT LIMITATIONS BASED ON 475 MVA XFMR RATING

Note: this assumes that the auxiliary transformers are in service; if not, limit output to 200 MW.
