## MEMORANDUM

TO FILE: American Nuclear Corp., Permit 357  
 FROM: Jim Finley, Hydrologist  
 DATE: October 29, 1985  
 SUBJECT: Review of Groundwater Conditions and  
 at the American Nuclear Mill Site

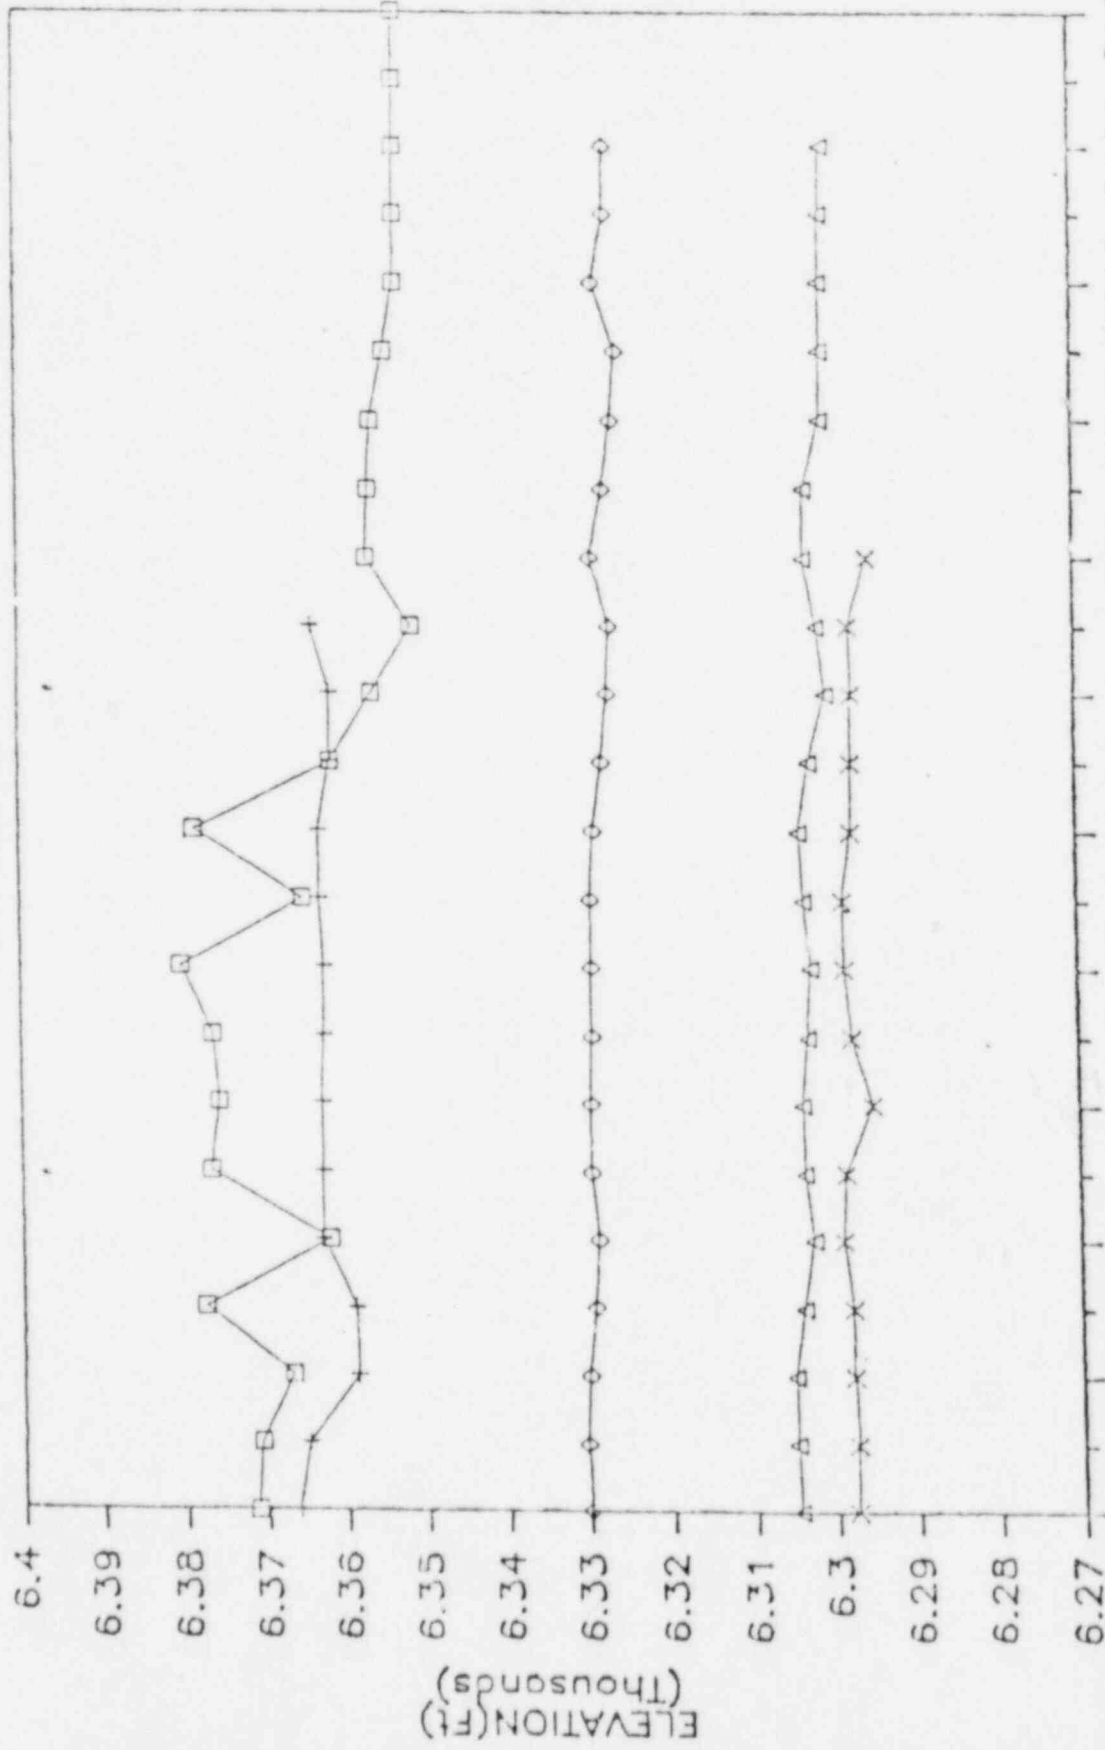
A new review of the data contained in the report was conducted in which both water levels and water quality were analyzed. Water levels for several monitoring wells were plotted against time. Water levels from five wells indicate that the pumpback system has not historically had much of an affect on the flow gradient (Figure 1). With no baseline or pre-1979 data, it is not possible to determine whether or not these down gradient water levels reflect the influence of seepage. Some of the original mathematical modeling of the perched aquifer indicates that water from this aquifer discharges approximately 2000 feet north of the tailings pond. The piezometric map and Figure 1 suggest this is not true, but that a discharge area possibly exists to the north of the Fox wells. Water levels are below the topographic surface in the three Fox wells plotted on Figure 1.

# WATER LEVELS AT FAP FOR SEVERAL WELLS

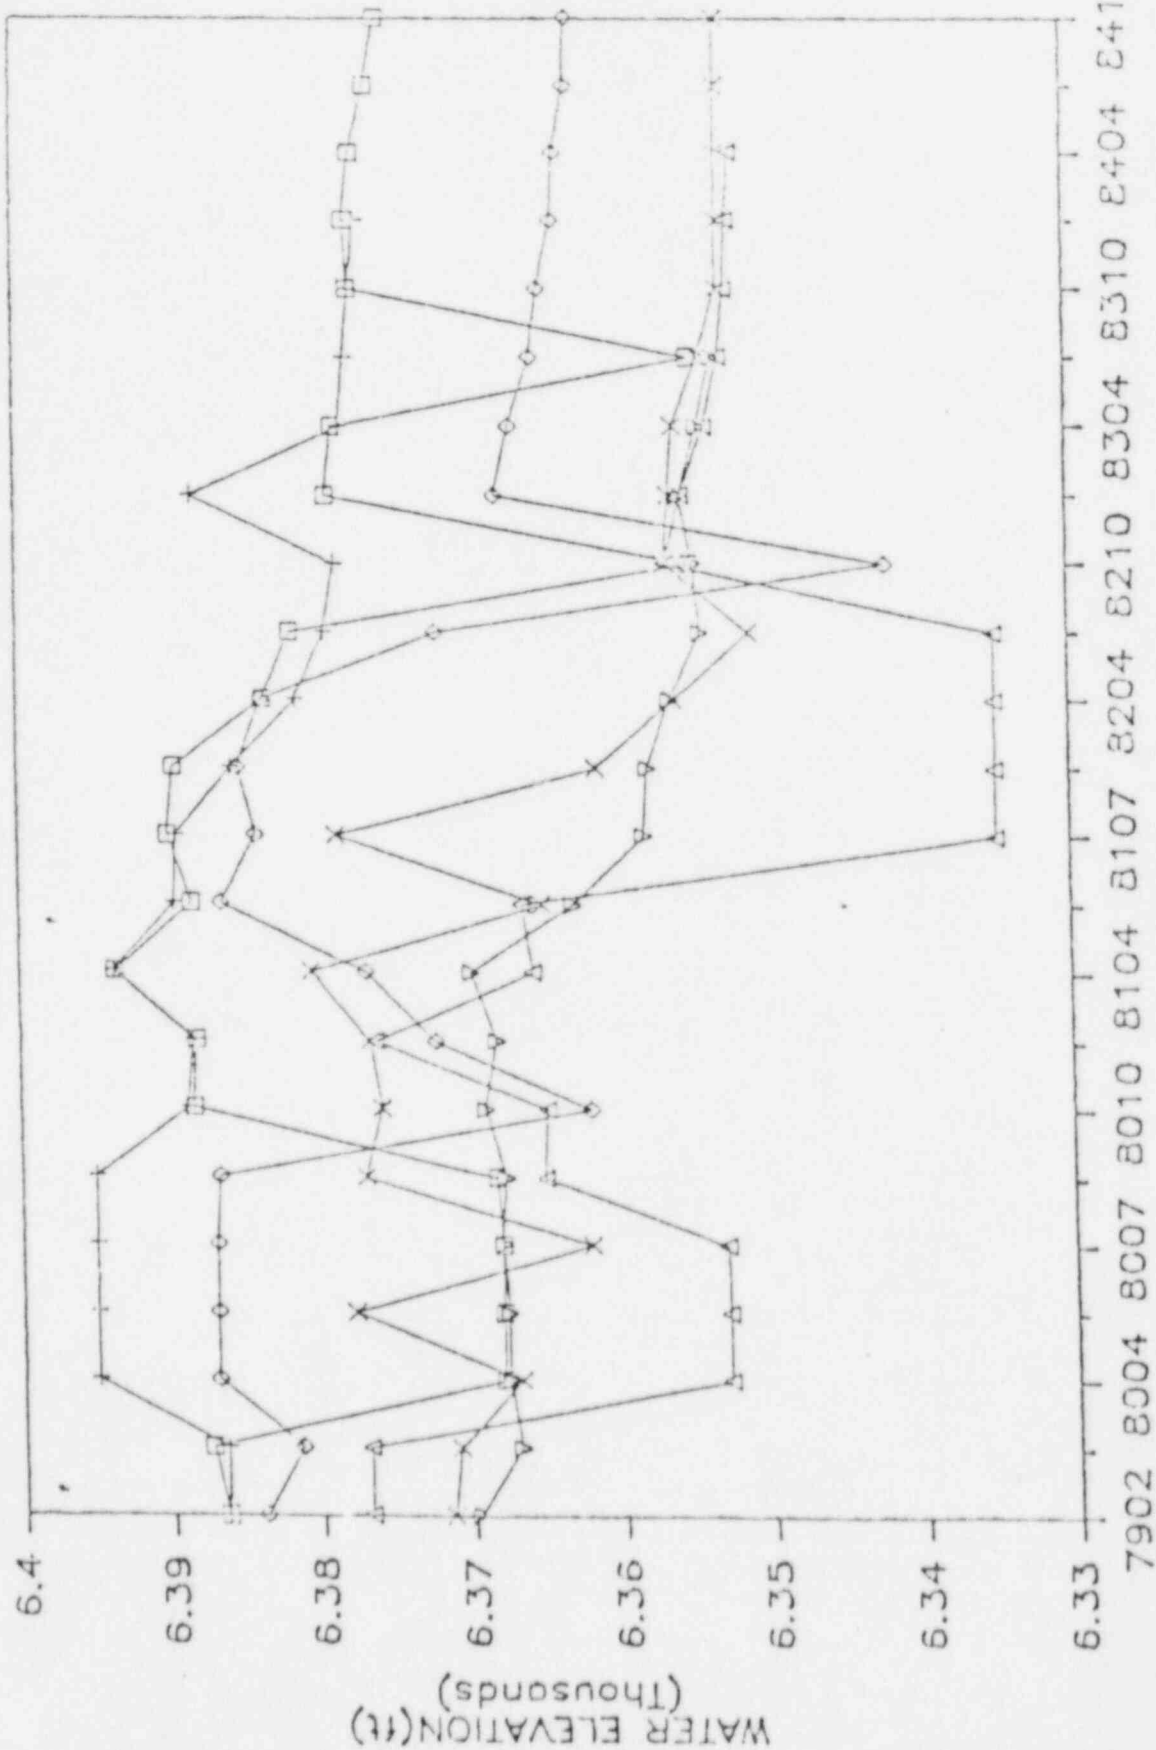
Figure 2

Periods of active pumping from the recovery wells have been sporadic for all wells (Figure 2). Water levels in the recovery wells have decreased since 1979, which is a combination of pumping and decreased water levels in Tailings Pond 1. R-4 has been pumped the most actively though water remains in all wells but R-5. This is not surprising considering that these wells should be drilled to the top of the clay and pre-mining water levels existed in the perched aquifer. Through time, decreased water levels in these wells should become stable, at which point seepage from the tailings pond will have ceased.

An effective pumpback system is necessary in order to minimize further seepage movement into the perched aquifer. The well system has not worked very reliably to date (Figure 2; see August 6, 1985 memo Niles Andrus to NRC). A rejuvenation of the well system coupled with a more effective evaporative technique (e.g. a mist system) should be considered for any decommissioning of this tailings pond.

# WATER ELEVATION

1. Renovation/upgrading of the pumpback system below Tailings Pond No. 1. This is imperative if the Susquehanna tailings are disposed of at this site.
2. Construction of a lined evaporation pond outfitted with equipment to enhance evaporation. Pumpback well operation is suggested during the summer months.

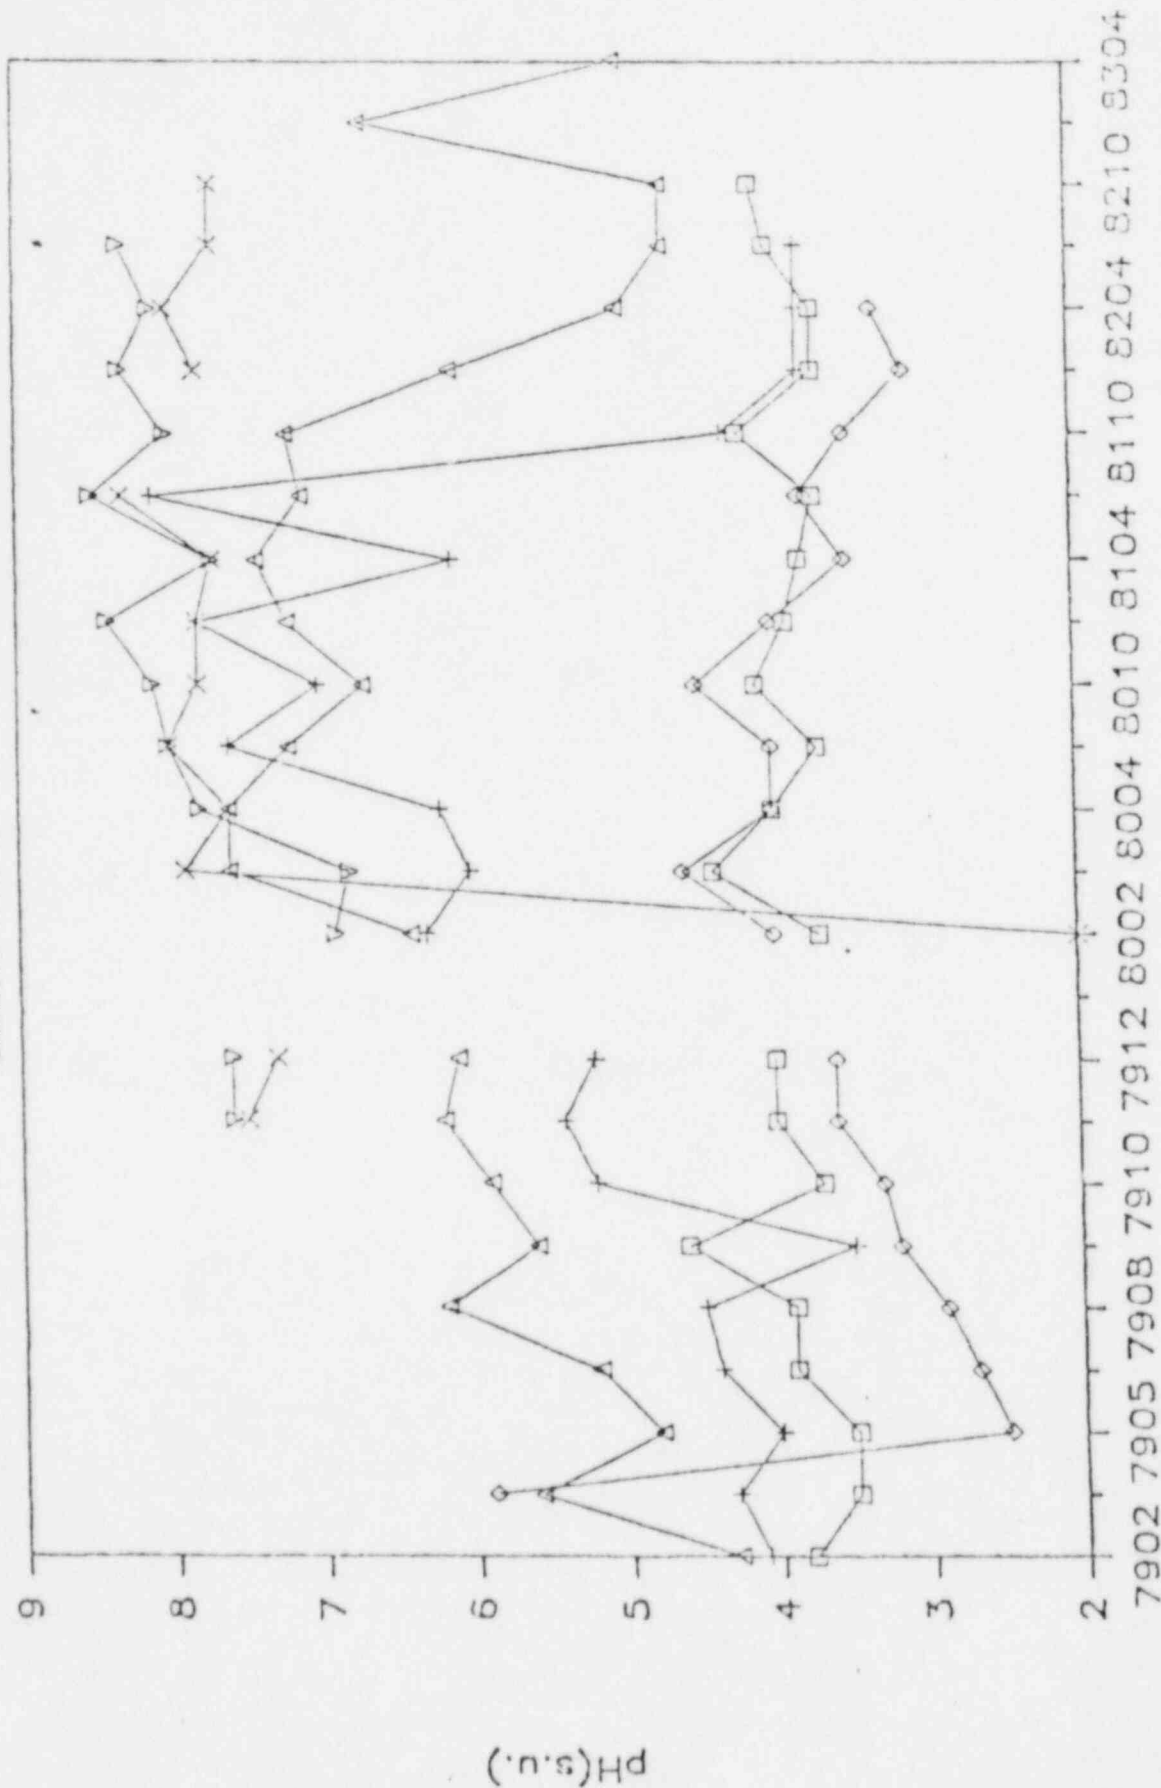
Figure 3

Several water quality parameters were plotted against time for wells in a down gradient direction (Figures 3, 4, 5, and 6). Values of pH rise from two (tailings liquor) to eight as distance down gradient of the tailings is increased (Figure 3). Low pH fluids seeping from the tailings pond are buffered by the natural salt content of the perched aquifer. The rate at which the buffering occurs is controlled by two processes: (1) reaction kinetics; (2) and relative permeability of the aquifer. Reaction kinetics is fixed if the medium is homogeneous. Directional permeability will control rates of flow affecting contact time. Zones of increased permeability (e.g. sand or gravel lenses) will transport low pH water further from the tailings pond. Changes in pH and Eh regulate the relative solubility of major cations and anions, and indirectly the chemistry of toxic trace elements (Johnson, 1985). Values of pH below 6 occur as far down gradient as TP1-1 (Figure 3). It is expected that the zone of low pH will slowly increase in size as the buffering capacity of the aquifer material is exhausted.

# pH CONCENTRATION

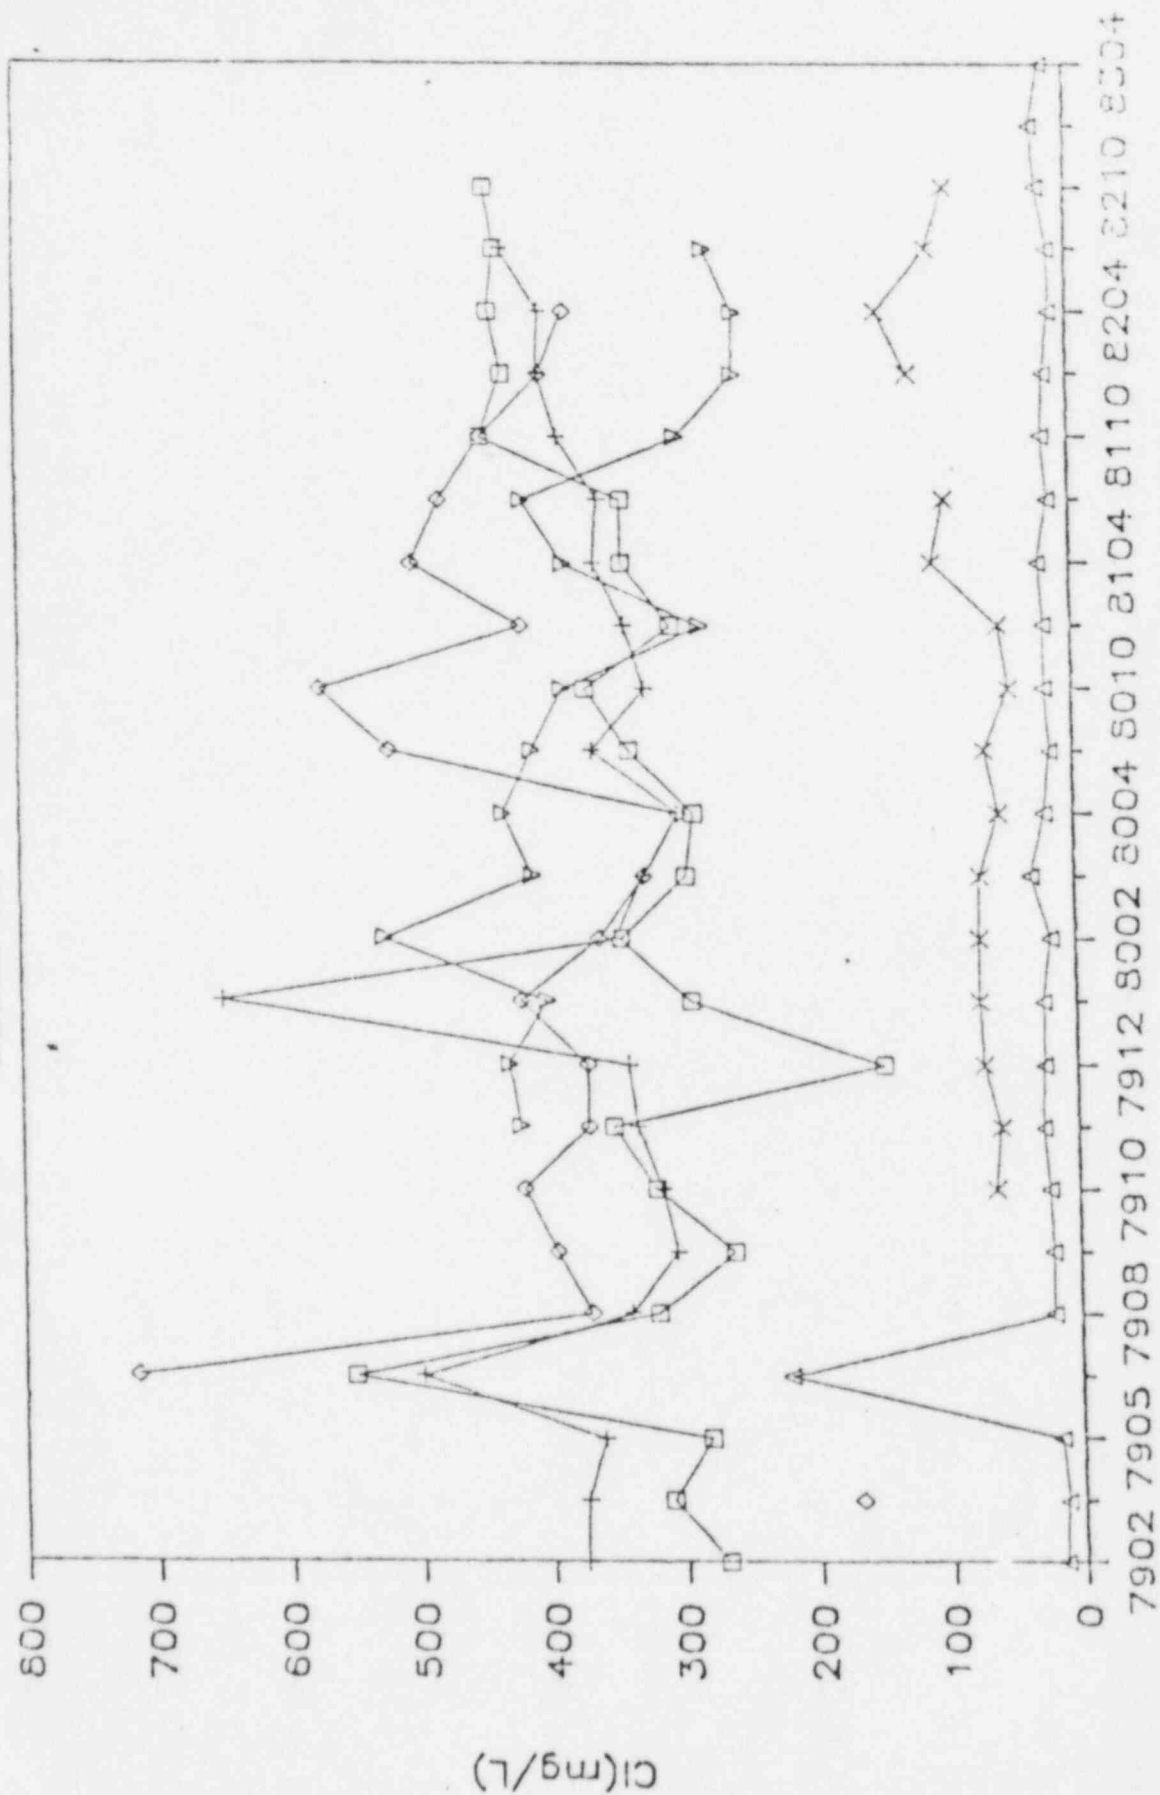
Figure 4

Chloride concentrations show no increasing or decreasing trend for any wells through time (Figure 4). Values range between 250 and 575 mg/L for all wells but Fox 2 and TP1-1. This again suggests that the sampling conducted to date reflects not pre-seepage conditions but those already created as a result of seepage. Other constituents plotted reflect the same conditions (Figures 4, 5, and 6). Nitrates at three wells peak in late 1981 then drop to within 10 and 20 mg/L (Figure 5). Sulfates generally increase in a down gradient direction with very high values recorded at Fox 5. Four wells range between 2000 and 7000 mg/L with a rising trend from 1981 to late 1982 (Figure 6). In all cases, Well TP1-1 had the lowest concentration of all parameters which indicates the plume has not moved in this direction. Flow may move in a more westerly direction though data are not available to evaluate this possibility.

# CI CONCENTRATION SELECTED WELLS AT FAP

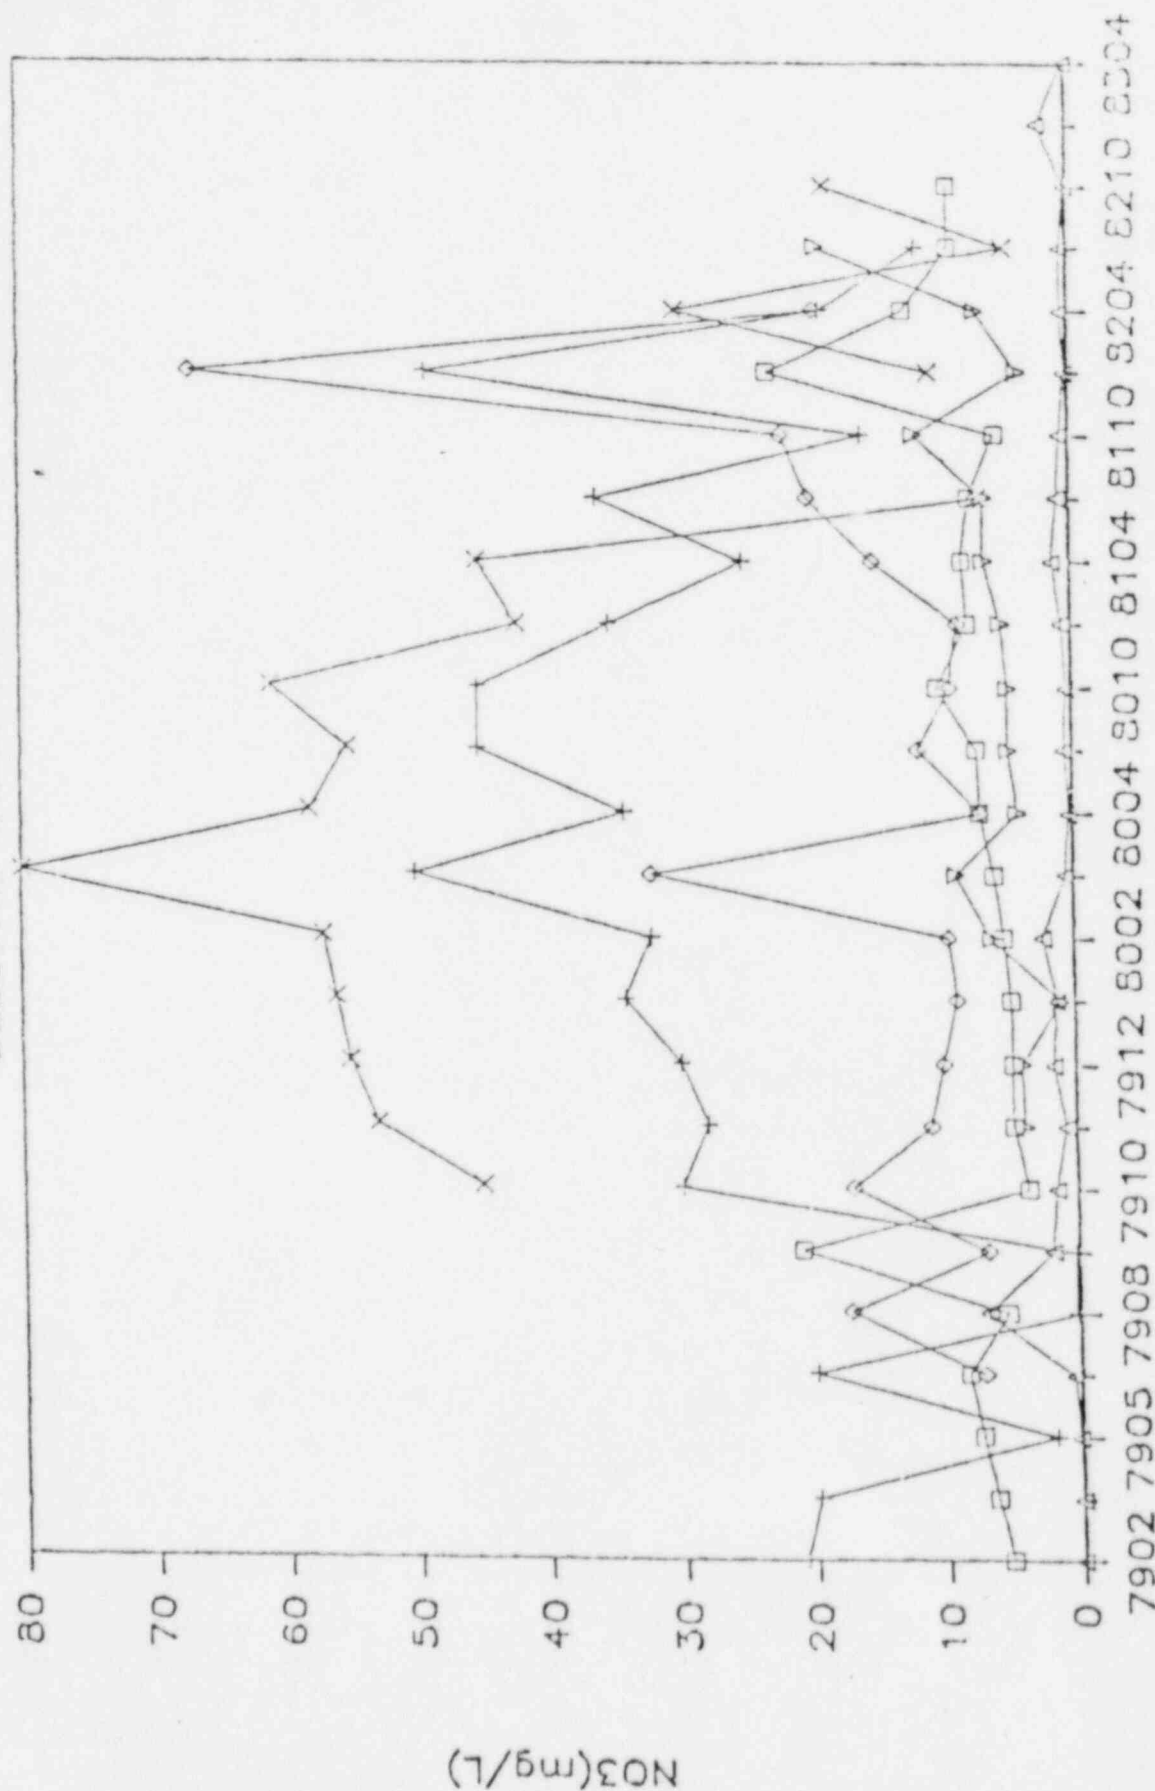
Figure 5

# NO3 CONCENTRATION

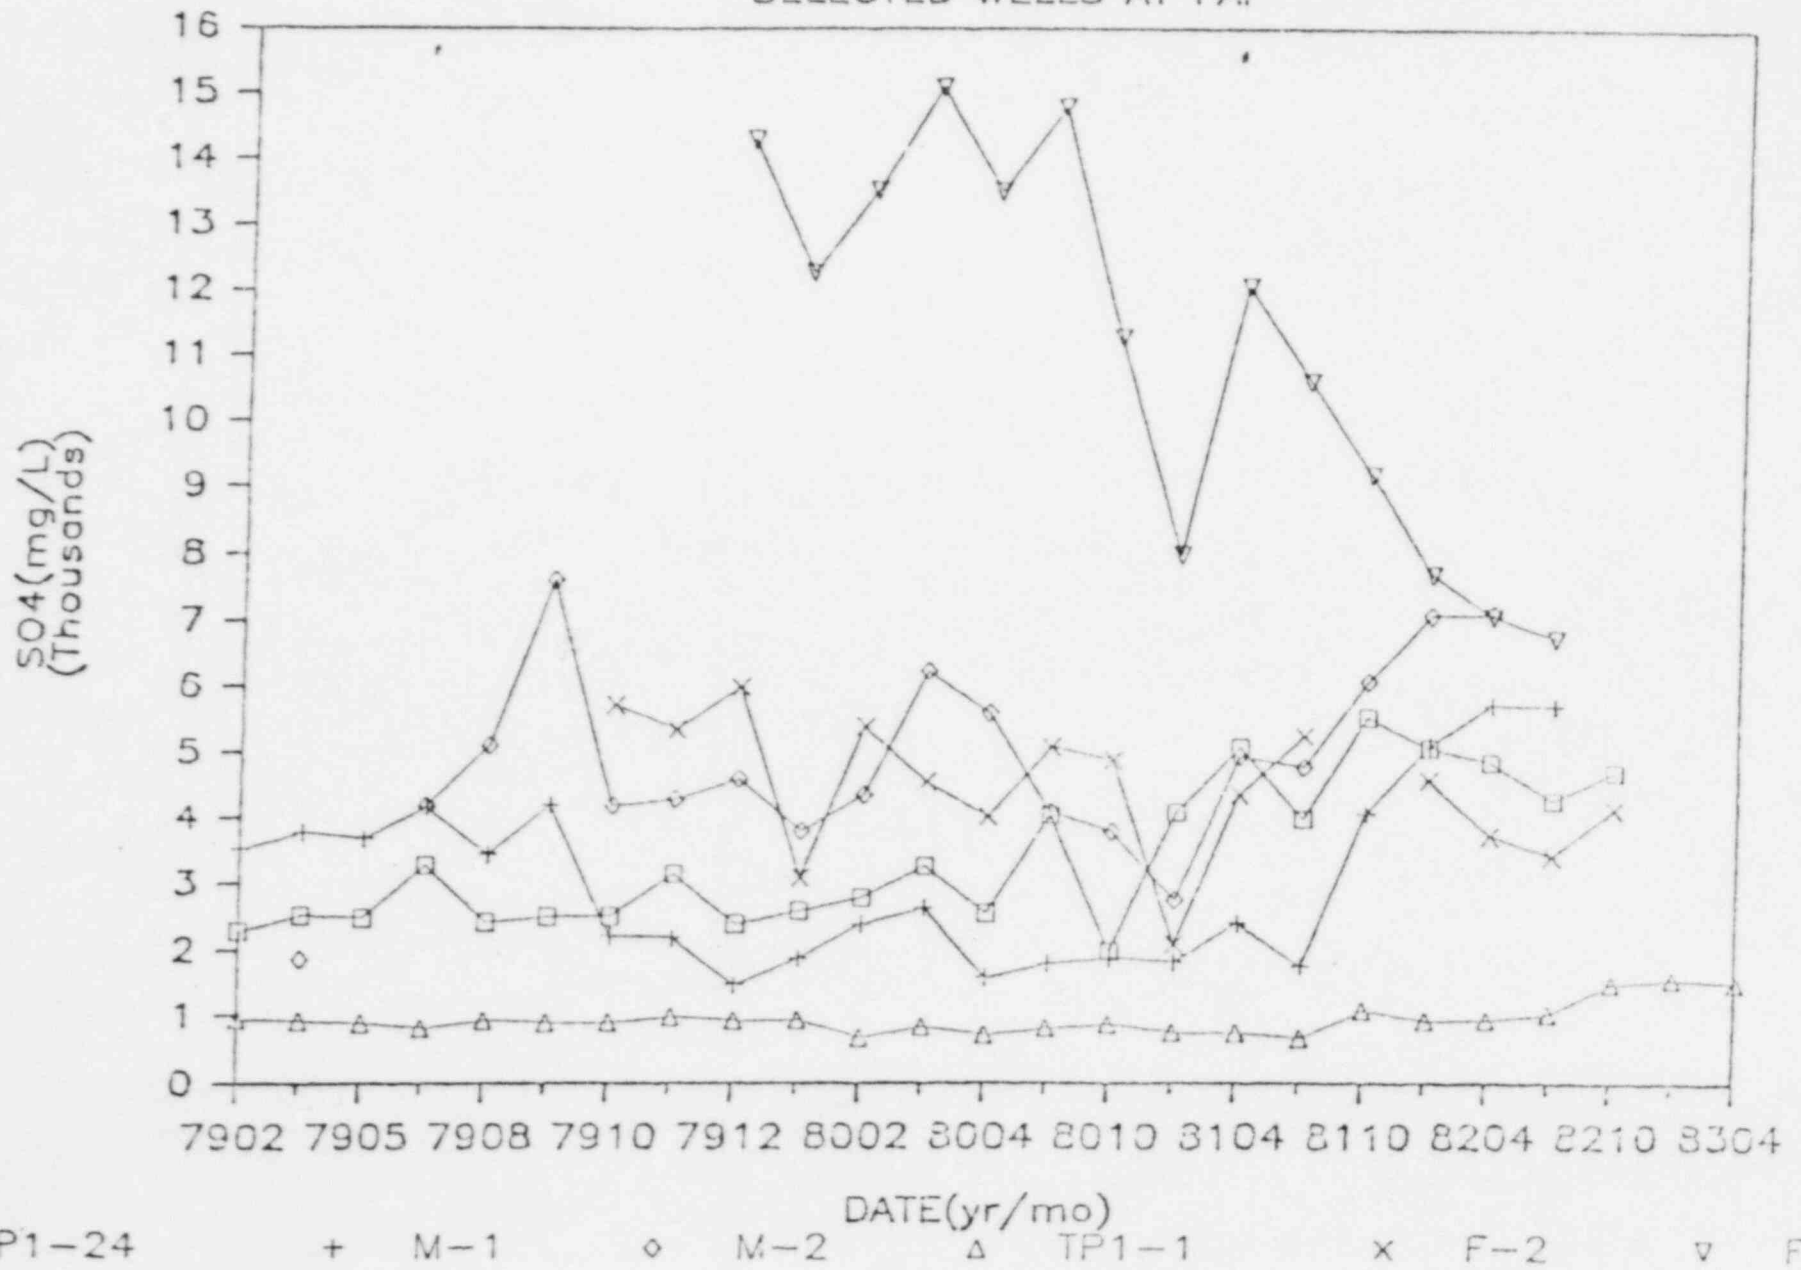
Figure 6

# SO4 CONCENTRATION SELECTED WELLS AT FAP
