Commonwealth Edison

Subject: Dresden Station Units 2 and 3
Quad Cities Station Units 1 and 2
Review of Fire Protection Requirements
NRC Docket Nos. 50-237, 50-249,
50-254 and 50-265

ATTACHMENT 1

CATEGORY 1 DISCREPANCIES - DRESDEN

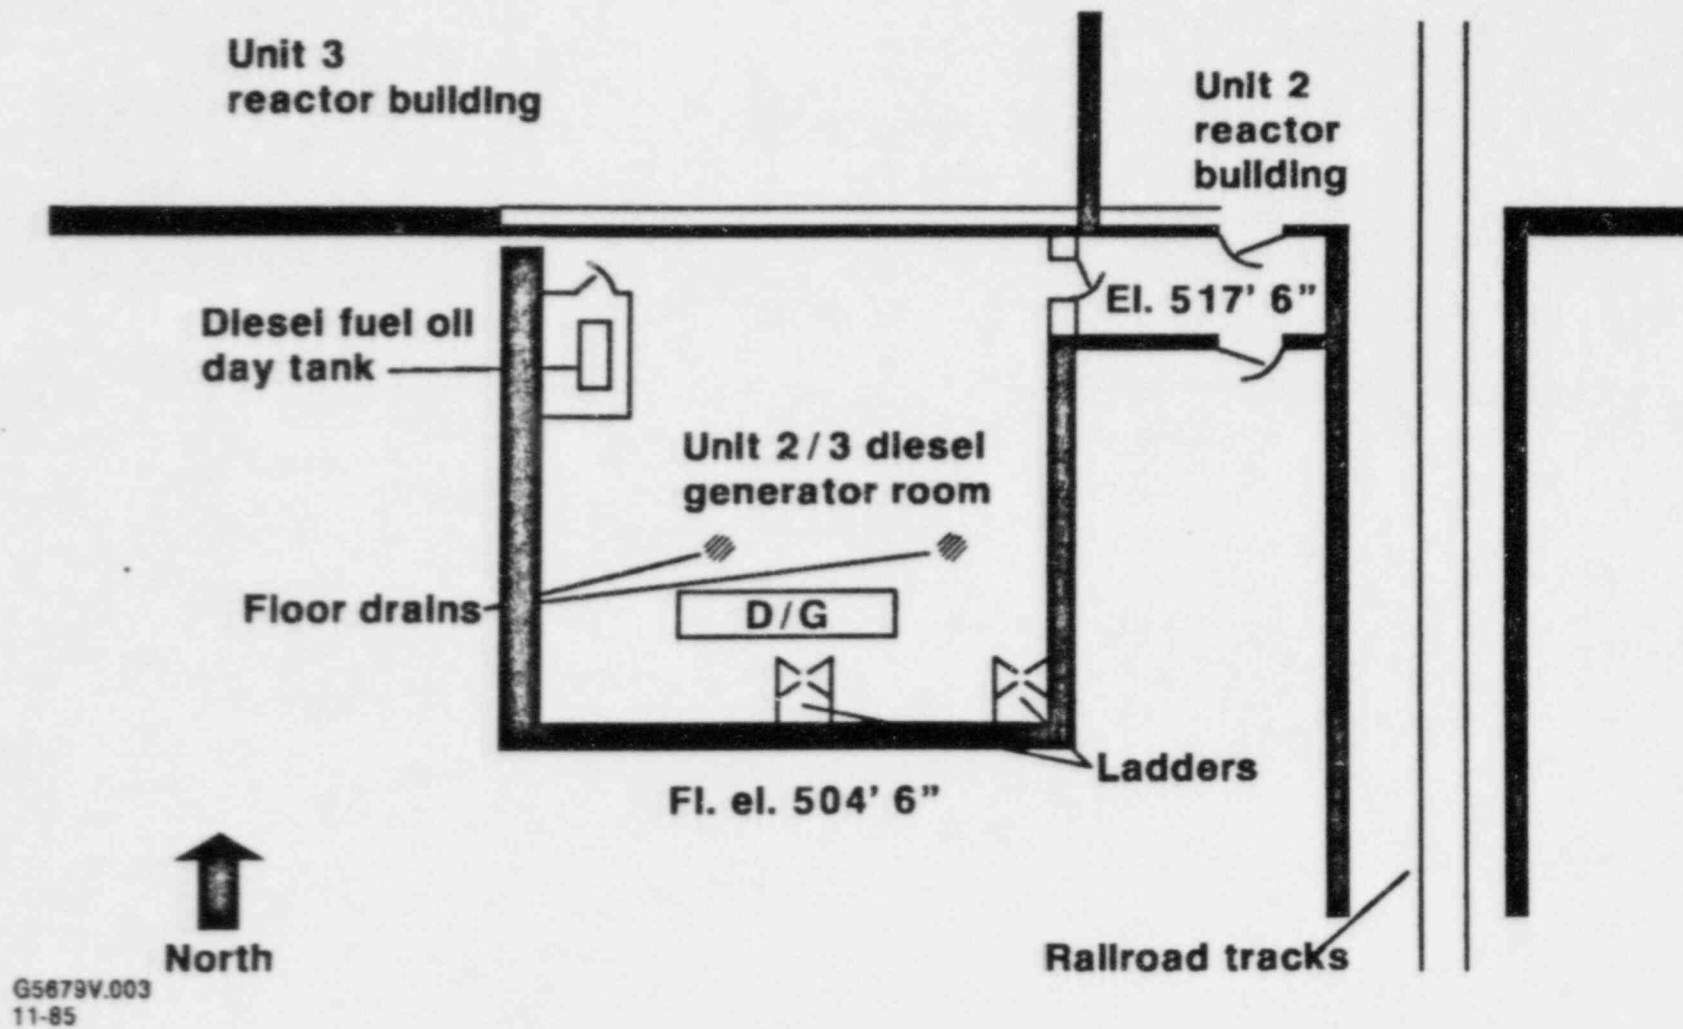
FIGURE 1

<u>ITEM</u>	<u>SER REFERENCE</u>	<u>DESCRIPTION</u>
3.1(a)	3.1.8	SER Section 3.1.8 states, "Fire doors will be provided...at the....diesel generator rooms." Fire doors were installed at the Turbine Building entrances to the DG2 and DG3 rooms. A fire door was not installed for the reactor building entrance to the 2/3 DG room through the secondary containment interlocked access corridor (heavy metal interlocked doors exist). Based on the brief description in the SER and previous correspondence, we believe a fire door was not intended here since this is an external door with no external combustible loads. The general policy used in the 1977 FHA was to install fire doors in external walls only when there was a clearly identified hazard outside. See Attachment 5 page 3 for the fire hazards analysis. See Figure 1.

3.1(b)	3.1.8	SER Section 3.1.8 states, "Fire doors will be provided...at the...diesel generator rooms." Since suppression exists in both the 2/3 DG and HPCI rooms, and two heavy metal doors are in place, a fire door was not intended and therefore not installed between the 2/3 DG room and the HPCI rooms. Refer to Section 2.3.9.7 of the 1977 FHA. See Attachment 5 page 3 for the fire hazards analysis. See Figure 1.

3.2	3.1.15	SER Section 3.1.15 states, "Curbs will be provided for the diesel generator room..." All doors in the DG rooms and Day Tank rooms have been provided with curbs except the entrance to the 2/3 DG room. A curb was not intended for this location since the entrance is 13 feet above floor level. See Attachment 5 page 3 for the fire hazards analysis. See Figure 1.

The diesel generator 2/3 room north wall separates this room from the Reactor Building (See Figure 1). This is a 3-hour rated fire barrier. The east, west and south walls and roof are exterior boundaries. These walls and roof are not fire rated. An unrated substantial metal door from the 2/3 diesel generator room eastwall opens to the secondary containment interlock corridor (See Figure 1). A door from the Unit 2 reactor building and from the exterior also opens into this corridor. The floor is a secondary containment boundary which separates the diesel generator 2/3 room from the Units 2 and 3 HPCI rooms. The floor is not fire rated. Unrated double doors provide access from the 2/3 diesel generator room to each HPCI room. The safety-related equipment in the diesel generator 2/3 room includes the 2/3 diesel generator, fuel oil transfer pump, and vent fans.

There are two hollow metal doors in series leading from the 2/3 diesel generator room into each HPCI room (4 doors total). These doors are normally closed and provide a secondary containment boundary. There is no continuity of combustibles through these double doors. The maximum flooding height due to 750 gallons (day tank capacity) of oil being discharged into the room would be approximately one-half inch. This assumes both four inch drains are completely blocked. The existing one-half inch threshold at the HPCI access doorways in conjunction with the existing drains provide adequate protection in the event of an oil spill. Figure 1 shows that an oil line break could not directly impinge an access door. The two four inch drains divert oil into the HPCI room trench which empties into the HPCI room sumps. However, the 2/3 diesel generator rooms and each HPCI room have complete automatic detection and suppression. The HPCI rooms are protected by a preaction water system. Consequently, a fire originating in either room would be promptly detected and suppressed. Additionally, the existing separation between these rooms provides a substantial barrier to fire spread.

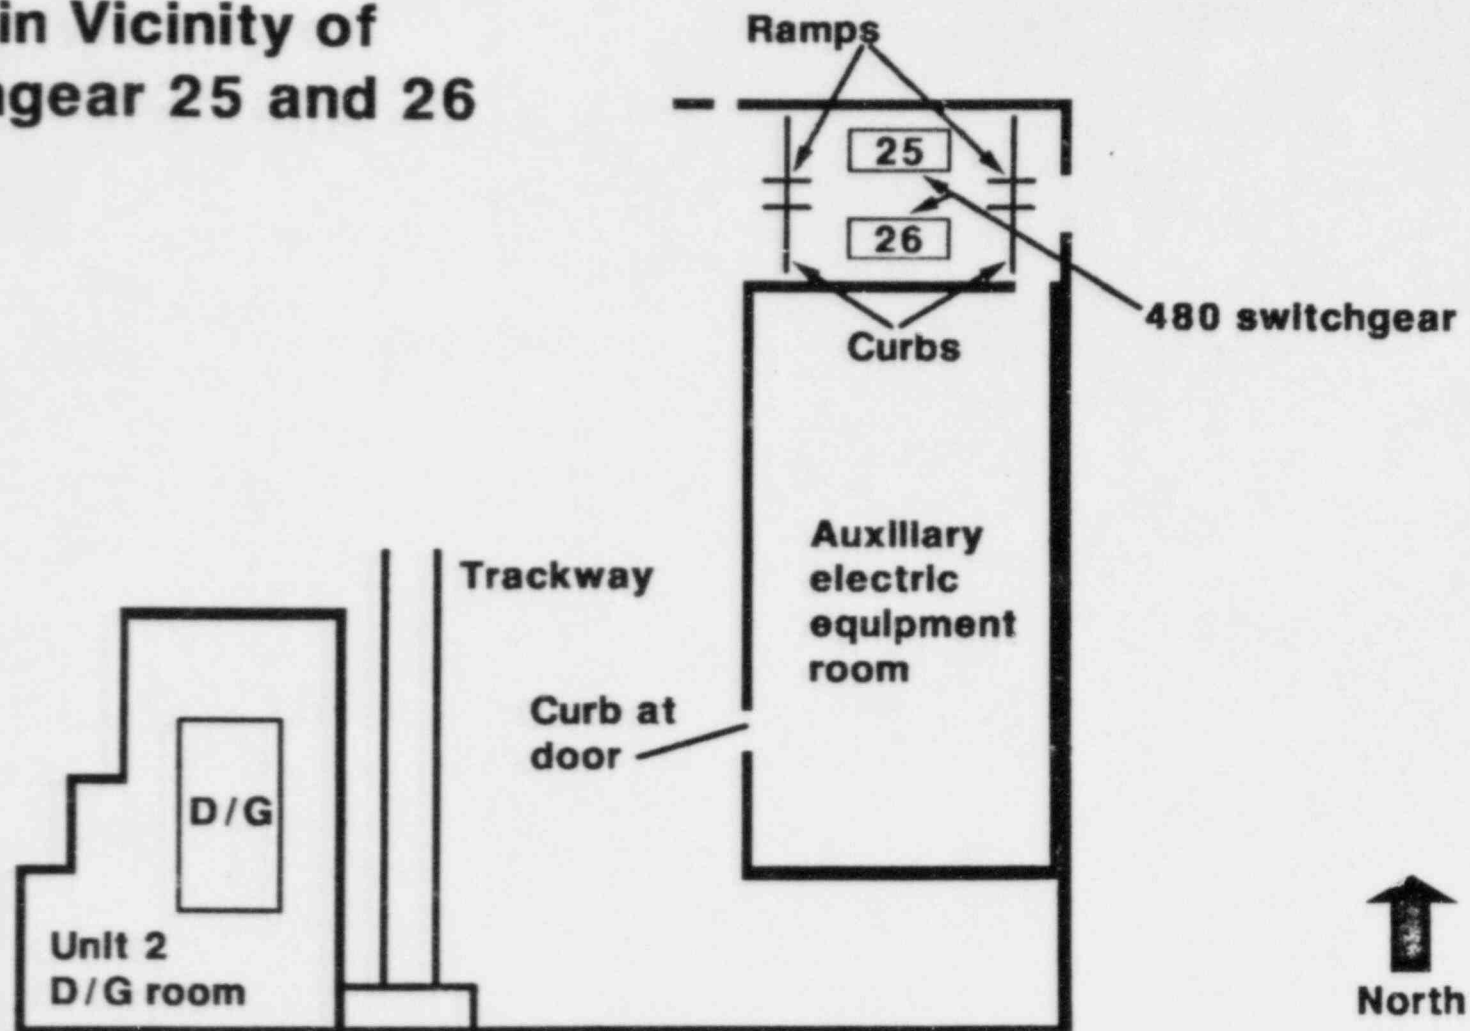
FIGURE 2

<u>ITEM</u>	<u>SER REFERENCE</u>	<u>DESCRIPTION</u>
3.4	3.1.15	SER Section 3.1.15 states, "Curbs will be provided at the entrance of the AEER room." The required curb was installed at the West door to the AEER to protect from potential transient combustibles in the Unit 2 trackway. A curb was not installed at the North door since curbs exist around adjacent 480V bus 25 and 26 transformers. These transformers are curbed and are the only fixed hazard in the vicinity. The north door does not access the Unit 2 trackway. See Figure 2.
