**Florida  
Power**  
CORPORATION  
Crystal River Unit 3  
Docket No. 50-302

Subject: Licensee Event Report (LER) 97-S01-00

TITLE (4) Maintenance Activities in Circulating Water System Result in Protected Area Breach

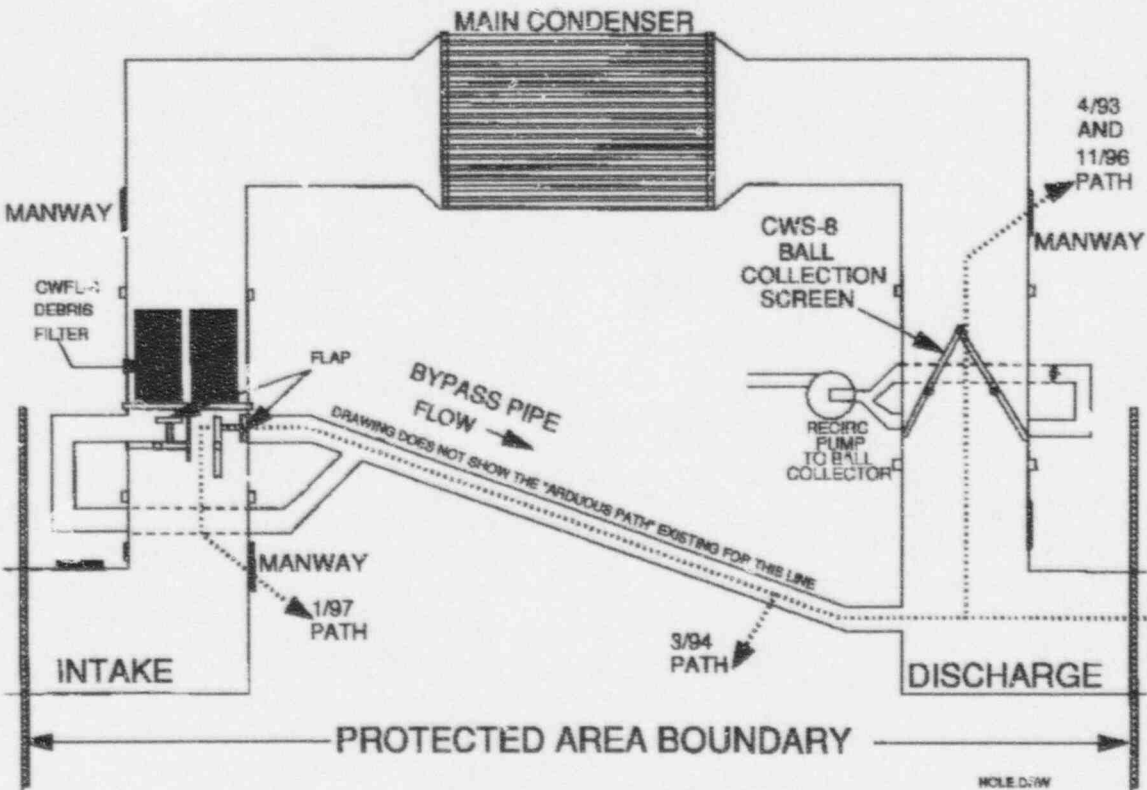
Figure 1

No safety systems were affected or threatened by this event; however, the removal of the Circulating Water System debris filter bypass line flap exposed a possible penetration path into the protected area.

Maintenance activity on the Circulating Water System debris filter bypass line flap began at approximately 2300 hours on January 29, 1997. By 0230 on January 30, 1997 the debris filter bypass line flaps were removed from the waterbox. The Protected Area breach could have existed for up to 16 hours and 20 minutes.

A root cause team was formed and concluded that the root cause was failure to identify and understand the security function of plant components affected by infrequently performed maintenance activities.

A contributing cause of this event was the fact that a similar event in 1994 involving the same access path, did not sufficiently diagnose the path for Protected Area vulnerability. The 1994 event and corrective actions were limited to removal of a section of the bypass line piping and did not identify the affect of removal of the bypass flaps.

Once security supervision discovered the possibility that a protected area penetration existed, they immediately established an armed security officer as a compensatory measure. The Protected and Vital Areas were searched for possible perpetrators. At 0230 hours on January 31, 1997, mechanics physically secured the breach.

The waterbox manways will be secured with Security-controlled locking mechanisms.

FPC Engineering will develop a Security Barrier Component List (SBCL) based on the 96 square inch opening criteria associated with protected and vital area barriers as established by the CR-3 Physical Security Plan. This SBCL will be integrated into the planning and work controls process for maintenance activities.
