SUBJECT: TRIP REPORT FOR PEACH BOTTOM SITE VISIT
REGARDING WRONG UNIT/WRONG TRAIN EVENTS

Peach Bottom Atomic Power Station,
Units 2 and 3

WRONG UNIT/WRONG TRAIN EVENTS AT PEACH BOTTOM

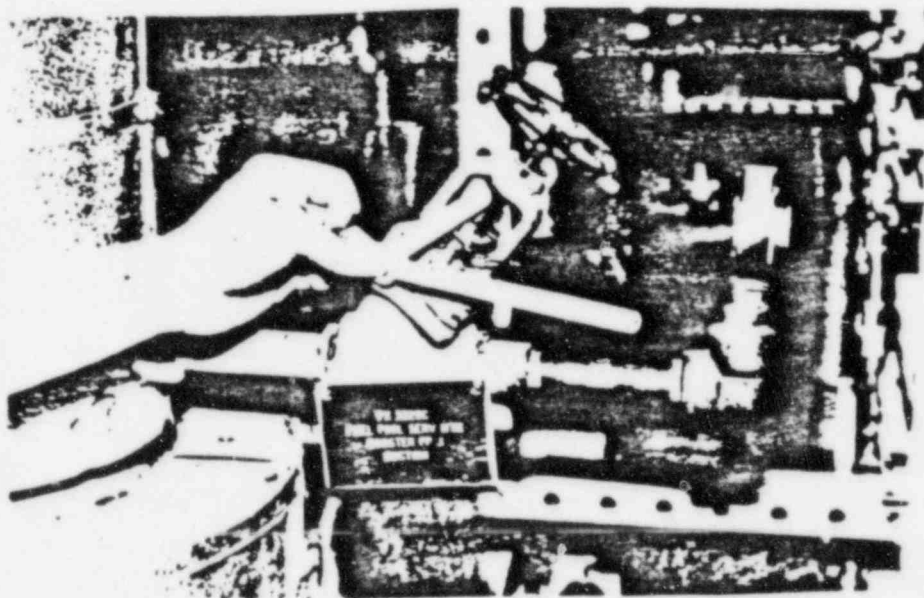
Component labeling at Peach Bottom currently employs plastic-type engraved labels, hung from a metal chain for valves, that provide unit, system, and item designation. The licensee's staff indicated that these labels do tend to get brittle and dirty (see Figure 3). Peach Bottom is currently in the process of installing CEMS labels (discussed above) which are expected to rectify these concerns (see Figure 4). However, the currently used CEMS labels are susceptible to high temperature degradation, a problem the licensee is working to address. The NRC staff's limited tour of the Peach Bottom facility found most valves and open components labeled with the exception of a group of valves (see Figure 3).

FIGURE 3 ENGRAVED LABELS AT PEACH BOTTOM

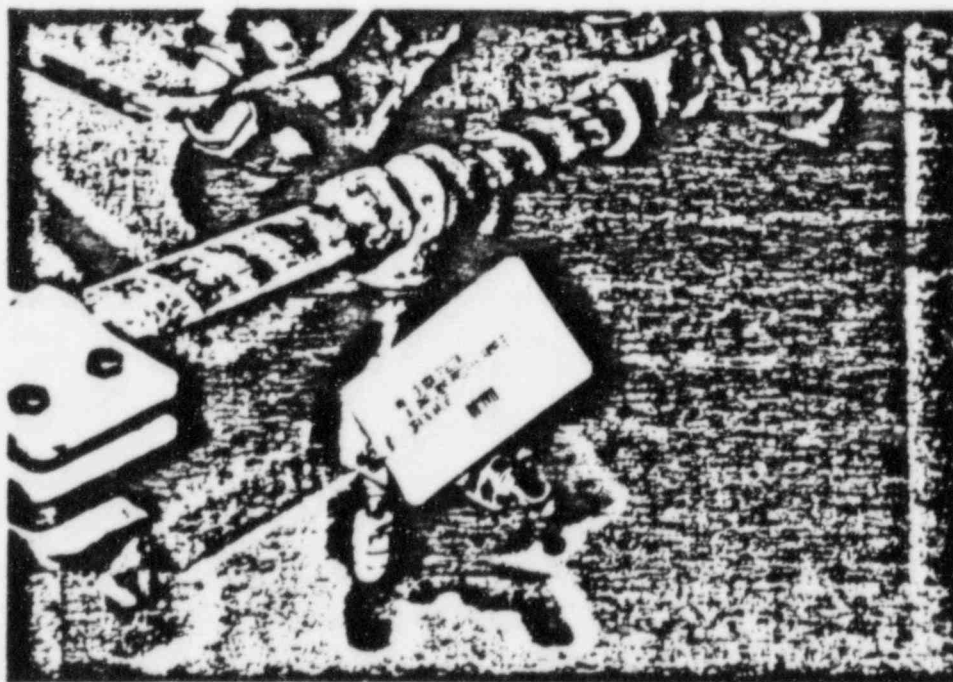
FIGURE 4 CEMS LABELS AT PEACH BOTTOM
