Sealed Source and Device Design Safety Testing

Technical Report on the Findings of Task 4

Investigation of a Failed Brachytherapy Needle
Applicator

Prepared by
S. J. Lukezich

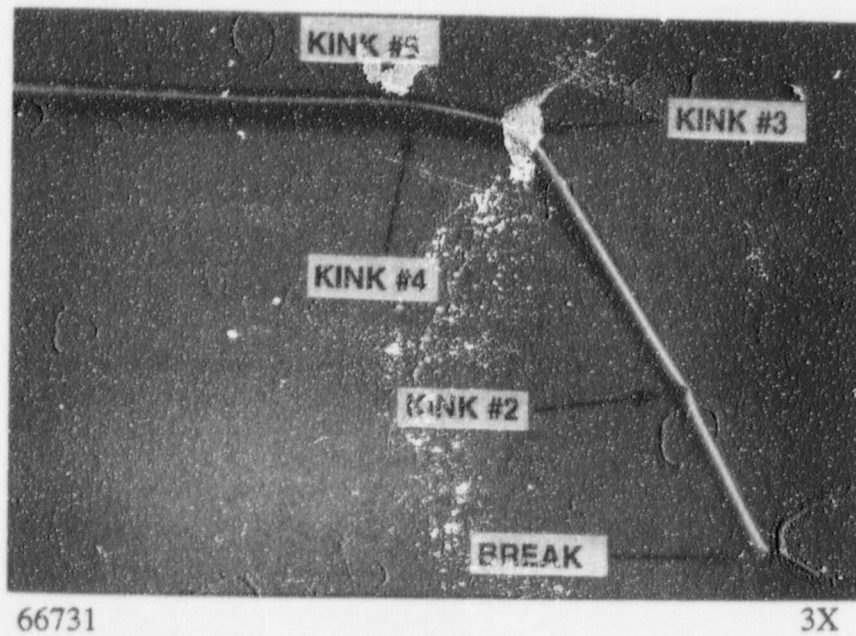
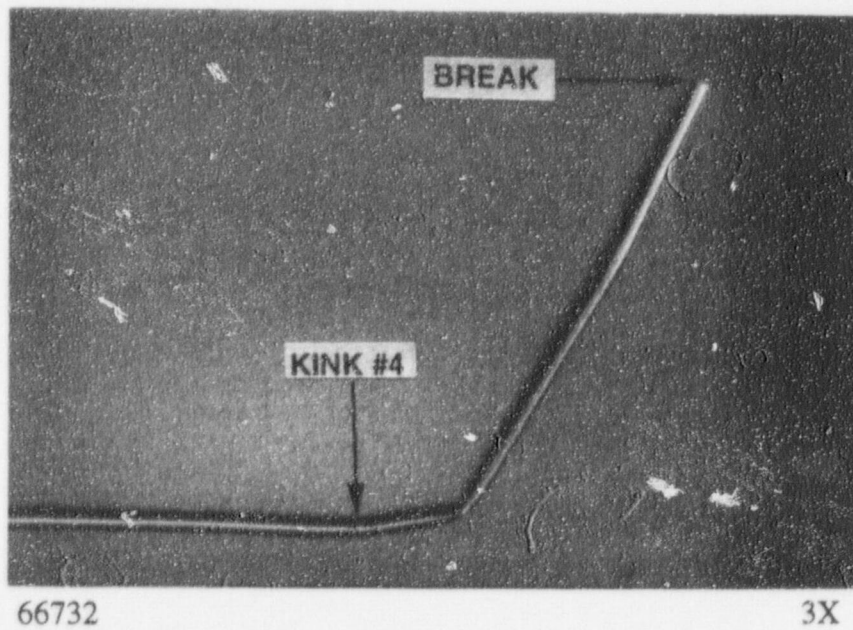
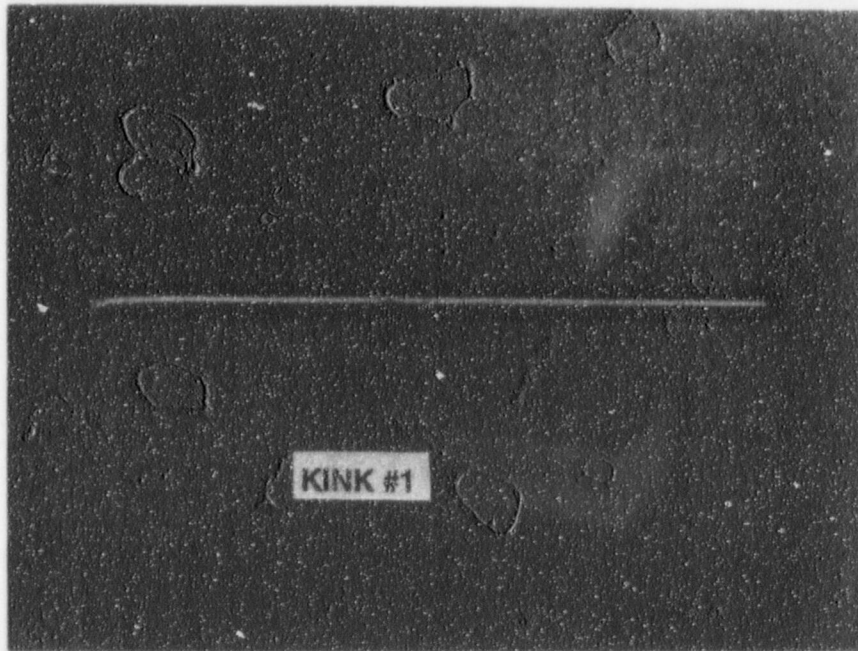
Figure 2-1. Subject Applicator. (a) and (b) are the damaged end of the needle.

In addition to these surface scratches, six sites of significant damage were observed. These sites are identified below and in Figure 2-1.

Of these damage features, Kink #3 is the only one reported to have been present immediately following the emergency extraction of the needle assembly. The remainder of the damage, including the break at the 17 mm location, is believed to have been inflicted during an examination of the needle after the incident. The ease with which the needle could be broken during this post-incident examination led to questions concerning the ductility of the stainless steel material used in the needles.

Figure 2-1 (continued). Subject Applicator. (c) the broken tip.

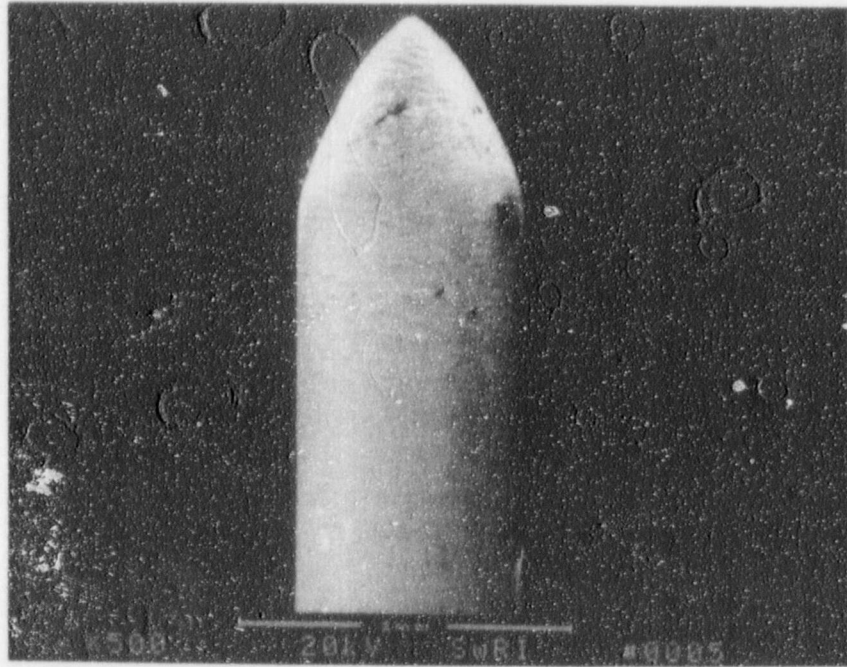
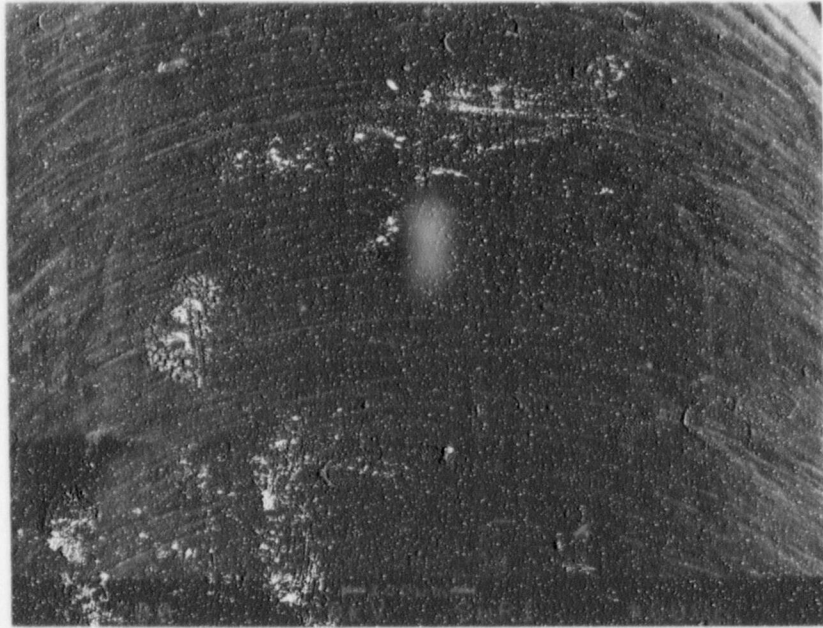
Figure 2-2. Subject Applicator. Condition of the OD surface near the tip.

The condition of the OD surface at the tip of the Subject Applicator is shown in Figure 2-2. The circumferential scratches observed during the examination with the optical microscope can be seen clearly at these higher magnifications. Even at 200X, the scratches are seen to be relatively shallow and somewhat regularly spaced. A few longitudinally oriented very shallow scratches are also present. Surface discontinuities such as these are consistent with a surface which has been ground.

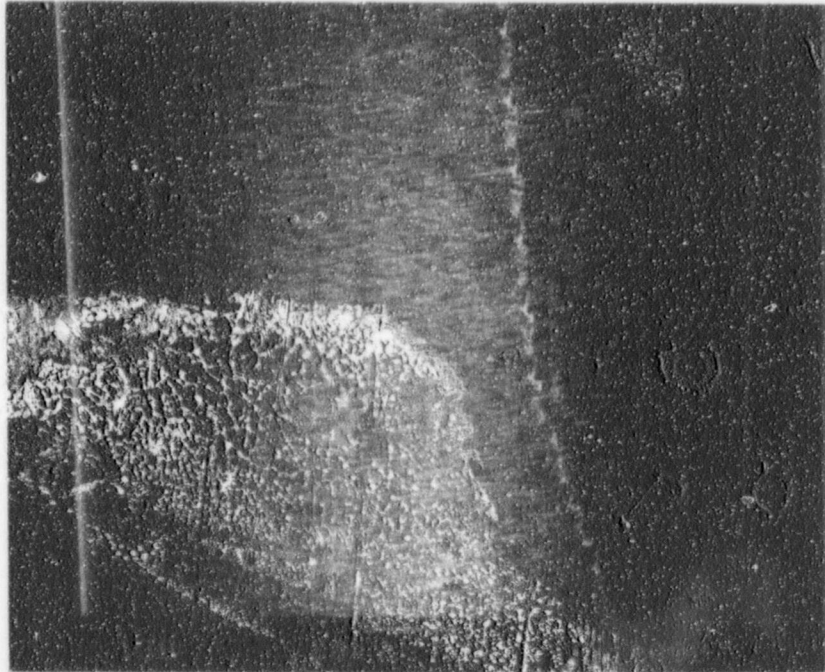
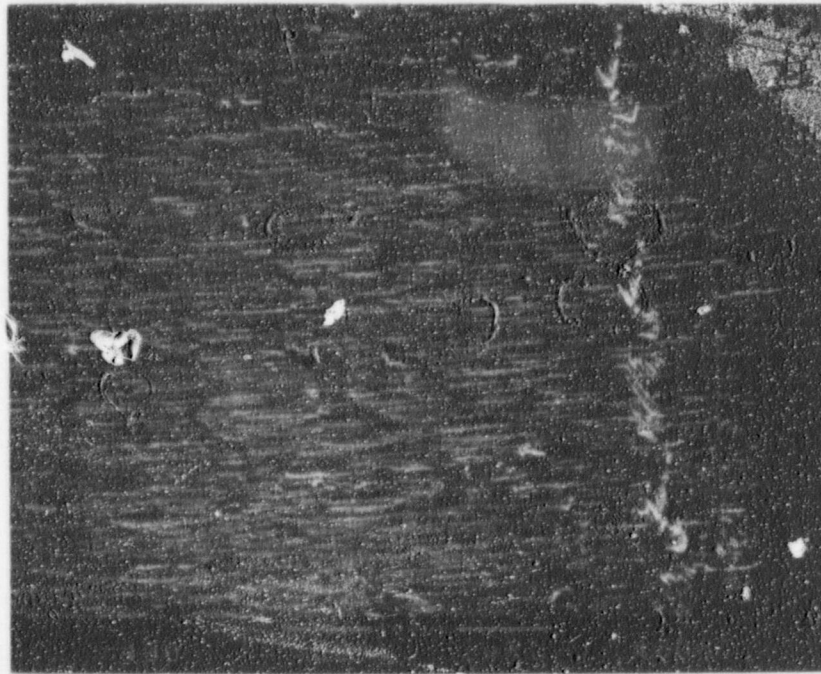
Figure 2-3. Subject Applicator. Condition of the OD surface at 4 cm from the tip.

A similar examination of the OD surface of this needle at locations approximately 4 cm and 15 cm from the tip of the needle reveals a nearly identical surface condition (Figures 2-3 and 2-4). The specimen from 4 cm from the tip of the needle, shown in Figure 2-3, corresponds to the underside of Kink #3, the only kink reportedly present at the time of the incident. The needle was broken at that location in the laboratory by reverse bending, and the surface features at the exact location of the kink were examined at higher magnifications (Figure 2-5). No significant discontinuity which may have contributed to the formation of a kink was observed. Small surface dents, and limited evidence of

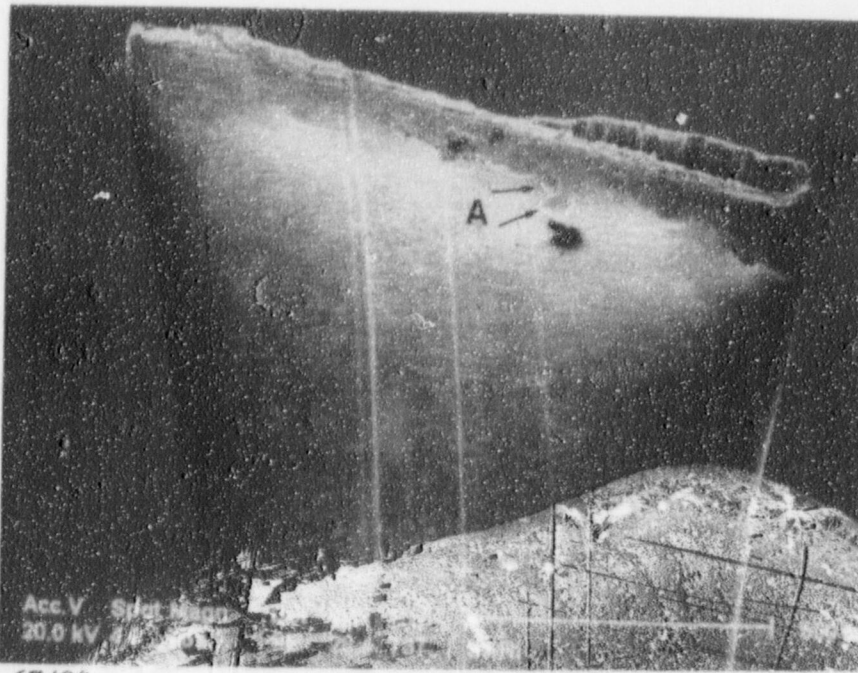
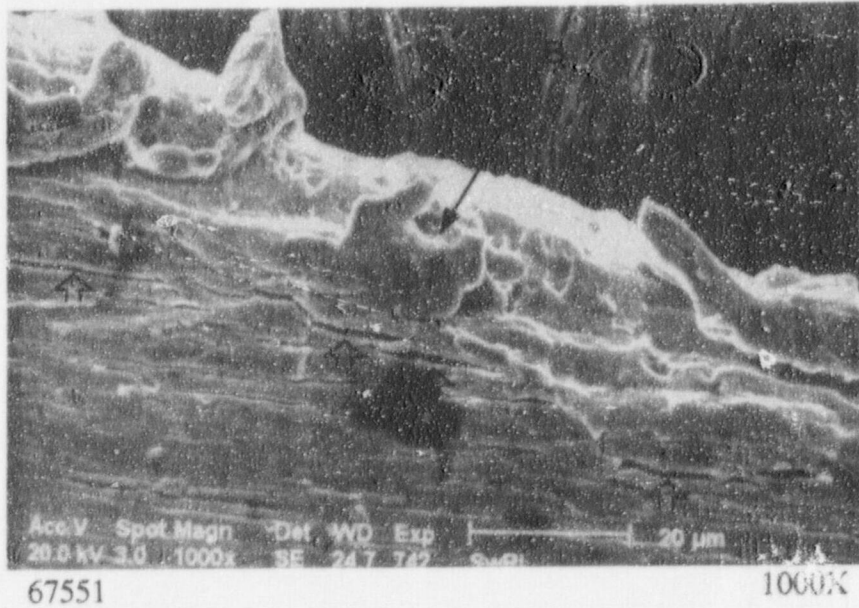
A potentially detrimental consequence of the circumferential scratches attributed to a grinding operation can be seen in Figure 2-5c. If the needle was loaded in bending, these scratches could act as stress concentration points potentially increasing the likelihood of forming either a kink, or as evidenced by the secondary cracking (arrows in Figure 2-5c) of initiating a fracture of the needle.

Figure 2-5. Subject Applicator. Condition of the OD surface at the inside edge of Kink #3. Note the surface dents (A), the scuff marks (B), and the secondary cracks (open arrows).

Figure 2-5 (continued). **Subject Applicator.** Condition of the OJ surface at the inside edge of Kink #3. Note the surface dents (A), the scuff marks (B), and the secondary cracks (open arrows).

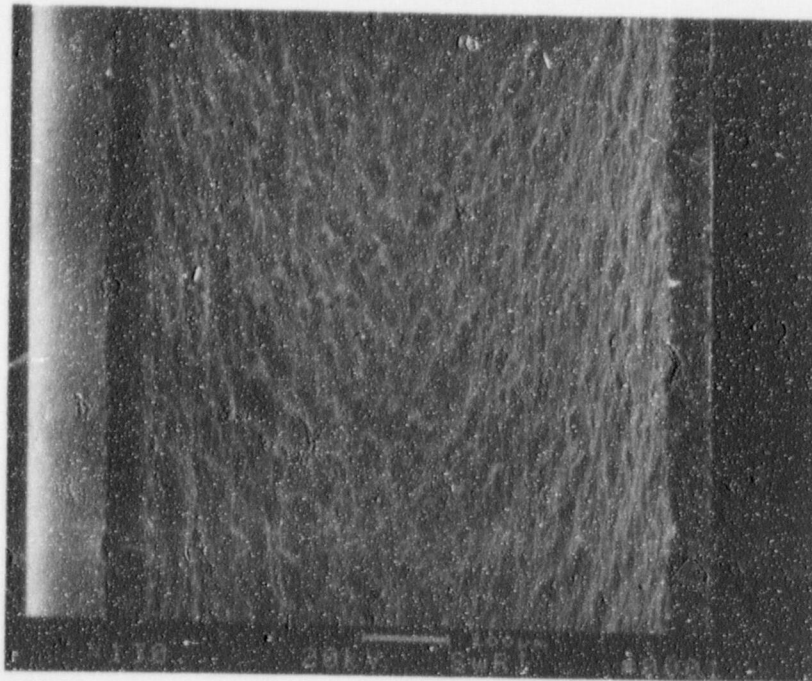
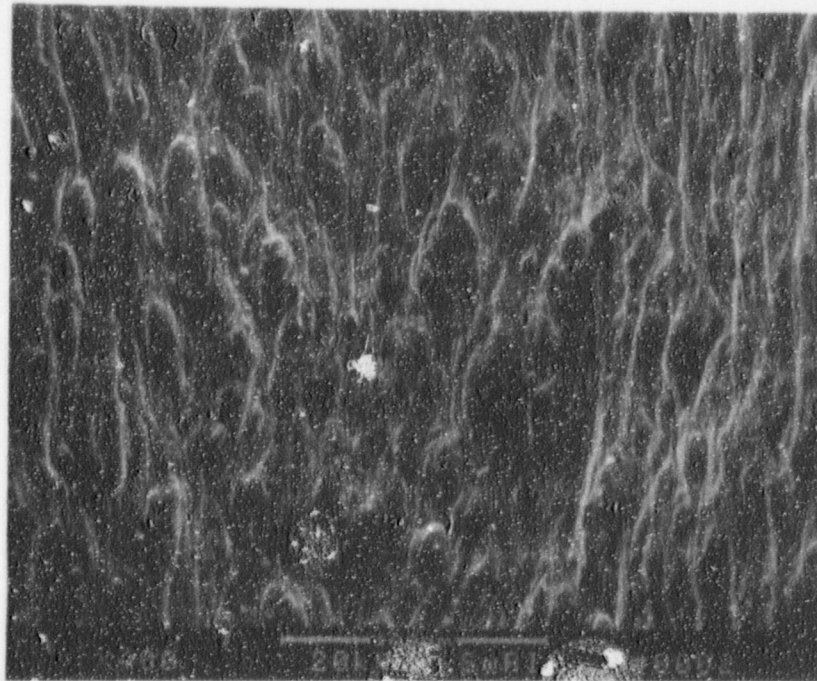
Figure 2-6. Subject Applicator. Condition of the ID surface at 4 cm from the tip.

The condition of the ID surfaces of the Subject Applicator was somewhat unusual, although consistent over the entire length of the needle. Typical examples of the ID surface are shown in Figures 2-6 and 2-7. As opposed to the ground appearance of the OD surface, the ID surface was rugged and very irregular, similar to the bottom of a creek bed. Such an appearance is often associated with a rapidly solidified or recast surface, and is typical of a surface which has been electrodischarge machined (EDM). In discussions with the manufacturer of the brachytherapy equipment it was learned that they purchase these needles as standard hypodermic needle tubing and the manufacturing process used are predominantly left to the manufacturer. It was not clear why such a finish is present on the ID surface.

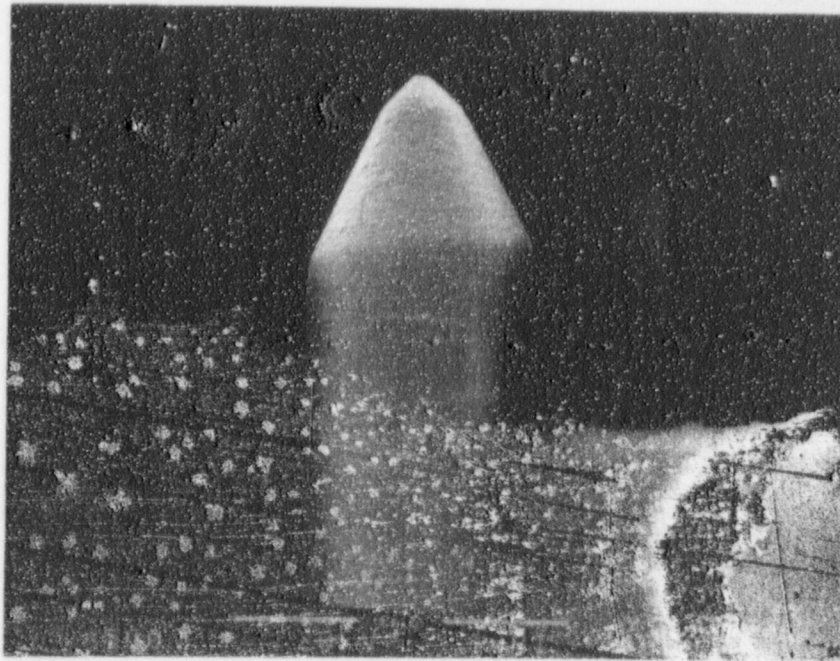
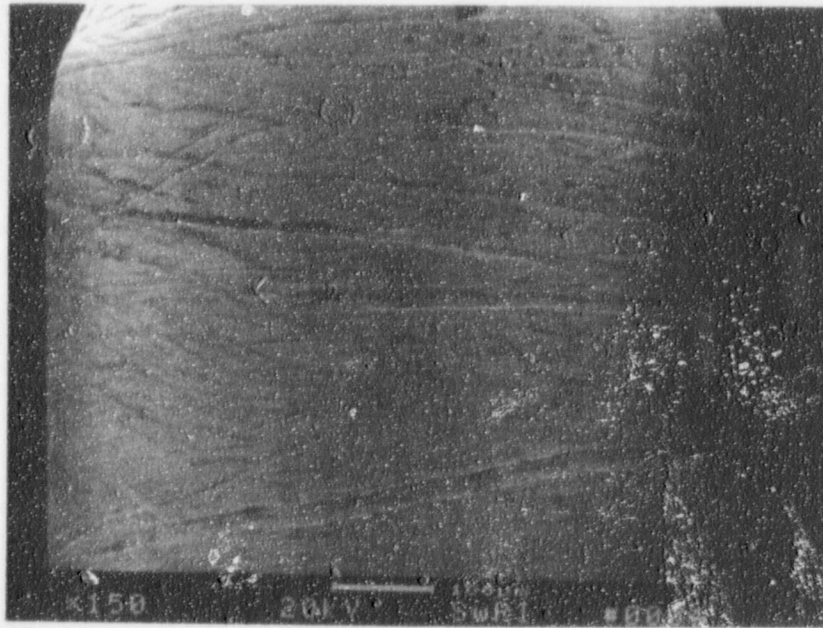
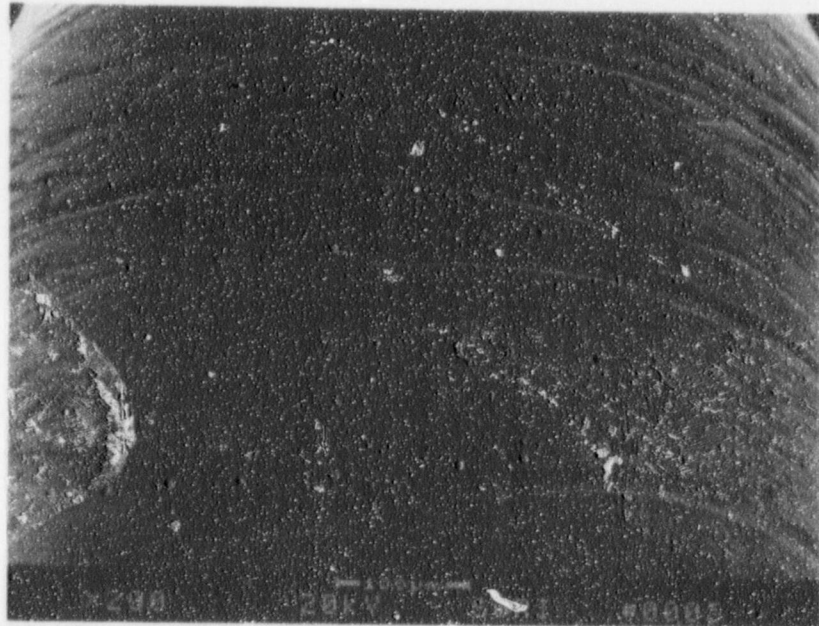
Figure 2-8. Unused Applicator. Condition of the OD surface near the tip.

The condition of the OD surface at the tip of the Unused Applicator is shown in Figure 2-8. The condition of the tip of this needle is very similar to that of the Subject Applicator except for several isolated deeper scratches. The depth of the worst scratches was determined during the microstructural examination (discussed in Section 2.3.1) and found to be approximately 0.00015" deep which corresponds to 10% of the wall thickness at this location. These scratches are not expected to be detrimental to the performance of the needle. In addition to the deeper scratches, closely spaced very shallow circumferential scratches were again present, a feature which is consistent with a surface that has been ground.

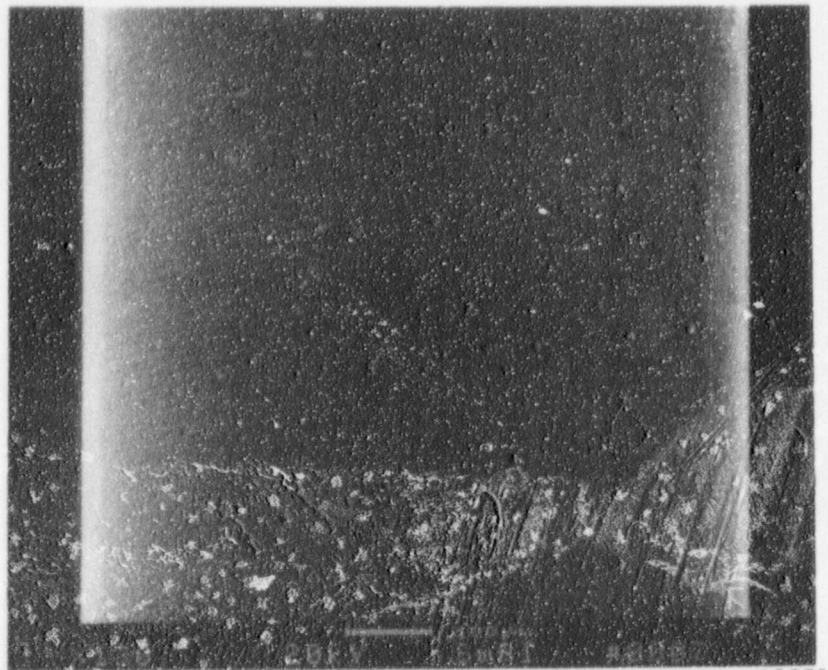
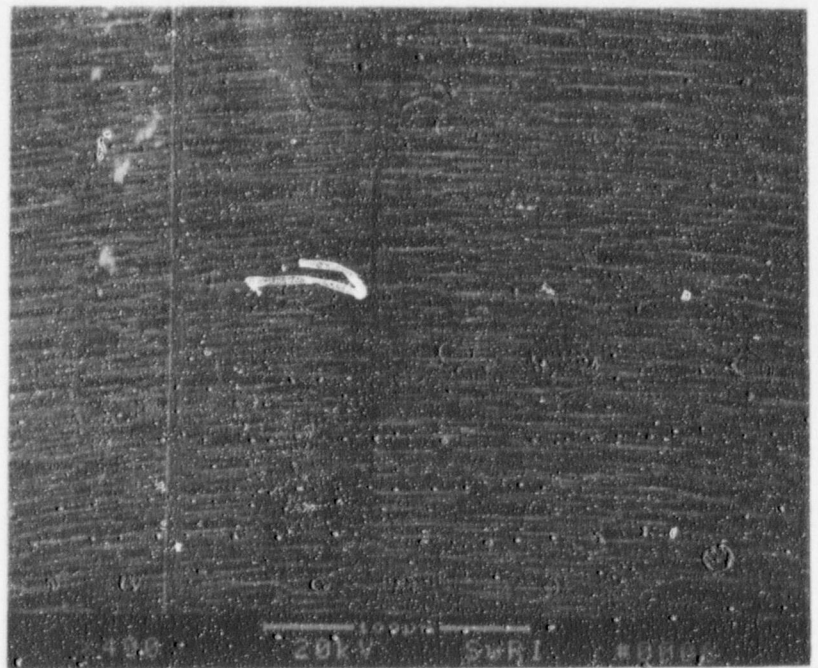
Figure 2-9. Unused Applicator. Condition of the OD surface at 4 cm from the tip.

The condition of the OD surface at locations 4 cm and 15 cm from the tip of the needle is shown in Figures 2-9 and 2-10. These two locations are essentially identical to each other, and to the comparable locations on the Subject Applicator. The surface is predominantly covered with an array of finely spaced, very shallow, circumferential scratches. Several isolated, somewhat deeper longitudinally oriented scratches were also observed. These longitudinal scratches are not expected to detrimentally affect the performance of the needle. The circumferential scratches, as was shown on the Subject Applicator, may act as areas of stress concentration for the initiation of either cracks or kinks if the needle is subjected to high levels of bending stress.

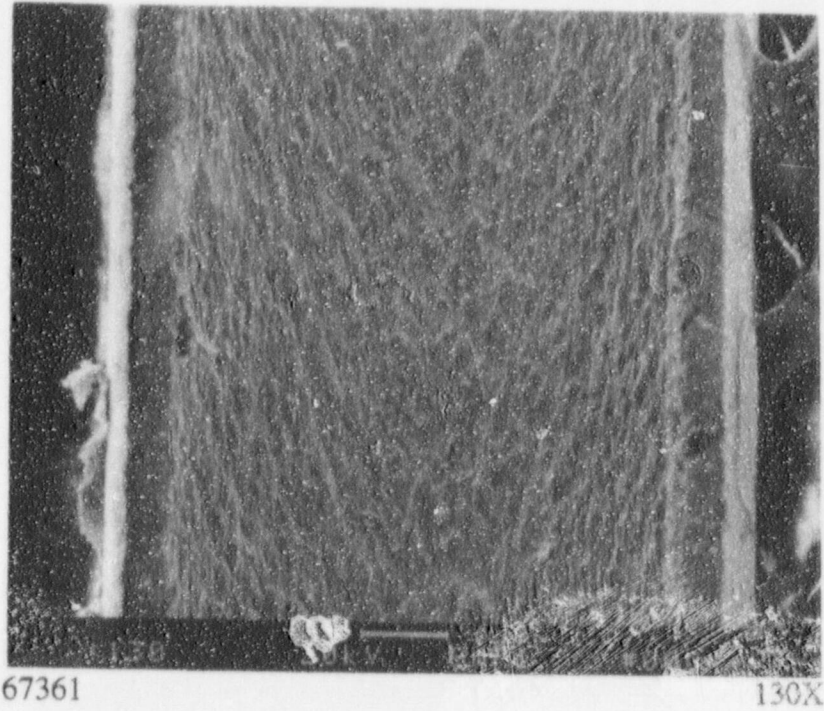
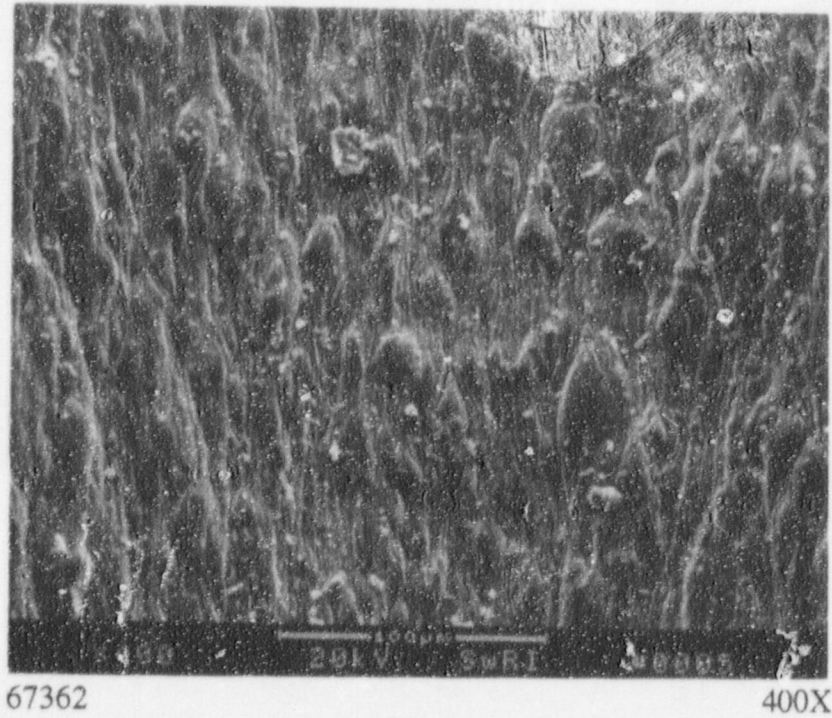
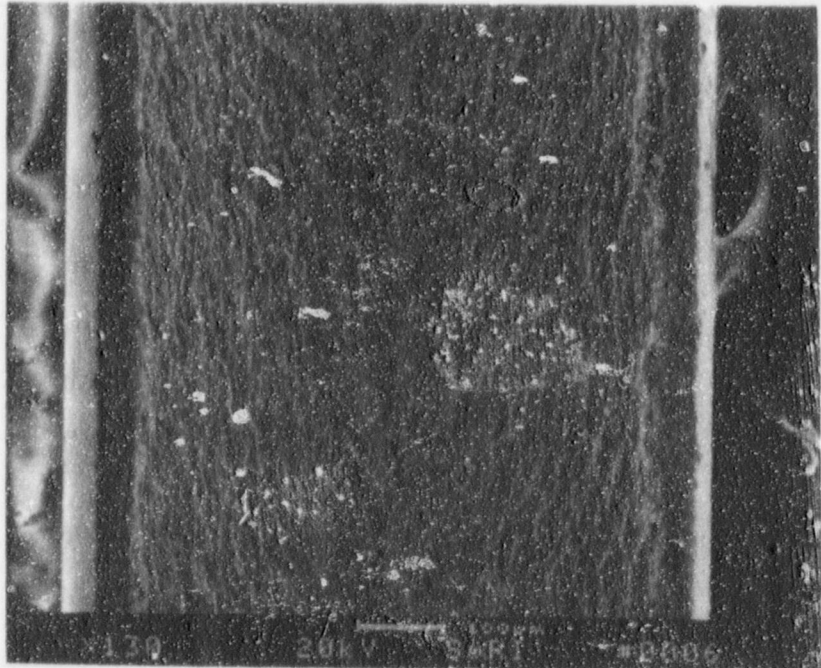
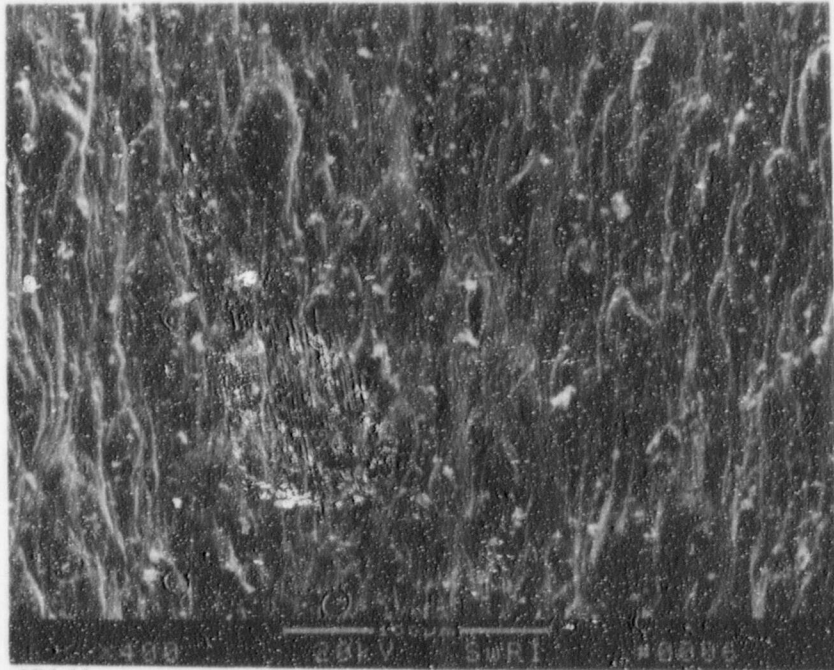
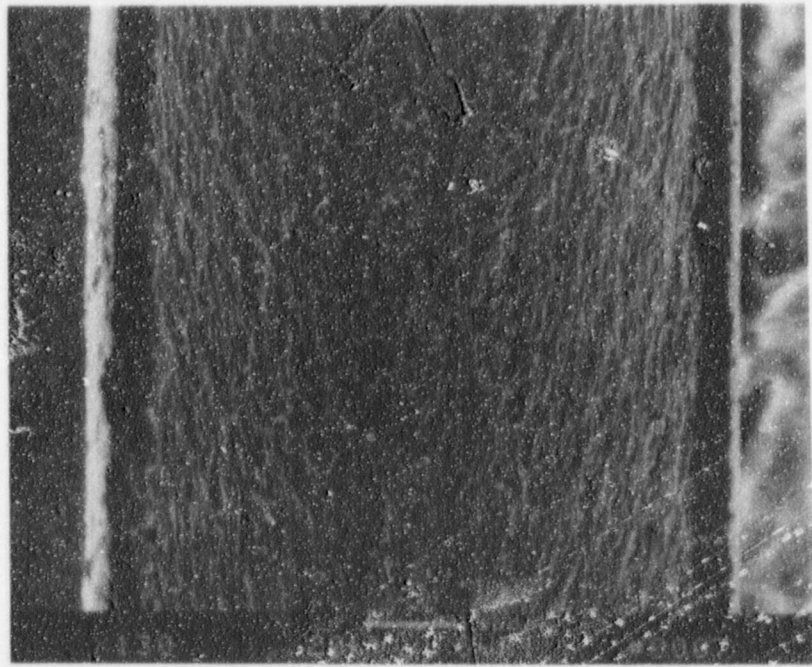
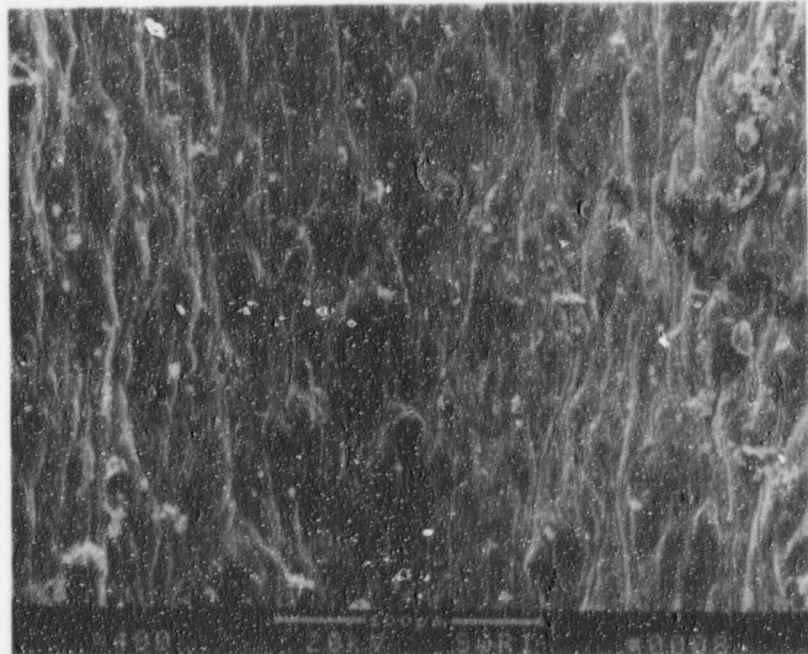
The condition of the ID surface of the Unused Applicator at the tip, and 4 cm and 15 cm from the tip of the needle are shown in Figures 2-11 through 2-13. The ID surface of this needle was identical to that of the Subject Applicator, exhibiting an irregular recast

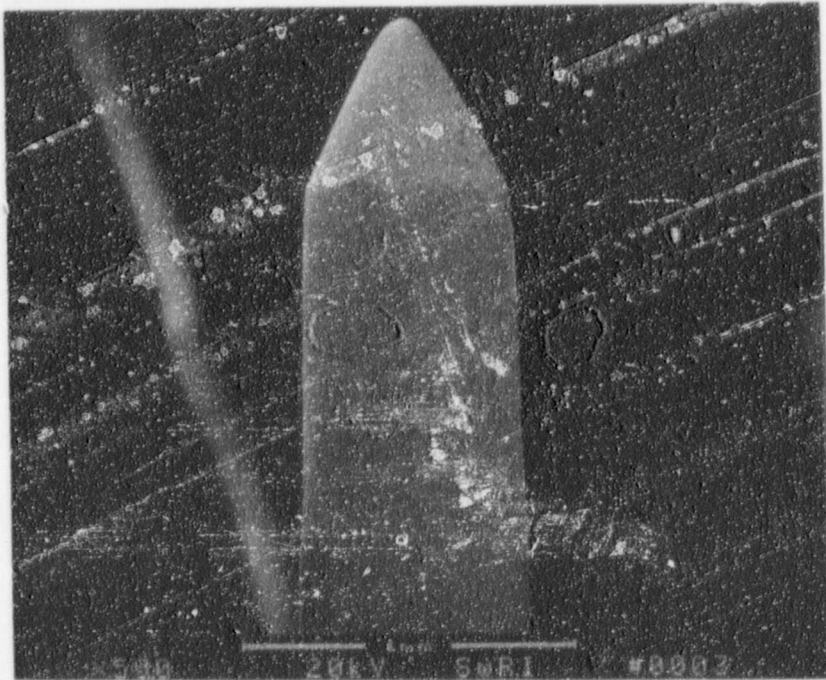
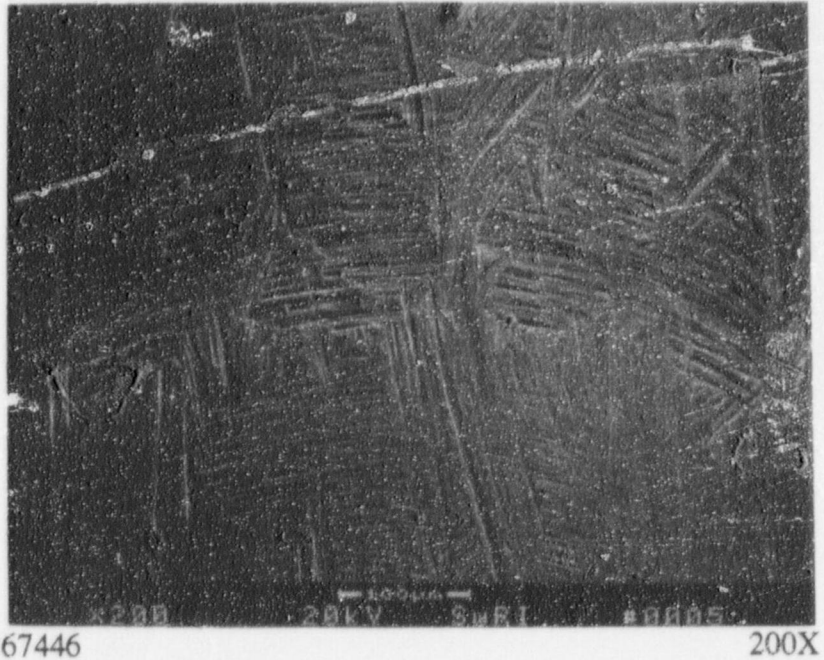
Figure 2-14. Raw Applicator. Condition of the OD surface near the tip.

The condition of the OD surface near the tip of the Raw Applicator differed substantially from the previous two needles (Figure 2-14). The tip appeared to have been more heavily ground, and bands of circumferentially oriented grinding marks are present. Scattered scratches oriented either longitudinally or at approximately a 45° angle from the axis of the needle were also observed. These scratches had a depth similar to that of the circumferential grinding marks. The deepest grinding extends for a distance of 2 mm or less, and the lighter grinding of the tip is present over a distance of approximately 7 mm.

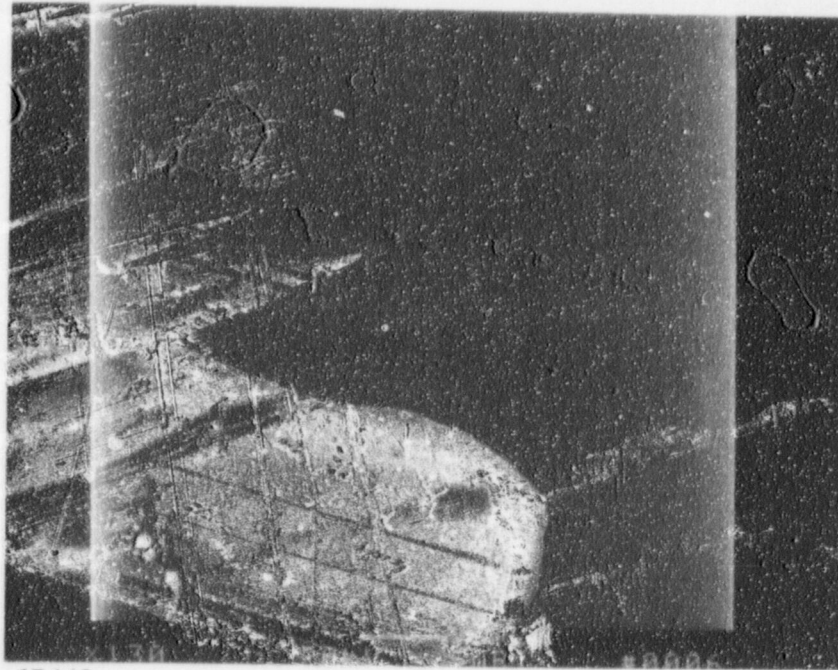
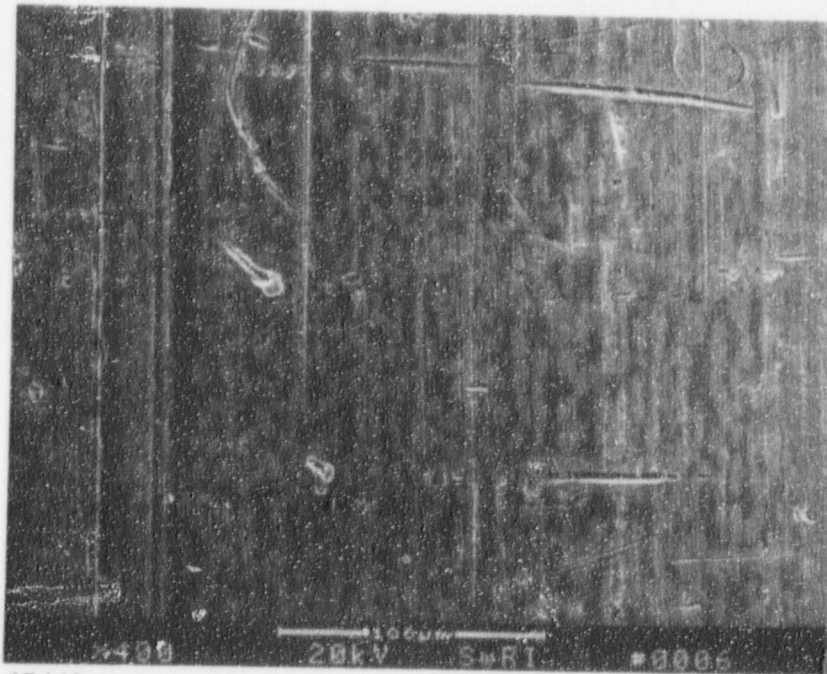
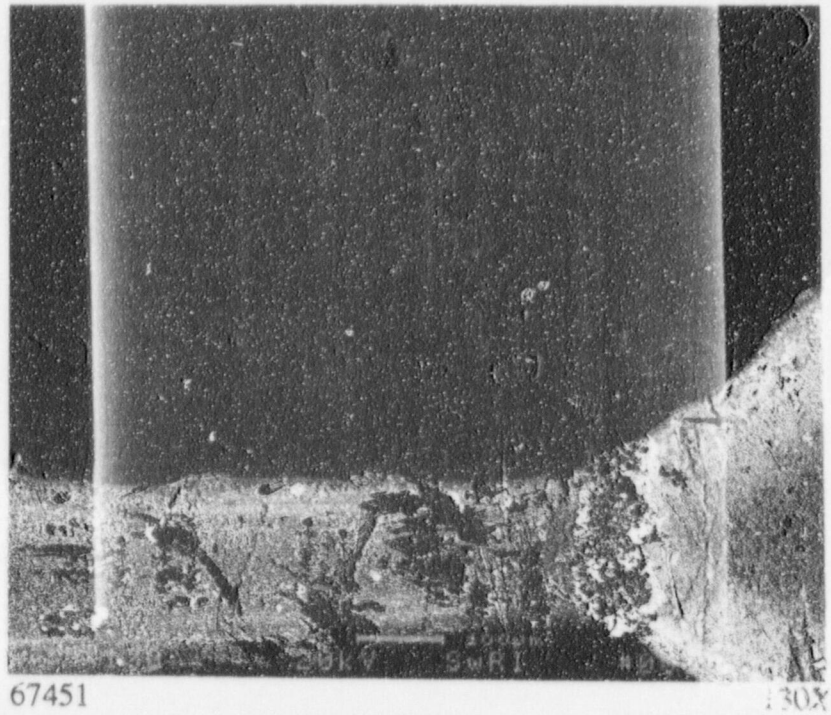
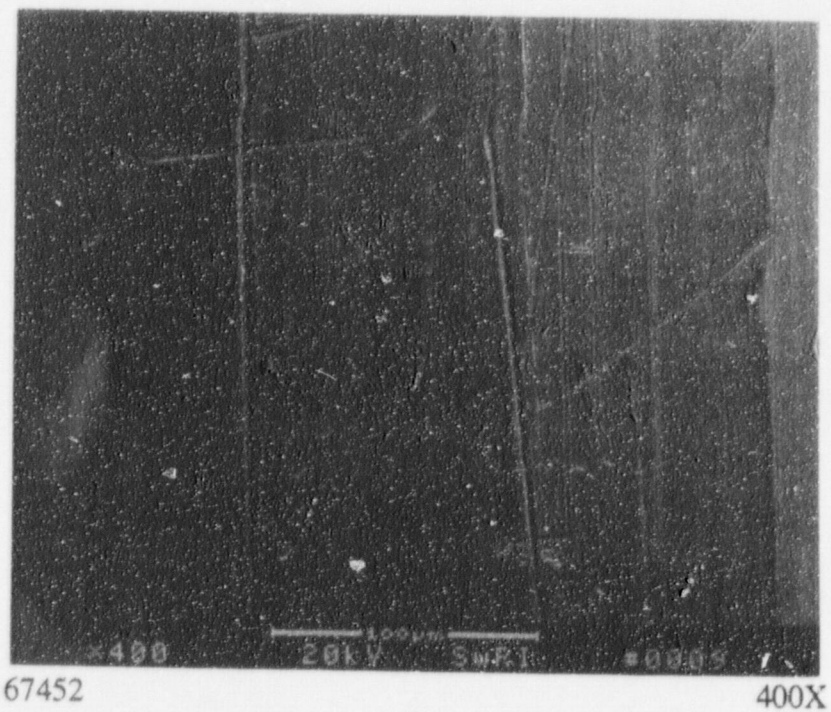
Beyond the first 7 mm from the tip, the OD surface condition of the needle is very consistent. As can be seen on the specimens from locations 4 cm and 15 cm from the tip (Figures 2-15 and 2-16), the OD surface is more polished than either the Subject or Unused Applicators. The majority of the surface is covered with fine longitudinally oriented scratches, combined with isolated but deeper, randomly oriented scratches. This surface condition is consistent with a tube that has been drawn through a polished external die.

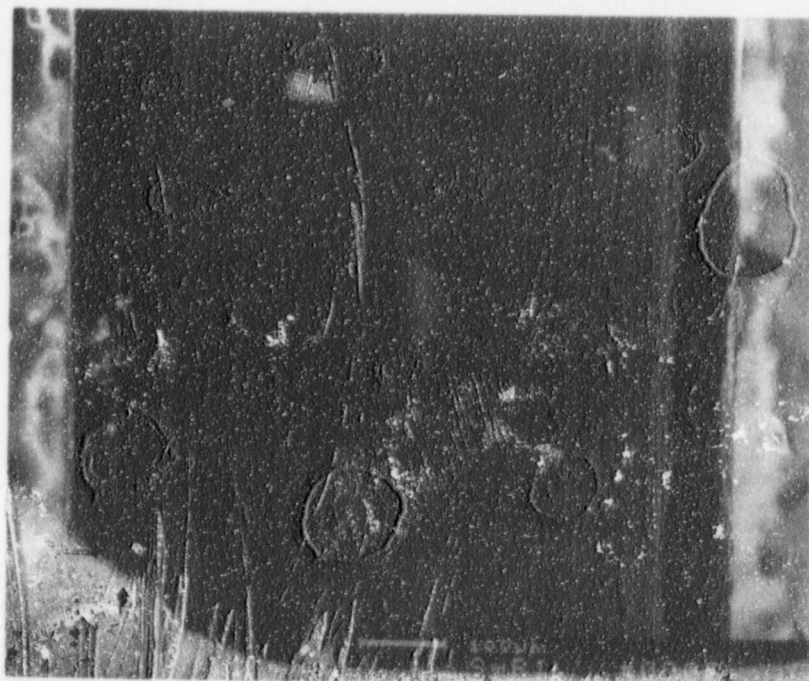
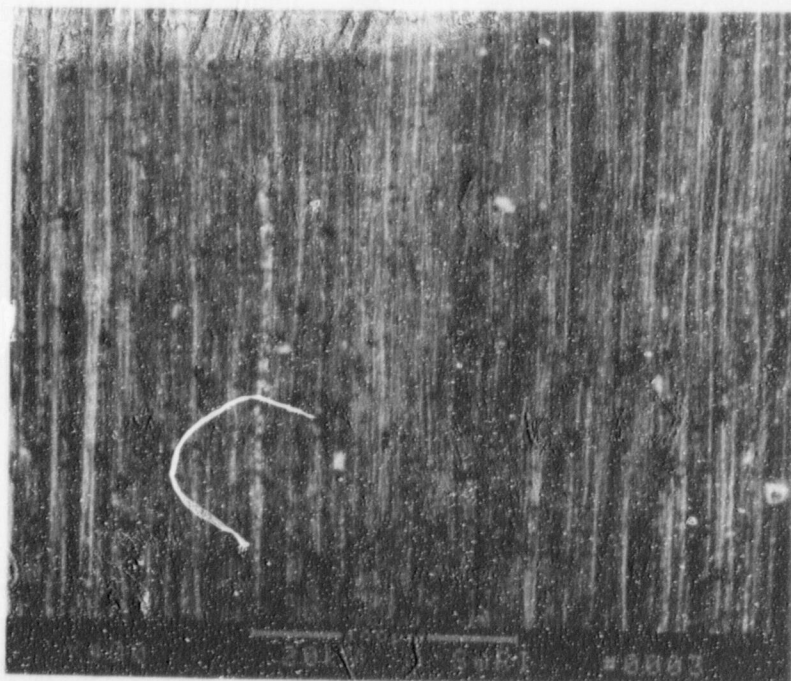
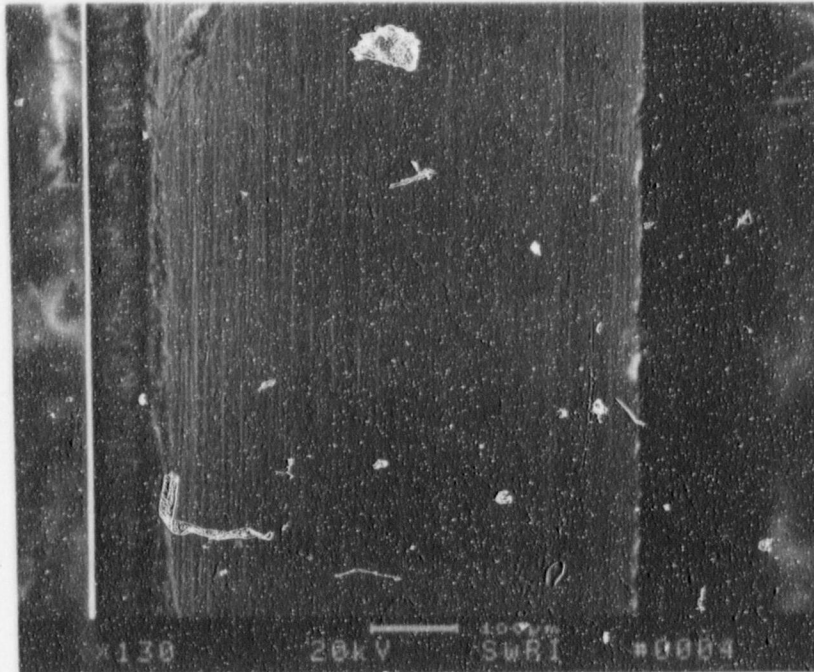
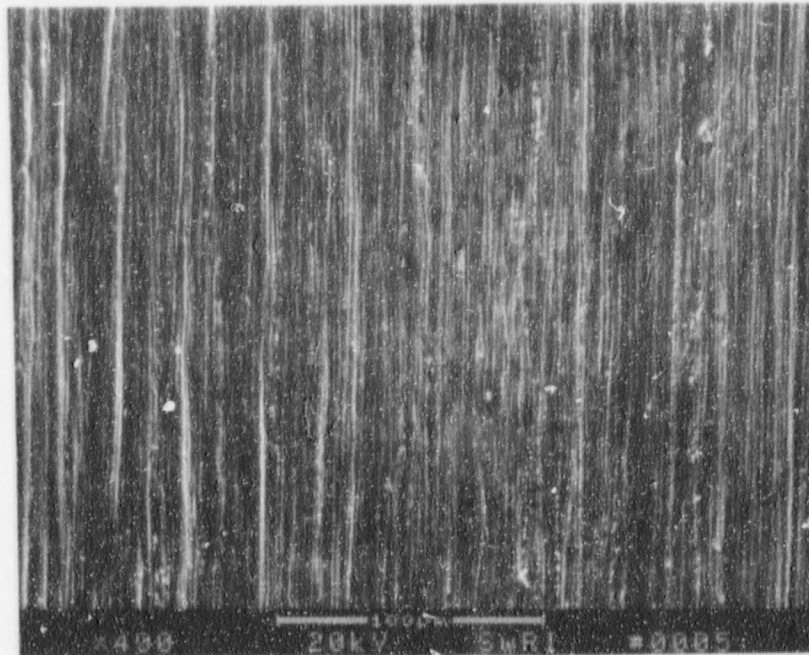
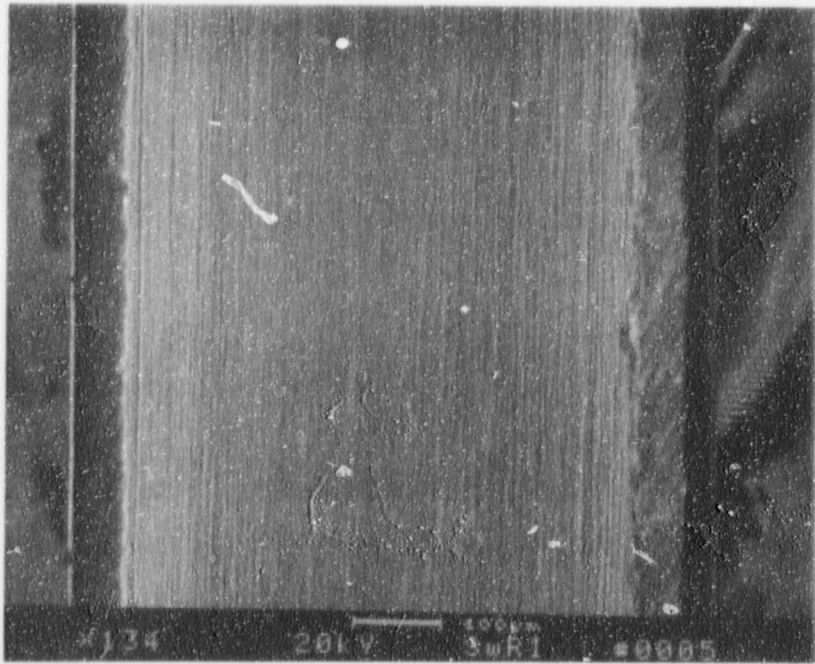
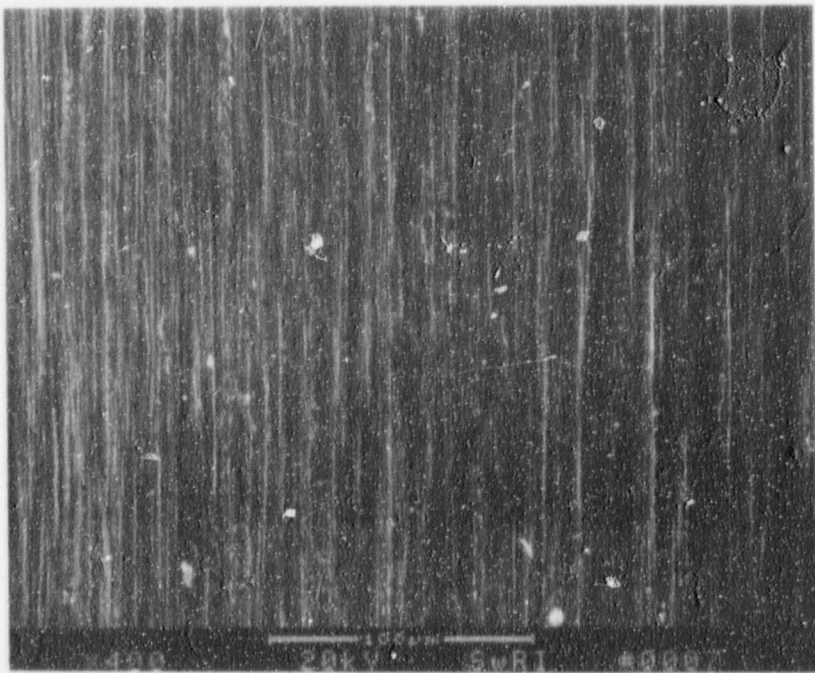
The condition of the ID surfaces of the Raw Applicator were also very different from the ID surfaces of the Subject and Unused Applicators. Unlike the irregular recast appearance observed on the previous two needles, the ID surface of the Raw Applicator consisted of an array of finely spaced, shallow, longitudinal scratches (Figures 2-17 through 2-19). This type of surface finish is consistent with a tube which has been drawn over an internal mandrel.

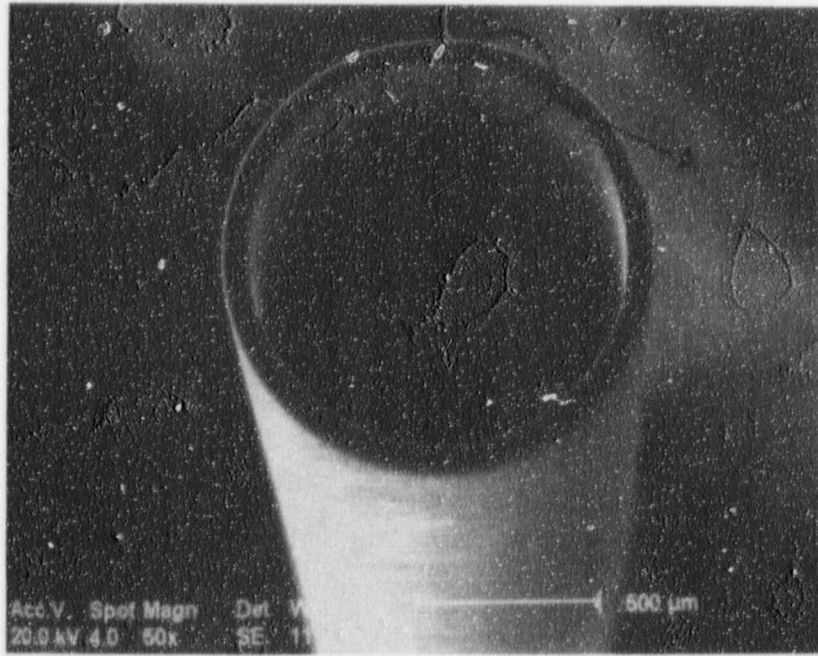
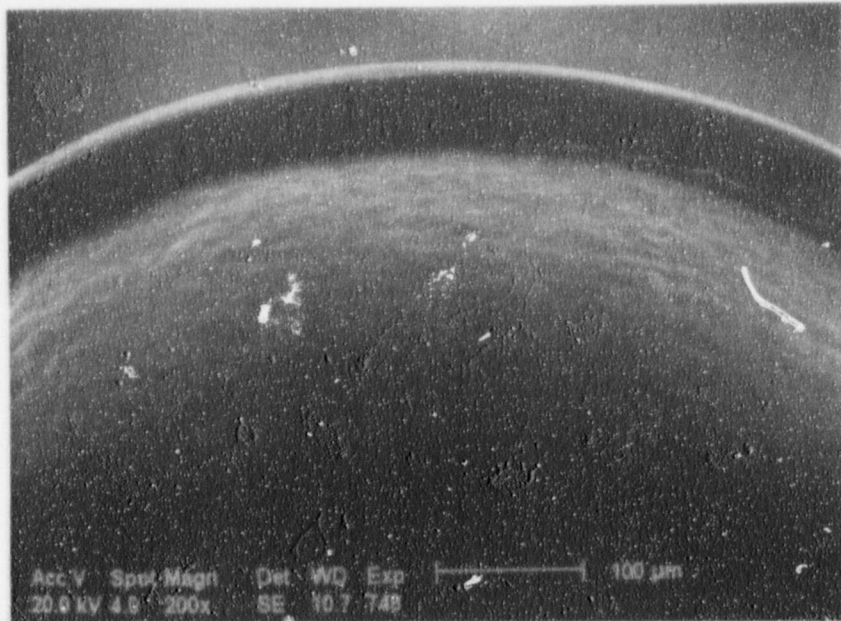
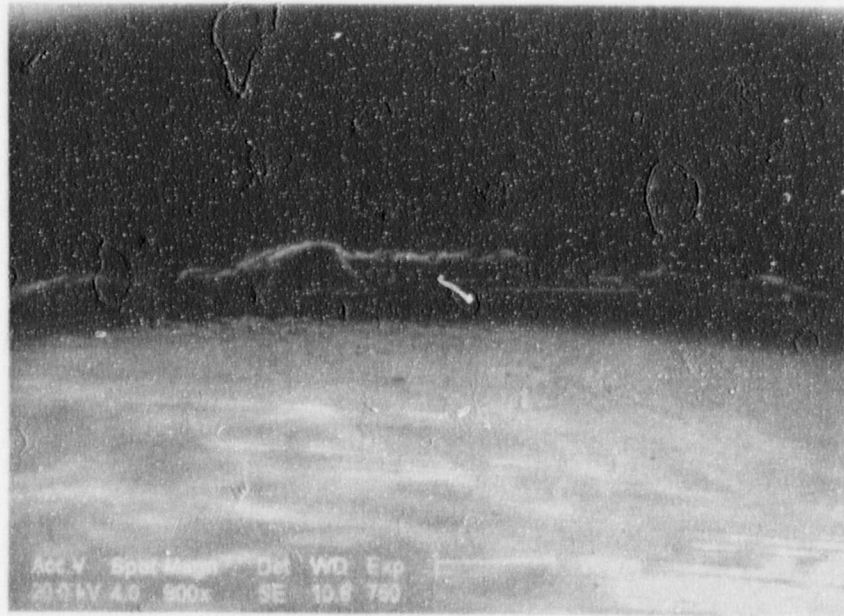
The open end of the biopsy needle, through which 4-5 cm of the tip of the Subject Applicator extended during the brachytherapy treatment, was examined in the SEM. As can be seen in Figure 2-20a, the overall condition of the end of the needle is very good. No significant distortion, burrs, or other features which may have contributed to the formation of a kink in the Subject Applicator were observed. There was a small region of deformed metal on the inside edge of the tip of the needle (Figures 2-20b and 2-20c). This distortion or smearing of the edge may be a result of the Subject Applicator impinging on the edge of the Biopsy Needle as would have occurred if the needle assembly were subjected to a bending load. The extent of the distortion is very limited, and is considered to more likely be an artifact of an impingement, and not expected to have contributed to the formation of the kink in the Subject Applicator.

Figure 2-20. Biopsy Needle. Tip of the needle through which 4.5 - 5 cm of the needle applicator extended during the treatment. (b) and (c) are higher magnifications of Location A.
