LICENSEE EVENT REPORT (LER)

FACILITY NAME (1) CRYSTAL RIVER UNIT 3	DOCKET NUMBER (2) 0 5 0 0 0 3 0 2	PAGE (3) 1 OF 0 5
---	--------------------------------------	----------------------

TITLE (4)
LOSS OF DECAY HEAT REMOVAL SYSTEM HEAT SINK DUE TO DIVER FATALITIES

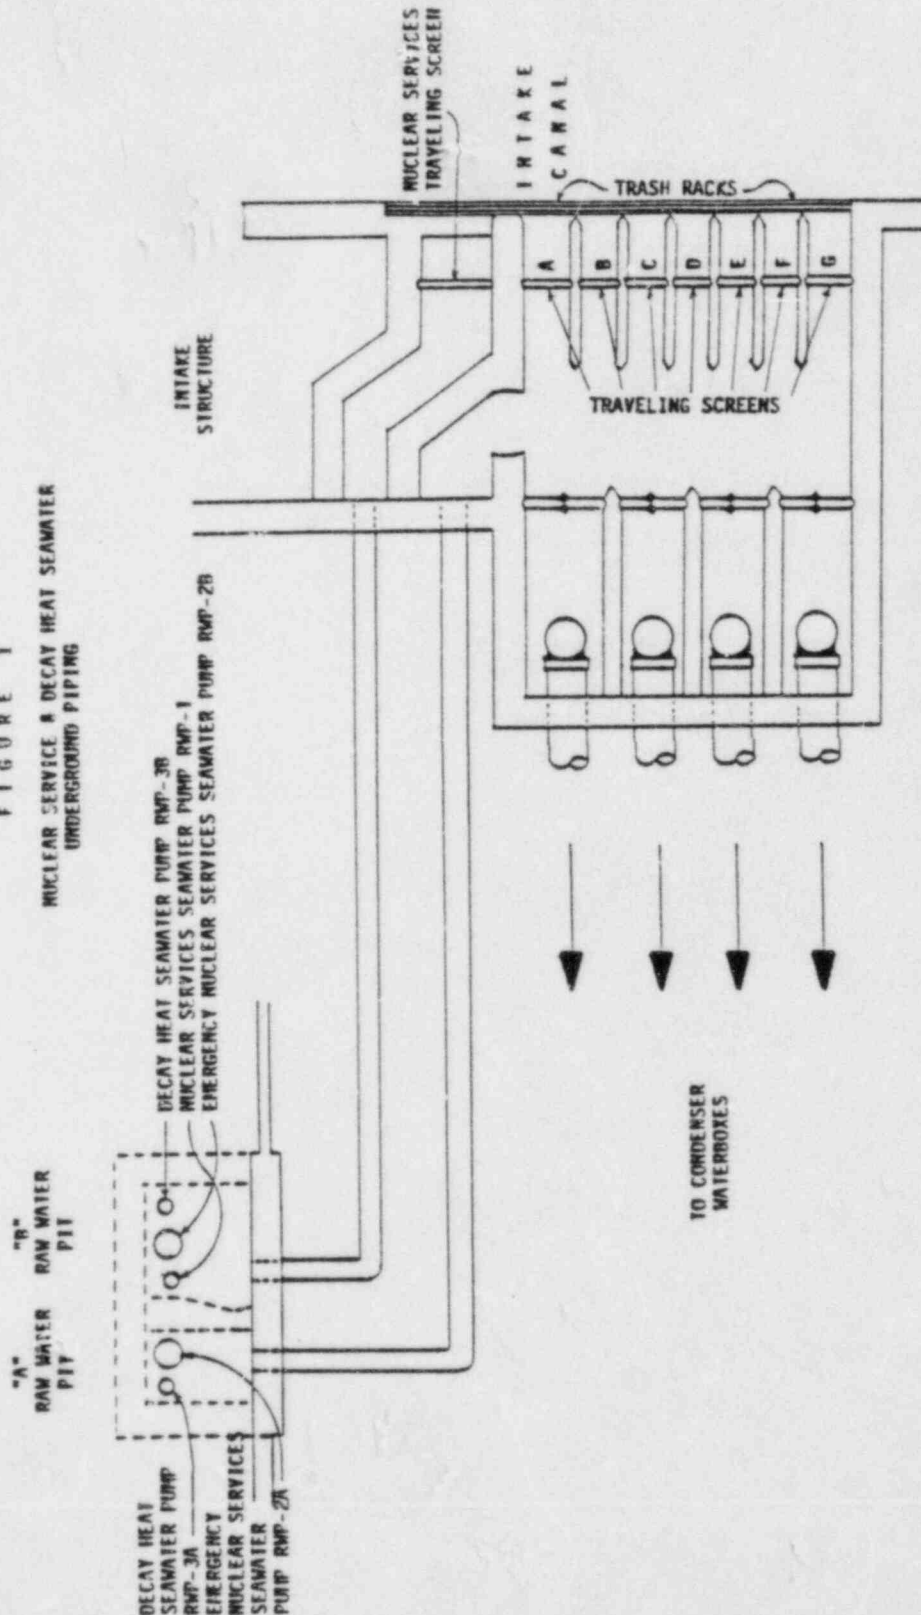
FIGURE 1
NUCLEAR SERVICE & DECAY HEAT SEAWATER
UNDERGROUND PIPING

On the afternoon of January 10, 1986, Crystal River Unit 3 was in Mode 5 during a maintenance outage. The Reactor Coolant System (RCS) [AB] was cooled by the "A" Decay Heat Removal (DHR) [BP] loop and temperatures were stable. The "A" decay heat seawater pump (RWP-3A) [BS, P] provided the heat sink for the "A" DHR loop. Various plant loads were supplied with cooling water from the Nuclear Services Closed Cycle Cooling Water System (SW) [CC], with the "A" emergency nuclear services seawater pump (RWP-2A) [BS, P] providing the heat sink. One of the maintenance items being performed was cleaning and inspection of the underwater areas of the intake structure. A contract diving firm, Dive-Tech International, had supplied two persons to perform this underwater cleaning and inspection. During the morning and early afternoon of January 10, 1986, the two divers performed a series of dives at the intake structure using SCUBA equipment. They removed debris, checked main circulating water pump impeller clearances, and inspected the general area of the intake structure. Refer to Figure 1 for details on the location of the pumps mentioned above.
