U.S. NUCLEAR REGULATORY COMMISSION

Report No. 50-263/97006(DRP)

Facility: Monticello Nuclear Generating Station

Monticello Nuclear Generating Station, Unit 1 NRC Inspection Report 50-263/97006

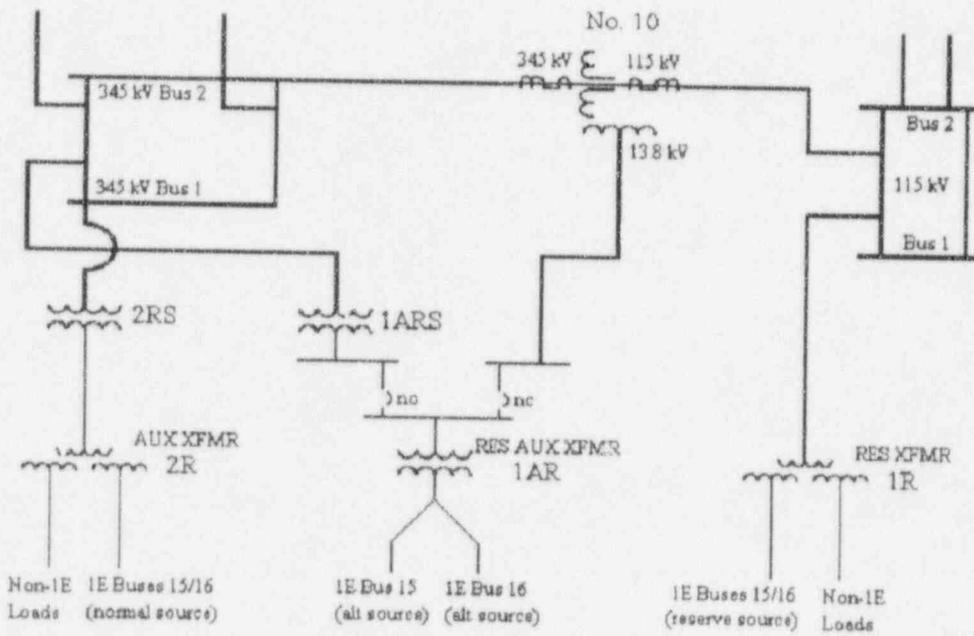
ATTACHMENT 1
Simplified Electrical Diagram

A simplified electrical one-line diagram is shown in Attachment 1 of this report. The USAR described three transformers to supply the site with offsite power from substations and all three sources can provide adequate power for the plant's safety-related loads. These included primary station auxiliary transformer 2R, reserve transformer 1R, and reserve auxiliary transformer 1AR. Transformers 2R and 1AR were considered one offsite source when 1AR was supplied from 345-kilovolt (kV) bus #1 since numerous common mode failures existed which could cause simultaneous de-energization of both transformers.

In order to maintain 1R transformer operable, a minimum of 119 kV was required at the high voltage side of the transformer. The inspectors noted that on two recent occasions, less than 119 kV was experienced at the high side of 1R transformer when the #10 transformer was taken out-of-service. These two instances indicated that 1R transformer was dependent on the 345-kV lines through the #10 transformer. The inspectors were concerned that system load growth had increased to where the plant would be outside the licensing basis whenever the #10 transformer provided power to both the 1AR and 1R transformers. Although the USAR was not clear on the dependence of the 119-kV and 345-kV lines on the #10 transformer, the licensee stated that the current design was within the licensing basis. The inspectors were provided with a safety evaluation from a 1984

Additional reviews indicated that TS 3.9.A.1 allowed for continued plant operation with transformers 1R and 1AR serving as the two offsite sources. However, there were no restrictions on both transformers being powered from the #10 transformer. Therefore, a loss of the #10 transformer would cause the unavailability of both offsite sources; the de-energization of the 1AR transformer and less than 119 kV at the 1R transformer. The licensee stated that although allowed by TS, the 1R and 1AR transformers would not both be energized from the #10 transformer, whenever possible. This operational restriction was not described in the TS or USAR, but was in Operations Manual B.9.3-05, "345 kV Substation," section A.2.c. The inspectors concluded that the current design of transformers 1R and 1AR being dependent on #10 transformer was not described in the licensee's USAR and required further NRC review. This issue is an Inspection Followup Item (IFI 50-263/97006-04(DRP)) pending review by the Office of Nuclear Reactor Regulation.

Additional review by the inspectors indicated a discrepancy in USAR 8.3.3, Performance Analysis. The USAR stated that "provisions are made for automatic, fast transfer of the auxiliary load from the primary station transformer to the reserve transformer or the auxiliary reserve transformer"; (i.e. 2R, 1R, and 1AR, respectively). The inspectors noted that the electrical design included a fast transfer feature from transformer 2R to 1R upon protective relaying actuation. However, there was no fast transfer feature of the auxiliary loads from transformer 1R to 1AR. The licensee stated that there was never a fast transfer scheme for all auxiliary loads among the three transformers. The inspectors noted that USAR section 8.2.1 stated that transformers 2R and 1R were of adequate size to provide the plant's full auxiliary load requirements. However, transformer 1AR was sized to provide only the plant's essential 4 kV buses and connected loads. The licensee was asked to evaluate the USAR discrepancy. The results of that evaluation will be reviewed during a future inspection (IFI 50-263//97006-05(DRP)).
