OFFICE OF INSPECTION AND ENFORCEMENT
DIVISION OF INSPECTION PROGRAMS

Report No.: 50-313/86-01

Facility Name: Arkansas Nuclear One, Unit 1

Inspection Conducted: January 6 - 31, 1986

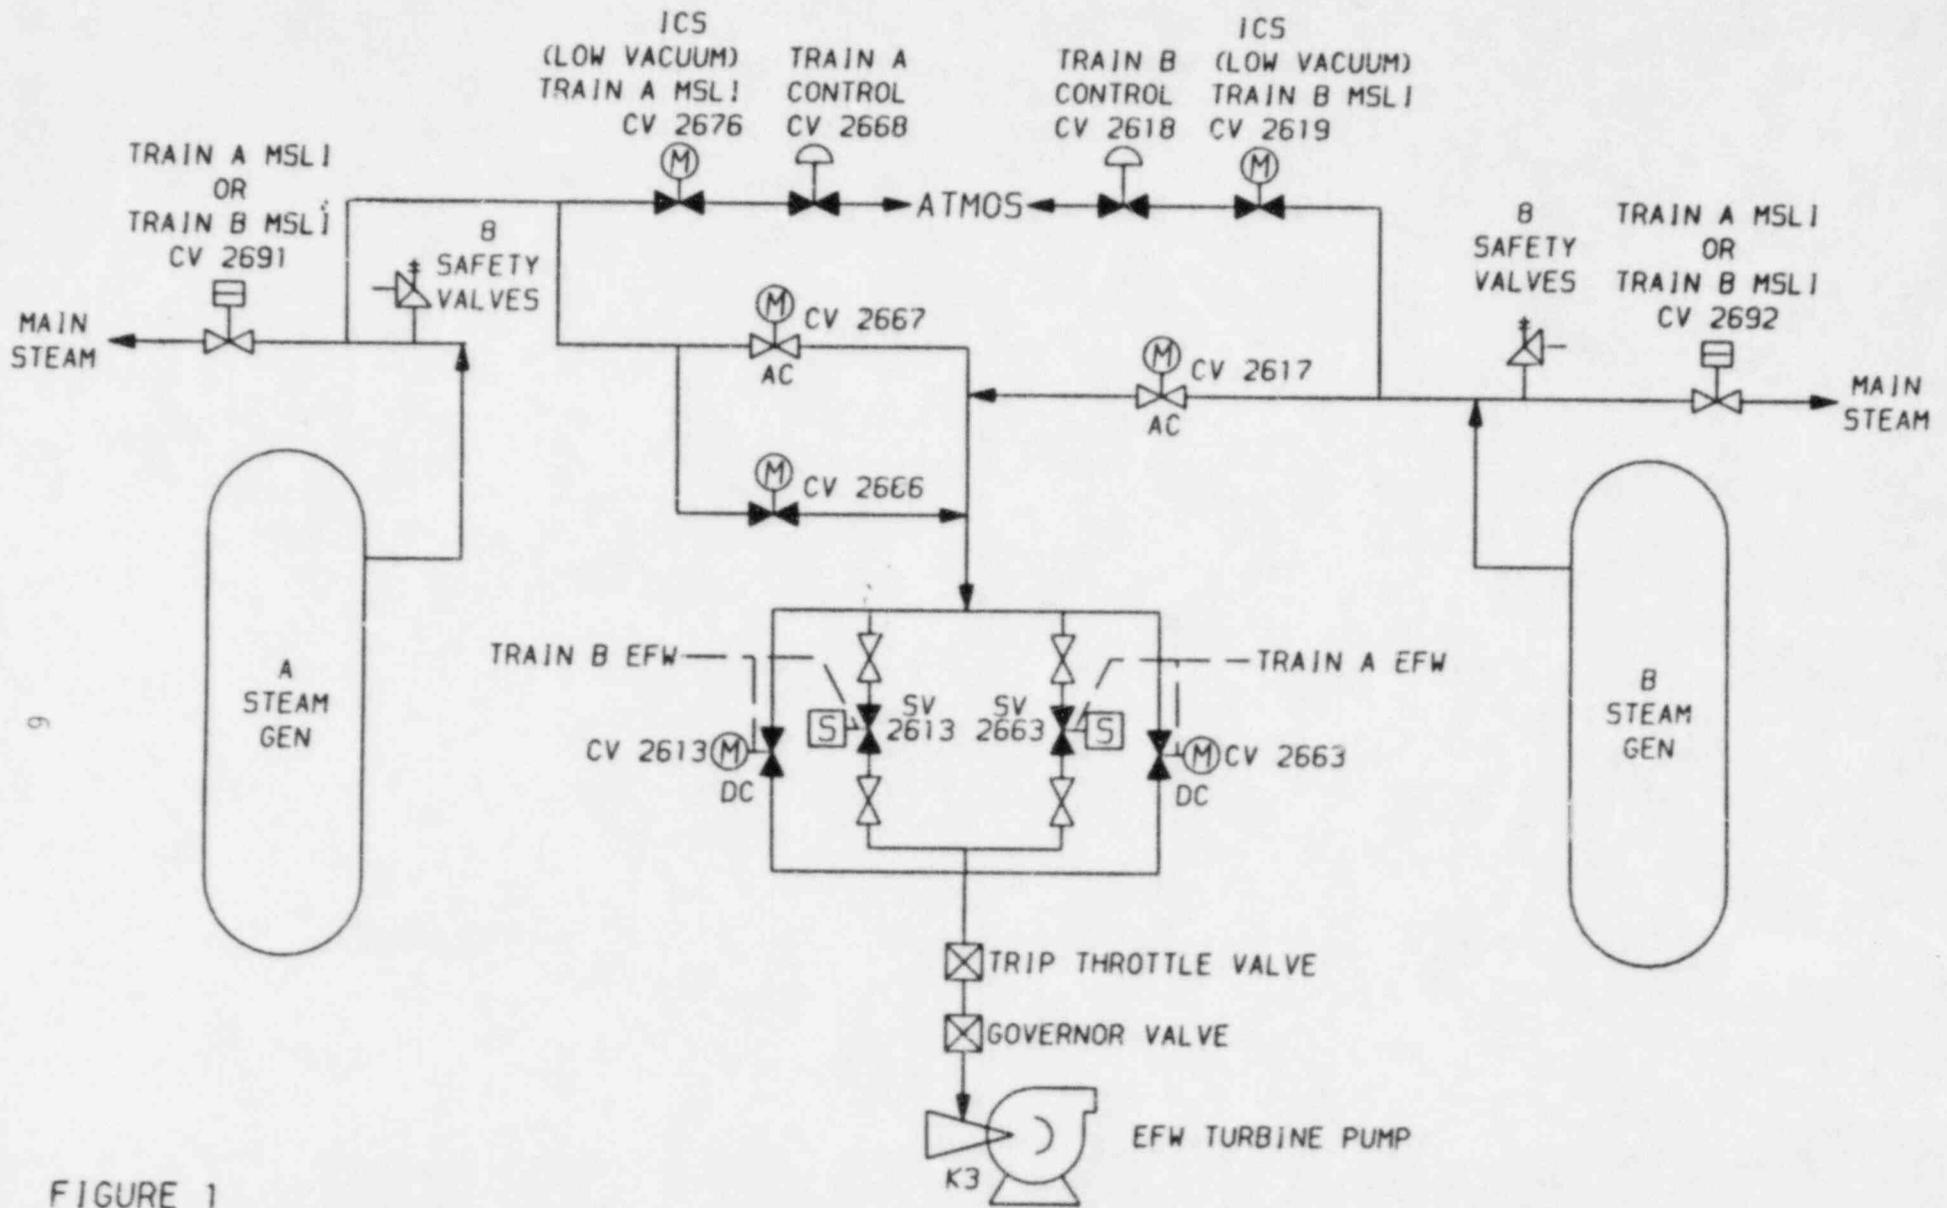
FIGURE 1
 ANO-1 MAIN STEAM SUPPLY
 TO EMERGENCY FEEDWATER TURBINE PUMP

1. The inspection team identified design concerns regarding the ability of the EFW system to perform its safety function during abnormal events.
 - a. For steam line break accident scenarios, given a single active failure within the electrical power system (i.e., vital power), the emergency feedwater initiation and control (EFIC) subsystem did not have the capability to isolate the affected steam generator (SG) from the unaffected SG. It appeared that this could result in the loss of all EFW flow to both SGs. For a nonisolable steam line break in SG A with a concurrent loss of offsite power, the EFW system and EFIC subsystem rely on onsite power sources. If the loss of "red" ac power is assumed as the single active failure (i.e., failure of "red" diesel to start, fault on bus, etc.), the EFW motor-driven pump is unavailable and motive power is lost to operate CV-2667 (the isolation valve between SG A and the EFW turbine-driven pump). As a consequence, CV-2667 could not be closed and EFIC would have unsuccessfully attempted to isolate SG A from SG B. Instead, the unaffected SG B would have been cross-connected to the affected SG A through CV-2667 and CV-2617. As a consequence, both SGs could have depressurized through the nonisolable break, and the steam supply to the turbine-driven EFW pump may have been insufficient, causing a complete loss of EFW. In addition, the blowdown of two SGs through a nonisolable break inside the containment building was outside the design basis for the containment building (See figure 1, page 6).

1. The team determined that the implementation of DCP 82-D-1050 failed to ensure that it met the single-failure criterion. Specifically, for steam line break scenarios, given a single failure within the electrical power system (vital power), the emergency feedwater initiation and control system (EFIC) would not have the capability to isolate the affected steam generator (SG) from the unaffected SG. It appeared that this could result in the loss of all EFW flow to both SGs.

Subsequent to the inspection, the licensee provided information indicating that, for the main steam line break accident postulated above, sufficient steam would have been available to the EFW turbine until SG pressure dropped to approximately 80 psia.

Review of DCP 82-1050 (the design change to install the new EFW turbine, new dc steam admission valves, and to modify EFW suction and discharge piping) indicated that a single-failure analysis was not performed. Specifically, question 15 of the DCP asked, "How was the impact of failure of the systems, components, and structures considered in the design?" In response, the Project Engineer indicated that the question was not applicable by answering "NA." This response was checked and approved without comment. Procedure 1032.01, "Design Control," Revision 7, required an independent reviewer to verify that responses to the Design Evaluation Questions had been properly addressed and that the discipline portion of the design change was complete and technically accurate.
