HYDROGEOLOGIC ASSESSMENT OF THE ELEVATED
URANIUM AND NITRATE CONCENTRATIONS IN
MONITOR WELL FTP-2A

SEQUOYAH FACILITY
SEQUOYAH FUELS CORPORATION
GORE, OKLAHOMA

Roy K. Widmann
Senior Hydrologist
Engineering Services Division
Hydrology Section
Kerr-McGee Corporation

March 20, 1986

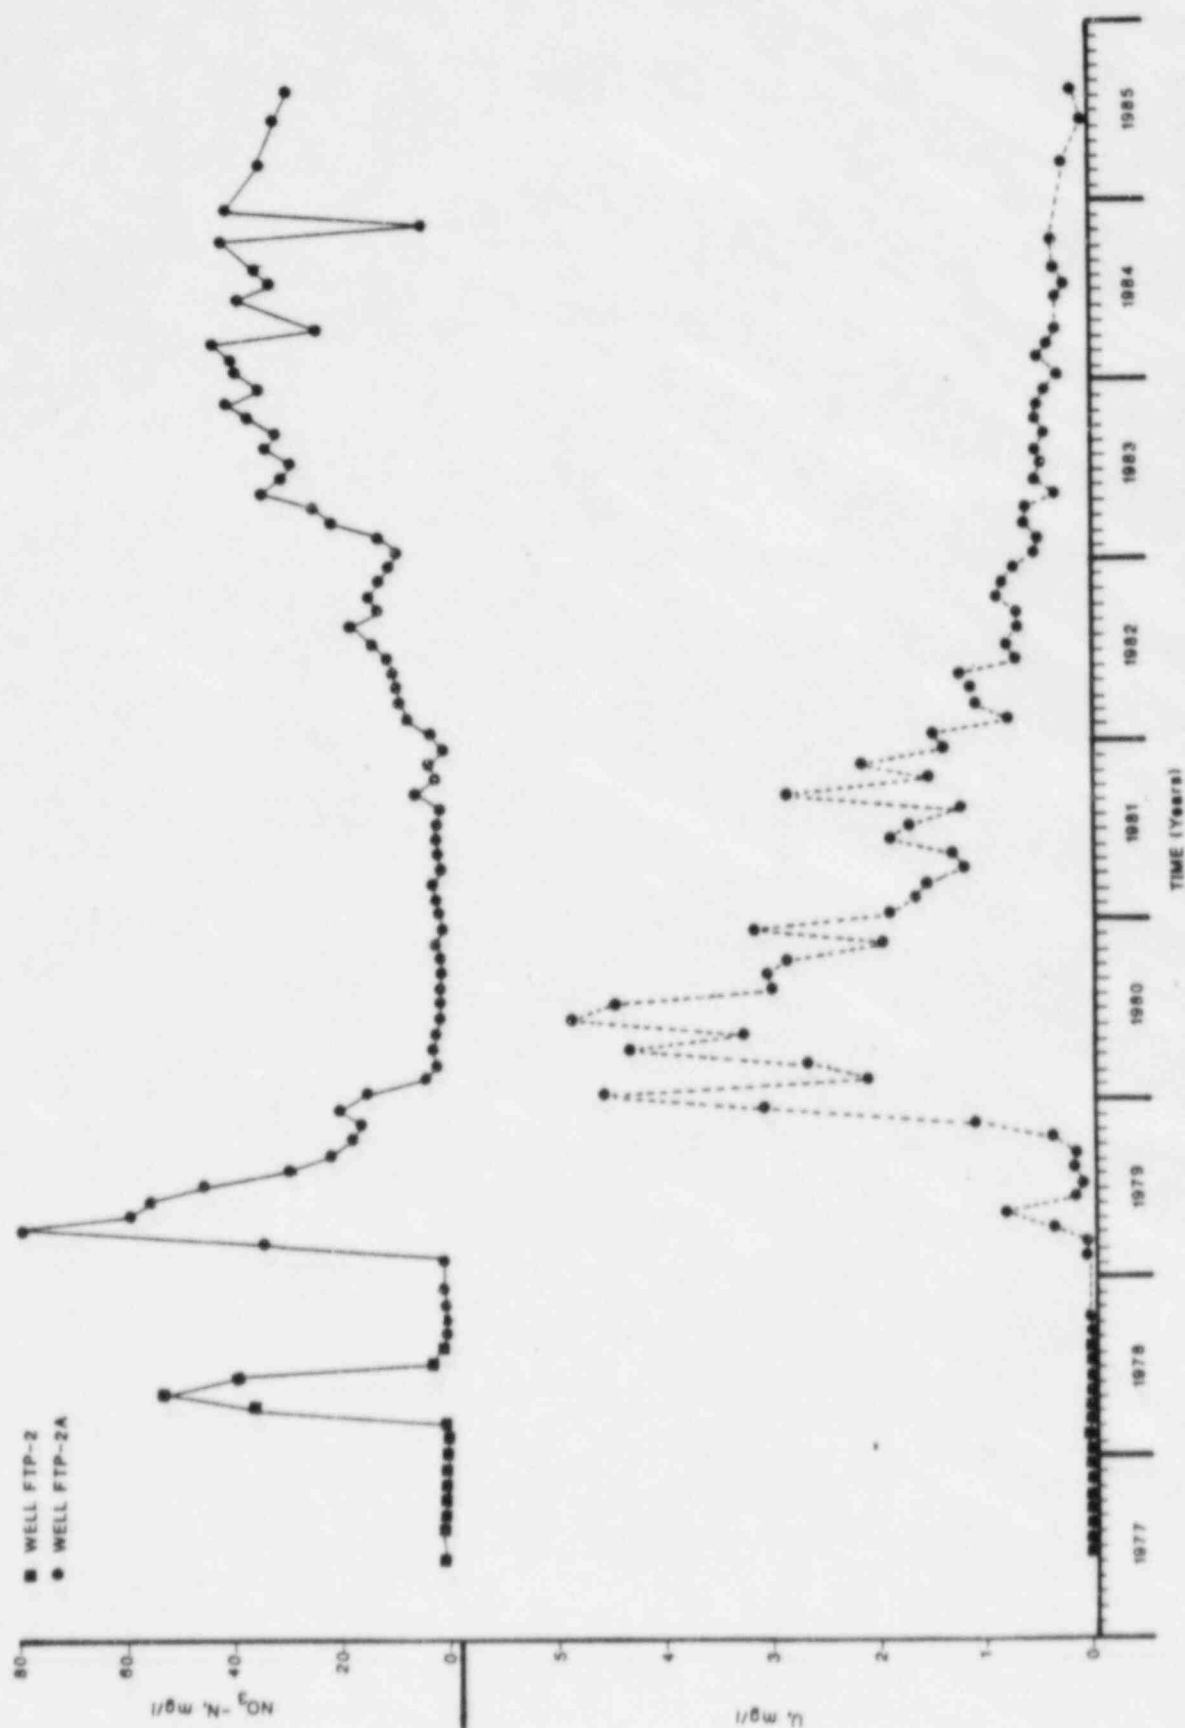
FIGURE 2 PLOT OF NITRATE AND URANIUM DATA VERSUS TIME FOR MONITOR WELL FTP-2A

For seven consecutive months after installation, well FTP-2A water quality data showed background nitrate concentrations (Figure 2 and Table 1), indicating the treated-raffinate spreading had no impacts to the shallow groundwater system in the test application area. However, nitrate levels rose abruptly in March 1979 (Figure 2 and Table 1), followed by an abrupt increase in uranium levels in April 1979. The uranium levels have exhibited an overall general decline since 1980. The nitrate concentrations decreased gradually to background levels by early 1980, but showed a gradual increase beginning in 1982.

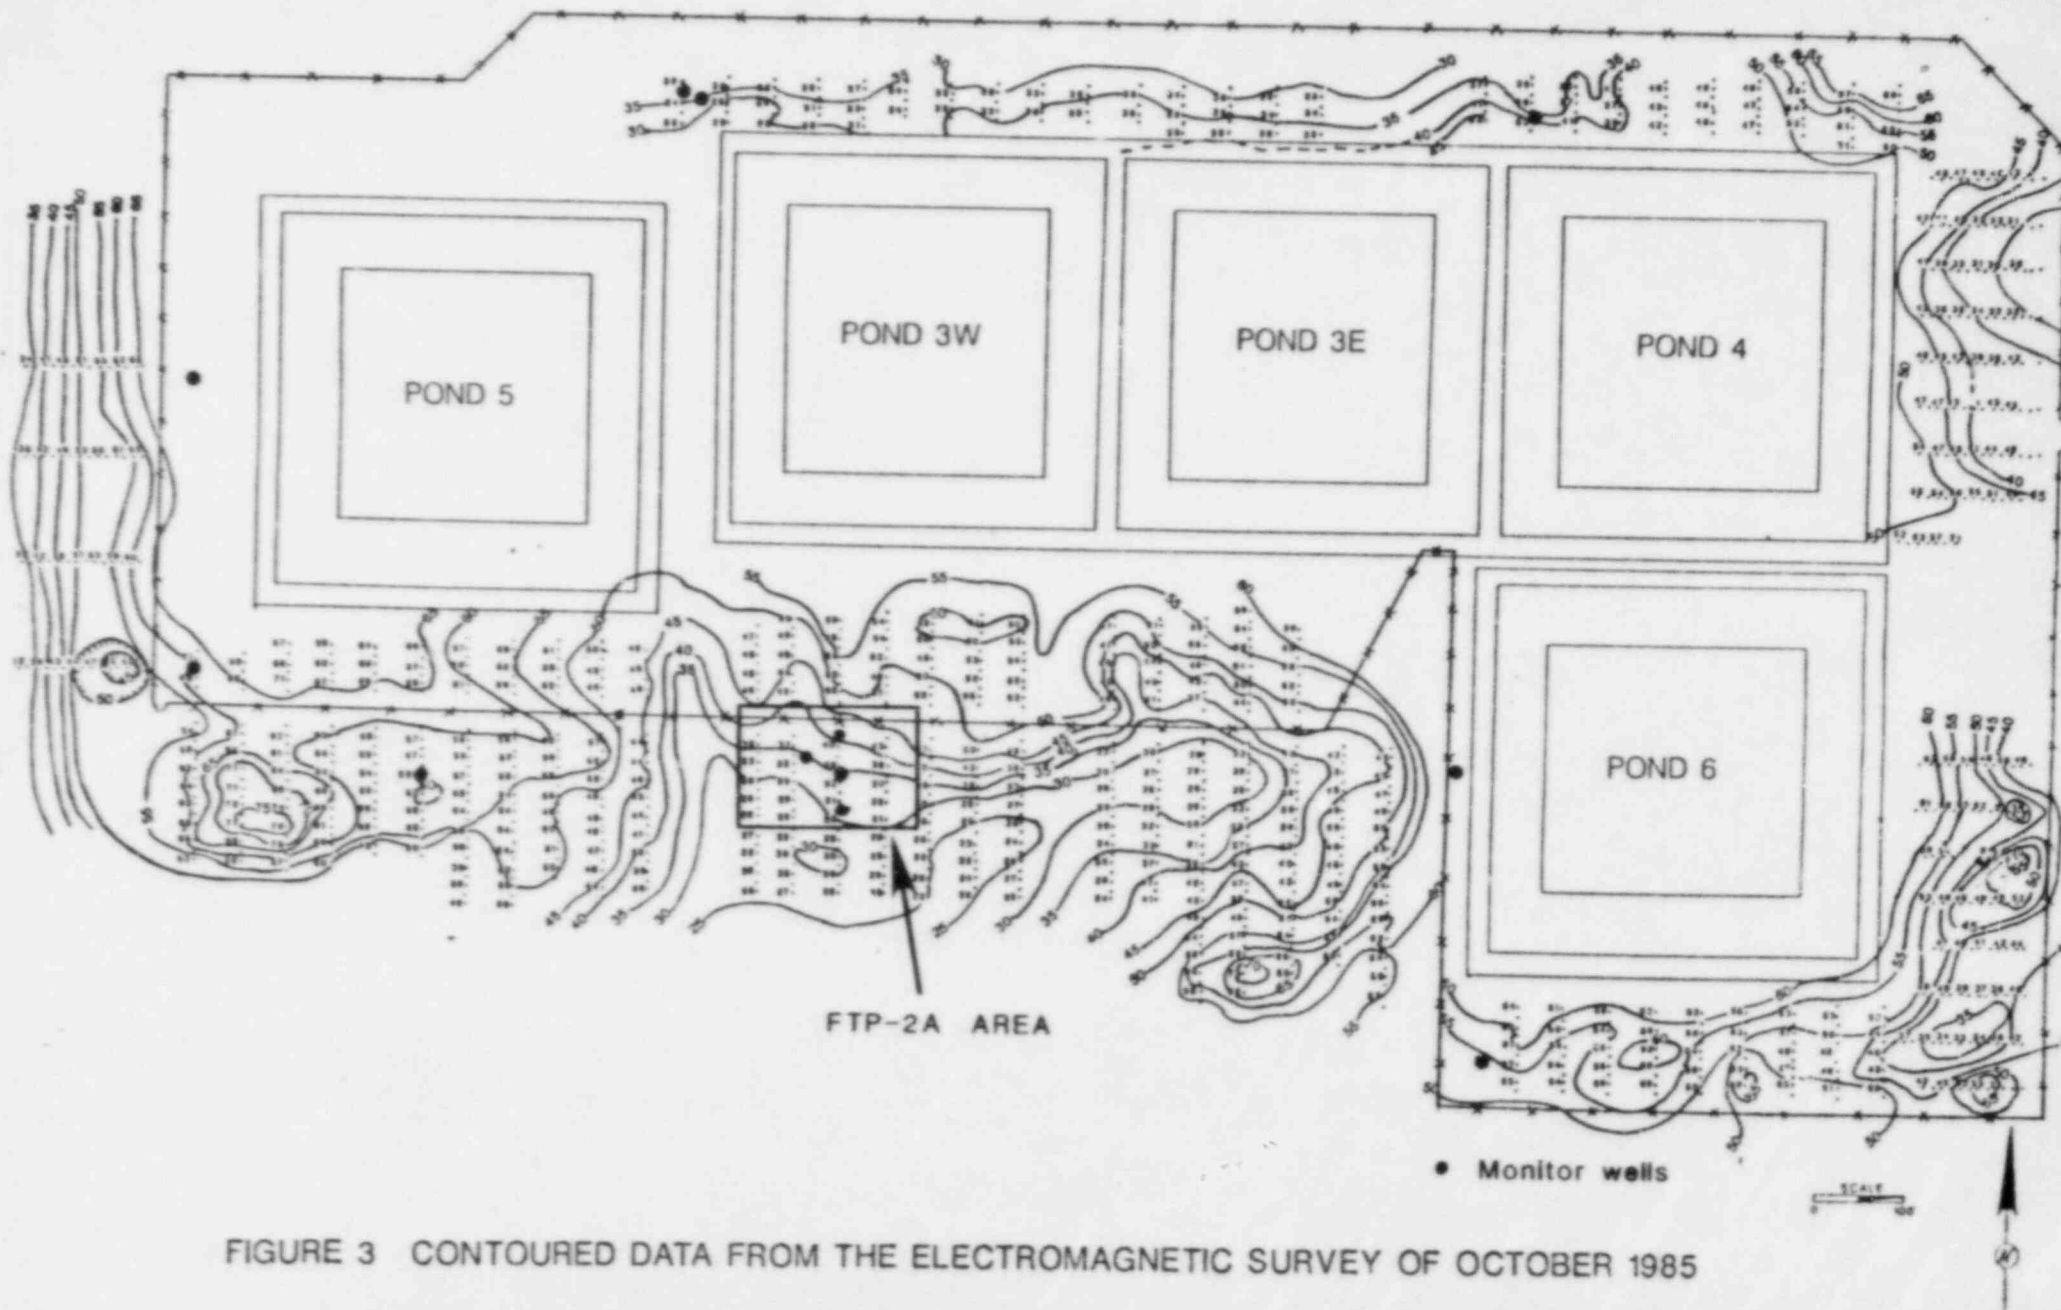
The ground conductivity data from the October 1985 electromagnetic survey are interpreted in Figure 3. In the well FTP-2A area, the iso-conductivity lines are

smooth and regular and do not exhibit a plume-shaped configuration. This contour pattern indicates no evidence of pond leakage and plume migration which could affect the well water quality.

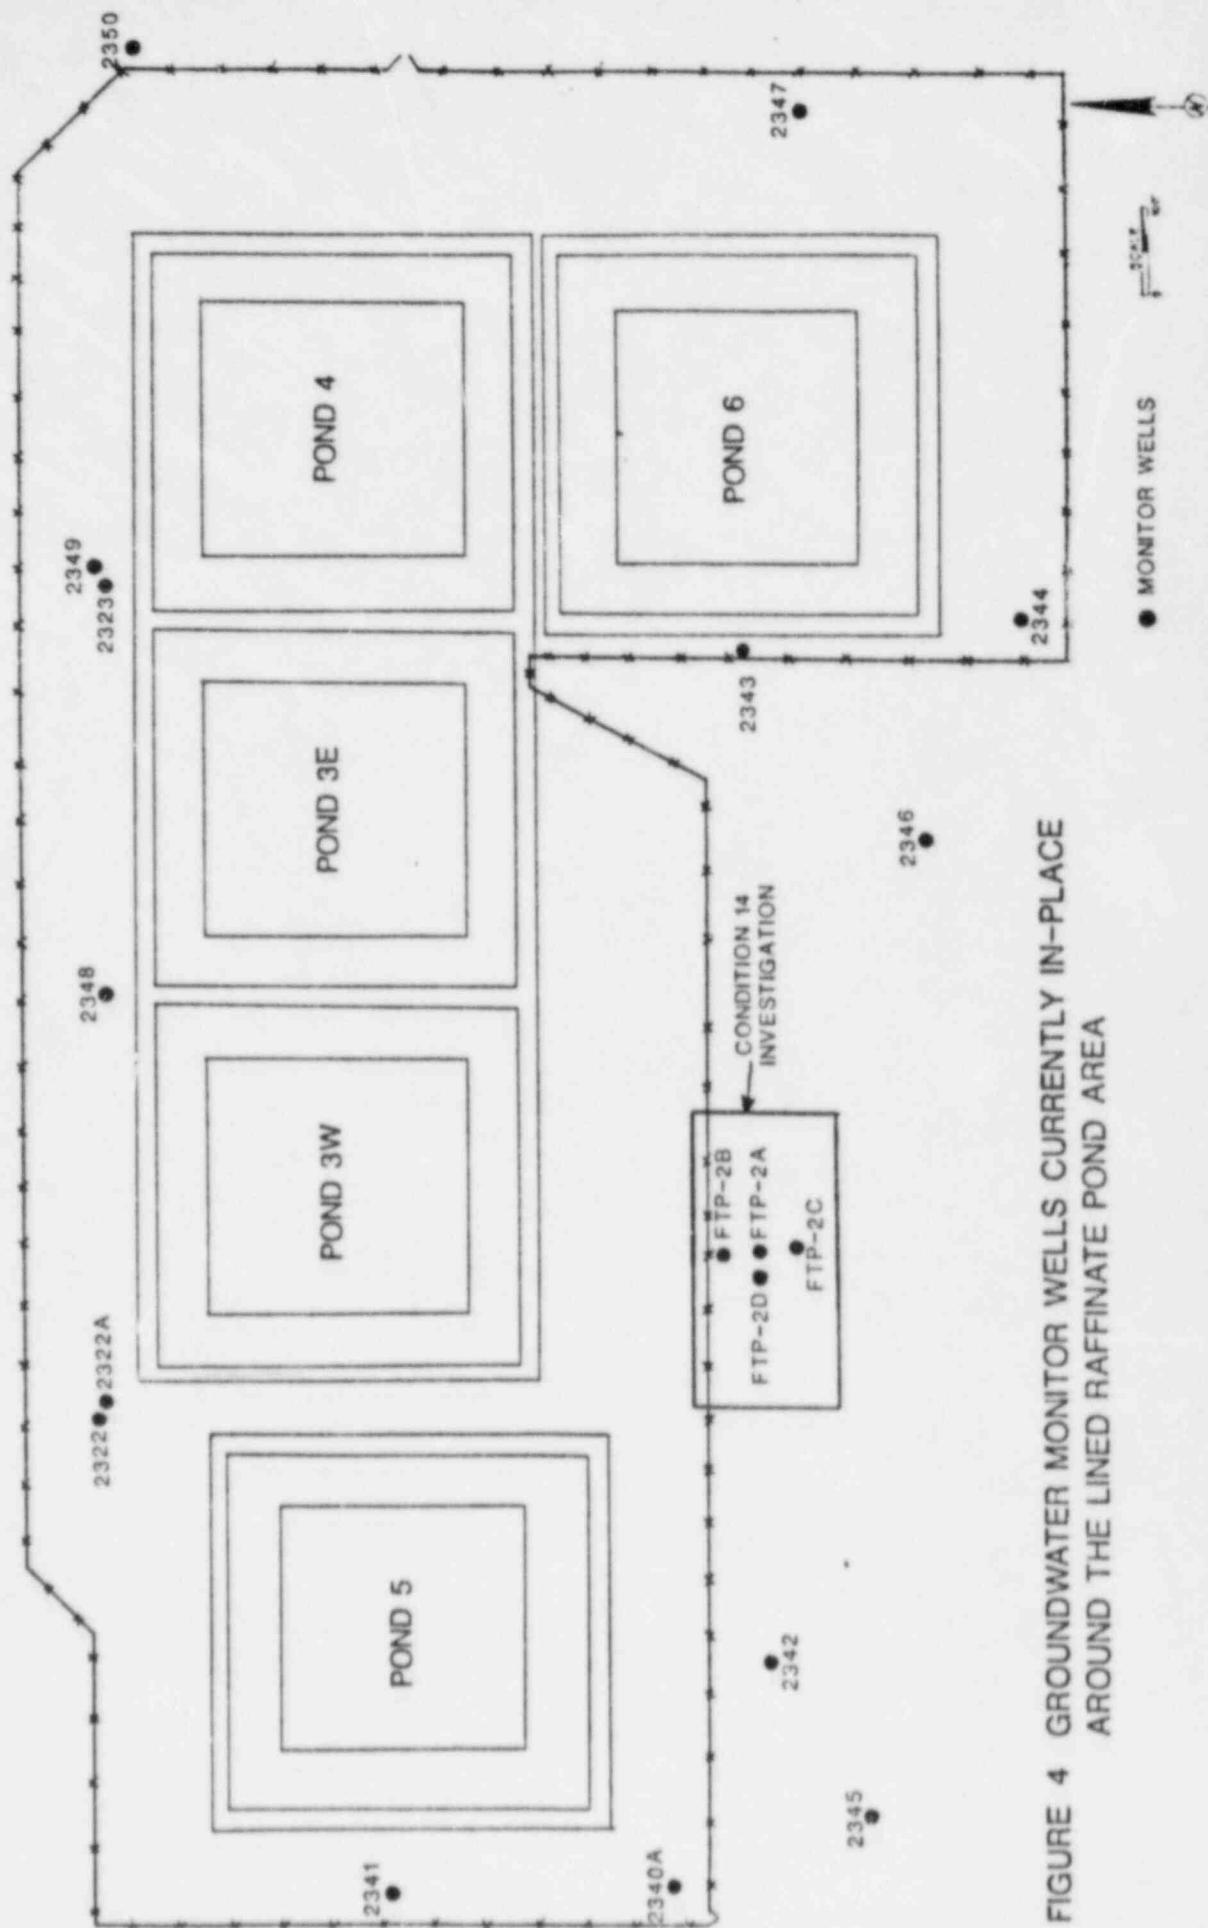
FIGURE 4 GROUNDWATER MONITOR WELLS CURRENTLY IN-PLACE
AROUND THE LINED RAFFINATE POND AREA

Sequoyah Fuels Corporation installed three new monitor wells near well FTP-2A (Figure 4) in November 1985 to investigate any areal distribution of nitrate and uranium levels in the groundwater. Monitor wells FTP-2B, FTP-2C and FTP-2D were installed using an air-rotary drilling rig and were located 55 feet north, 50 feet south, and 24 feet west (respectively) from well FTP-2A (well logs are contained in Appendix A). These new wells, together with well FTP-2A, were sampled in November 1985. The analytical results of these samples are presented in Table 2 and interpreted below.

The data in Table 2 clearly show the elevated nitrate concentration in well FTP-2A is localized. There is no widespread areal impact to the shallow aquifer in the study area from either the treated raffinate application program or from the lined ponds. Water quality in FTP-2A is a very localized phenomenon and is totally unlike that of the three newer wells.

Based upon the results of this study, monitor wells FTP-2A, FTP-2C and FTP-2D should be properly plugged with a cement/bentonite grout and abandoned. Monitor well FTP-2B should be incorporated into the quarterly monitoring program for the treated raffinate storage ponds.

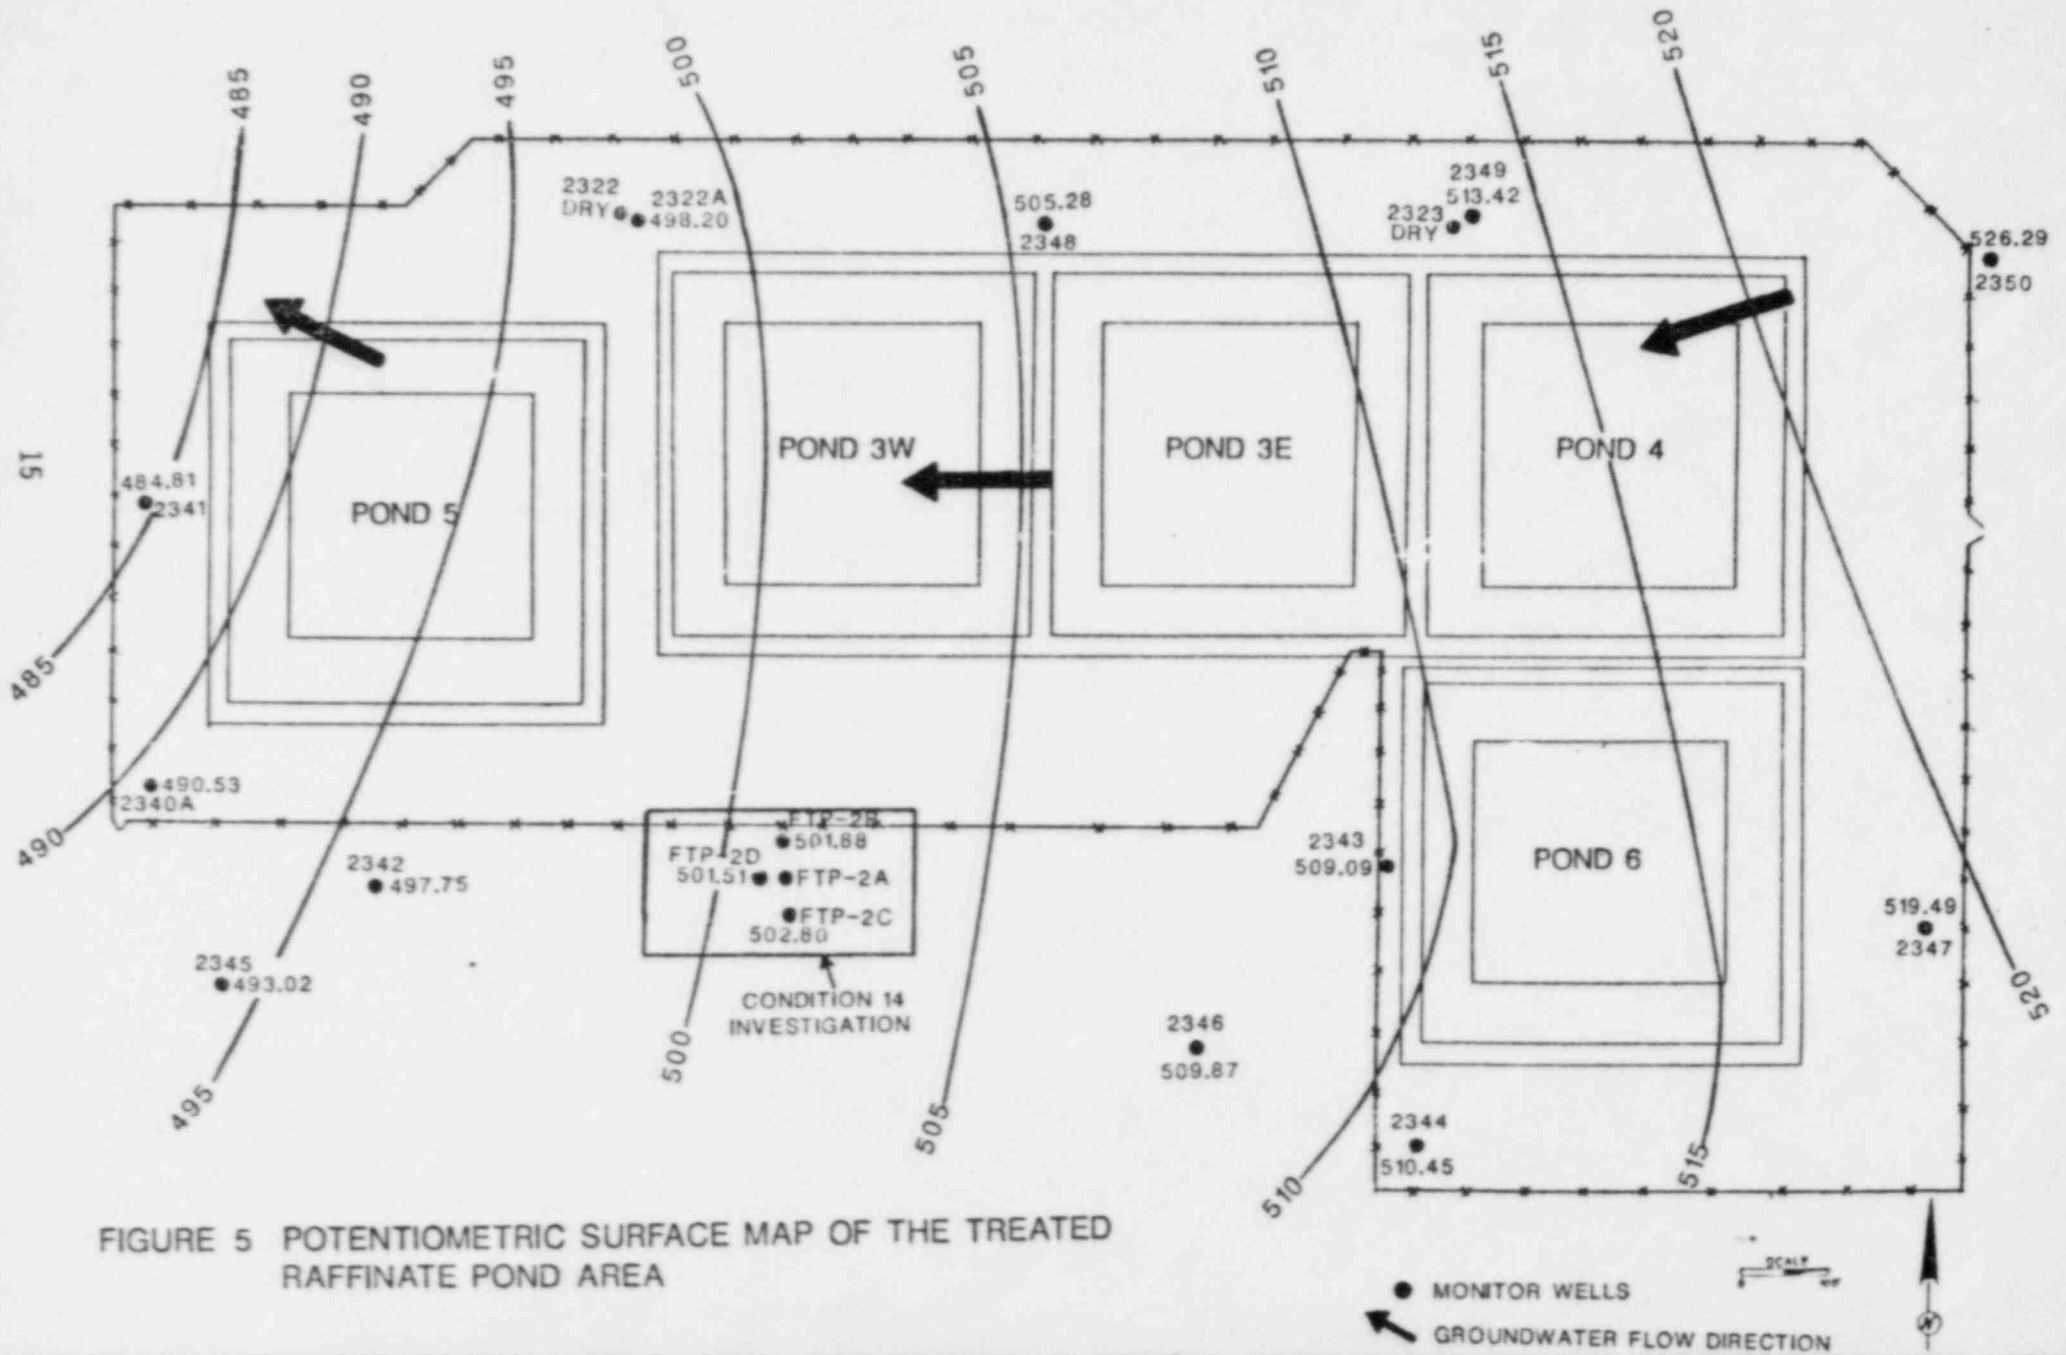
FIGURE 5 POTENTIOMETRIC SURFACE MAP OF THE TREATED RAFFINATE POND AREA

The numerous monitor wells in the treated raffinate pond area have allowed construction of an area potentiometric surface. The potentiometric surface map shown in figure 5 was constructed from water levels of December 4, 1985. The data clearly show a smooth groundwater flow direction that is west-south-westerly beneath the eastern pond area, with a gentle turn toward the west-northwesterly direction beneath pond 5. A gradient of about 0.02 is fairly constant across the site, with no water level anomalies evident which would indicate any localized flow character or pond leakage.

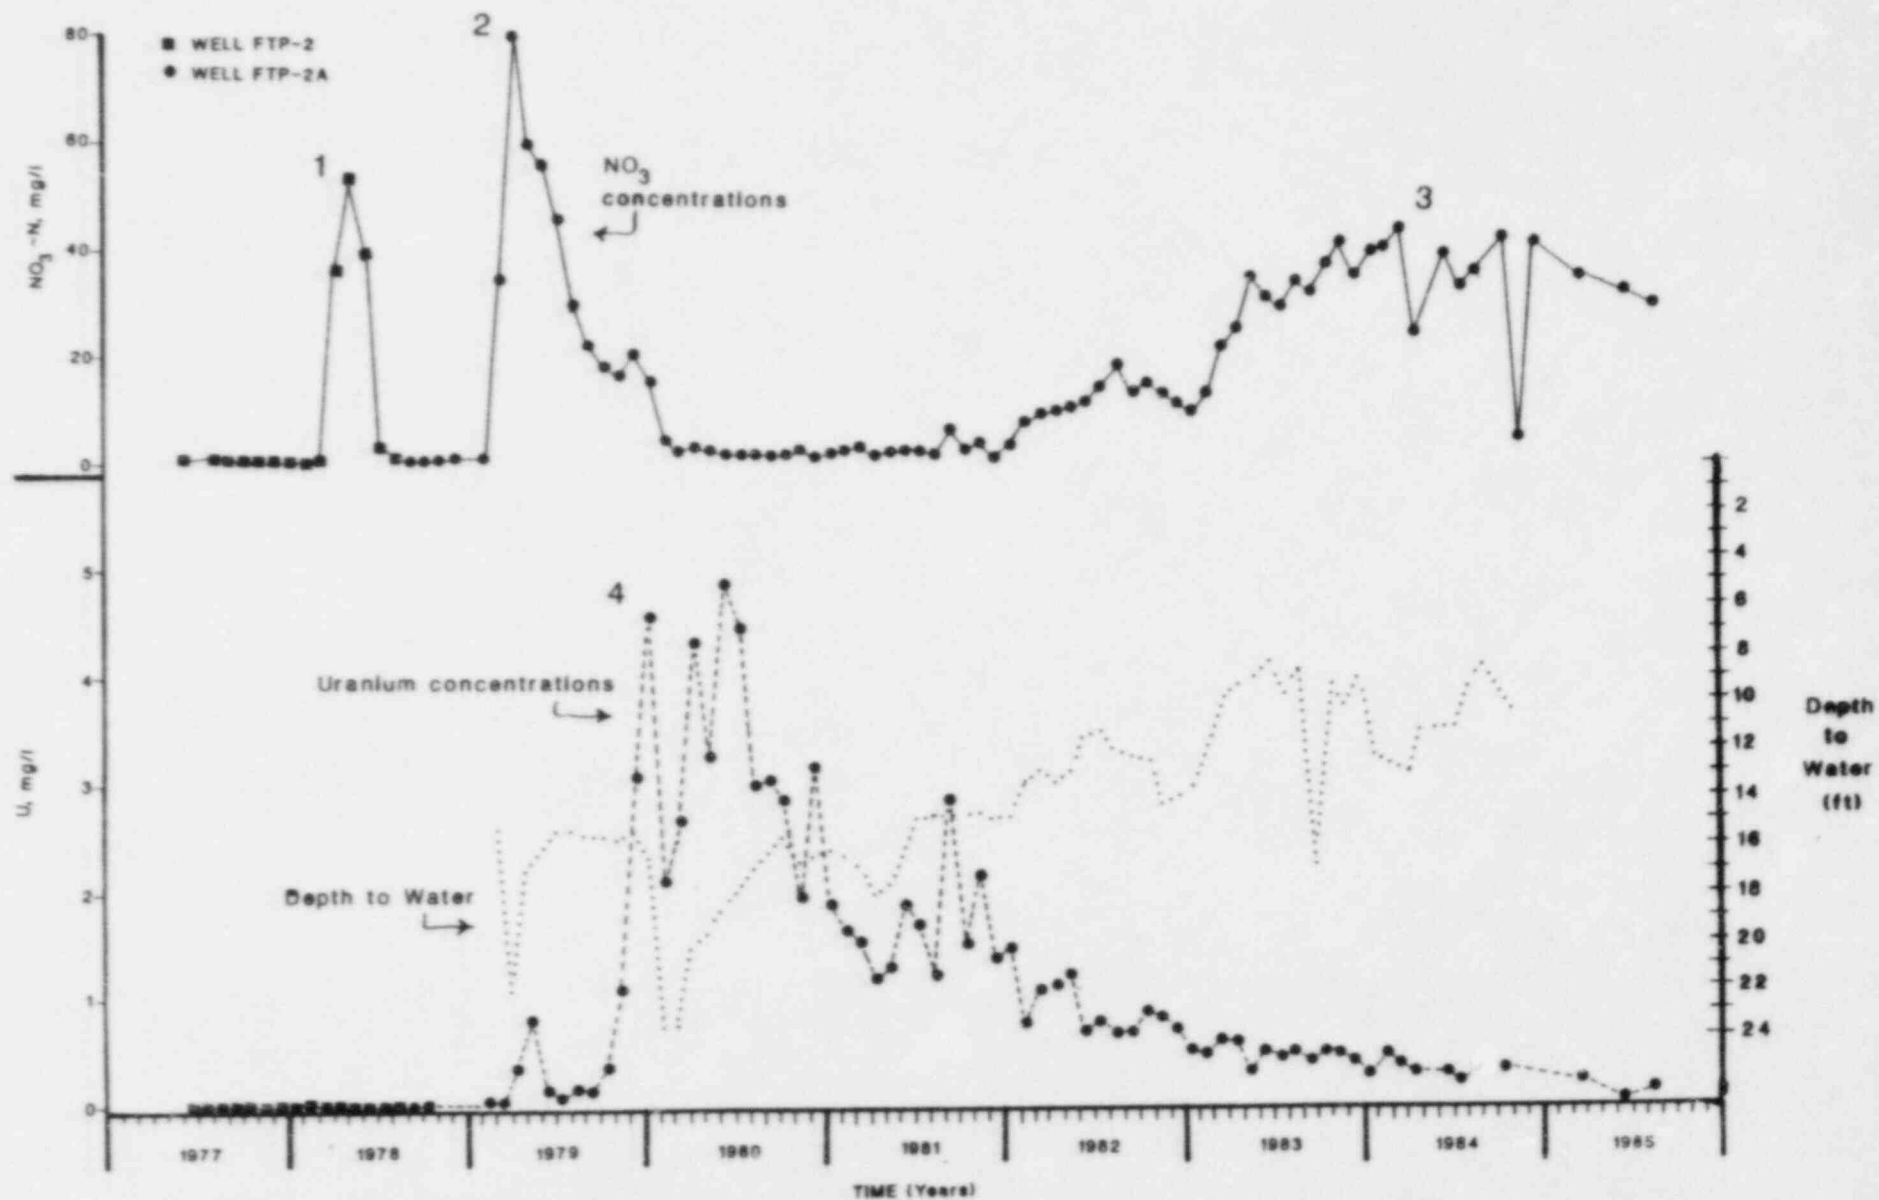
FIGURE 6 PLOT OF NITRATE, URANIUM AND WATER LEVEL DATA VERSUS TIME FOR MONITOR WELL FTP-2A

Figure 6 shows nitrate and uranium concentrations and water level data with time for wells FTP-2 and FTP-2A. The peaks labelled 1, 2 and 4 show sharp increases over a very short period of time (two months) and subsequent decreases. This is indicative of direct introduction of material into the monitor well. Such spikes would not occur as a result of aquifer contamination, but would only occur by a "short circuited" pathway in which a contaminant was introduced and quickly detected.

In the case of peak #1, well FTP-2 was contaminated from the application of treated raffinate because the well did not contain a surface seal. The gravel pack from the surface to total well depth created a pathway by which surface runoff or treated raffinate fertilizer entered the well. Likewise, the sudden spike in nitrate concentration in 1979 in well FTP-2A (peak #2) indicates local entry of nitrate. Although well FTP-2A had been installed as a replacement well for FTP-2 and had a surface casing, the inside well casing was gravel packed from total depth to the surface. This manner of completion provided a direct route for material from the surface to enter the well. (See Appendix A for a completion diagram of well FTP-2A).

Peak #4, for uranium, is as sudden as peaks #1 and #2 for nitrate, and therefore also indicates direct contamination of the well. The uranium concentration approaches 5 mg/l. Treated raffinate could not be the cause of this peak, because the average yearly uranium concentrations of treated raffinate applied to the land from 1977 through 1979 were 0.083, 0.153 and 0.044 mg/l. However, the 1979 Completion Report (Kerr-McGee Corporation, 1979) shows that a pelletized commercial phosphate fertilizer applied to the land during that year contained 227

ppm uranium. A very small amount of phosphate introduced inadvertently into the exposed gravel-packed area of the well, followed by rainfall, would easily account for the nearly 5 mg/l uranium found in the well. Since that time, only uranium-free commercial phosphate fertilizer has been applied to the land treated acreages. This accounts for the steady decline of uranium concentration toward background levels for the past several years.

Peak #3 shows the nitrate level increased gradually over a period of about three years and in 1983 began a slow but consistent decline. The pattern suggests a slight impact to the near surface groundwater and probably reflects the high rate of ammonium-nitrate application (1000 lbs. nitrogen/acre) in 1977 (Kerr-McGee Corporation, 1978). The excess nitrate was able to migrate below the root zone without being taken up by vegetation. Once below this zone, the nitrate would migrate with infiltrating rainwater to a depth where well FTP-2A was impacted. Treated raffinate fertilizer solution application has been discontinued in this area.

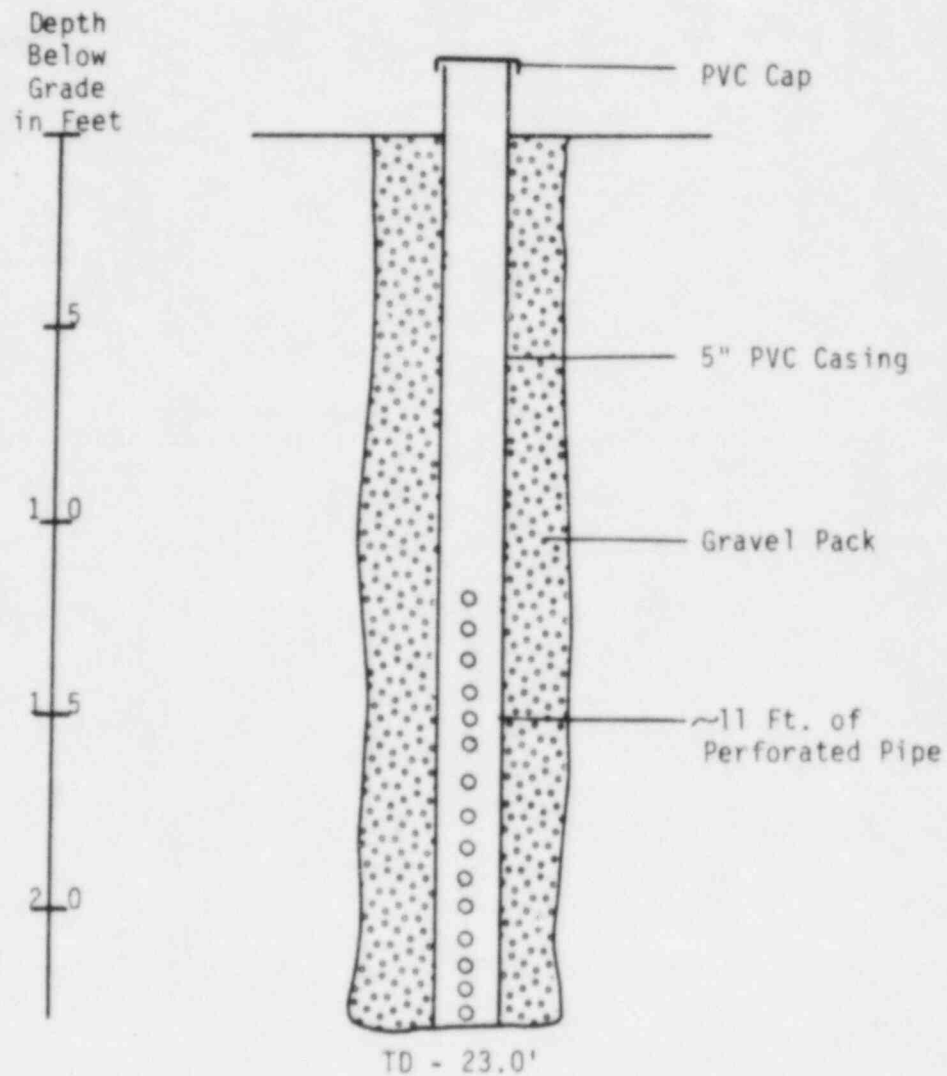
MONITOR WELL FTP-2
SOUTH OF POND 3
SEQUOYAH FUELS CORPORATION
GORE, OK

Upon detailed evaluation, well FTP-2 was found to have been constructed without a well seal (Appendix A). The rapid nitrate increase was concluded to have resulted from the infiltration of runoff down the improperly sealed well bore, rather than from an over-application of the ammonium-nitrate fertilizer. Monitor well FTP-2A was therefore installed in August 1978 to replace FTP-2.

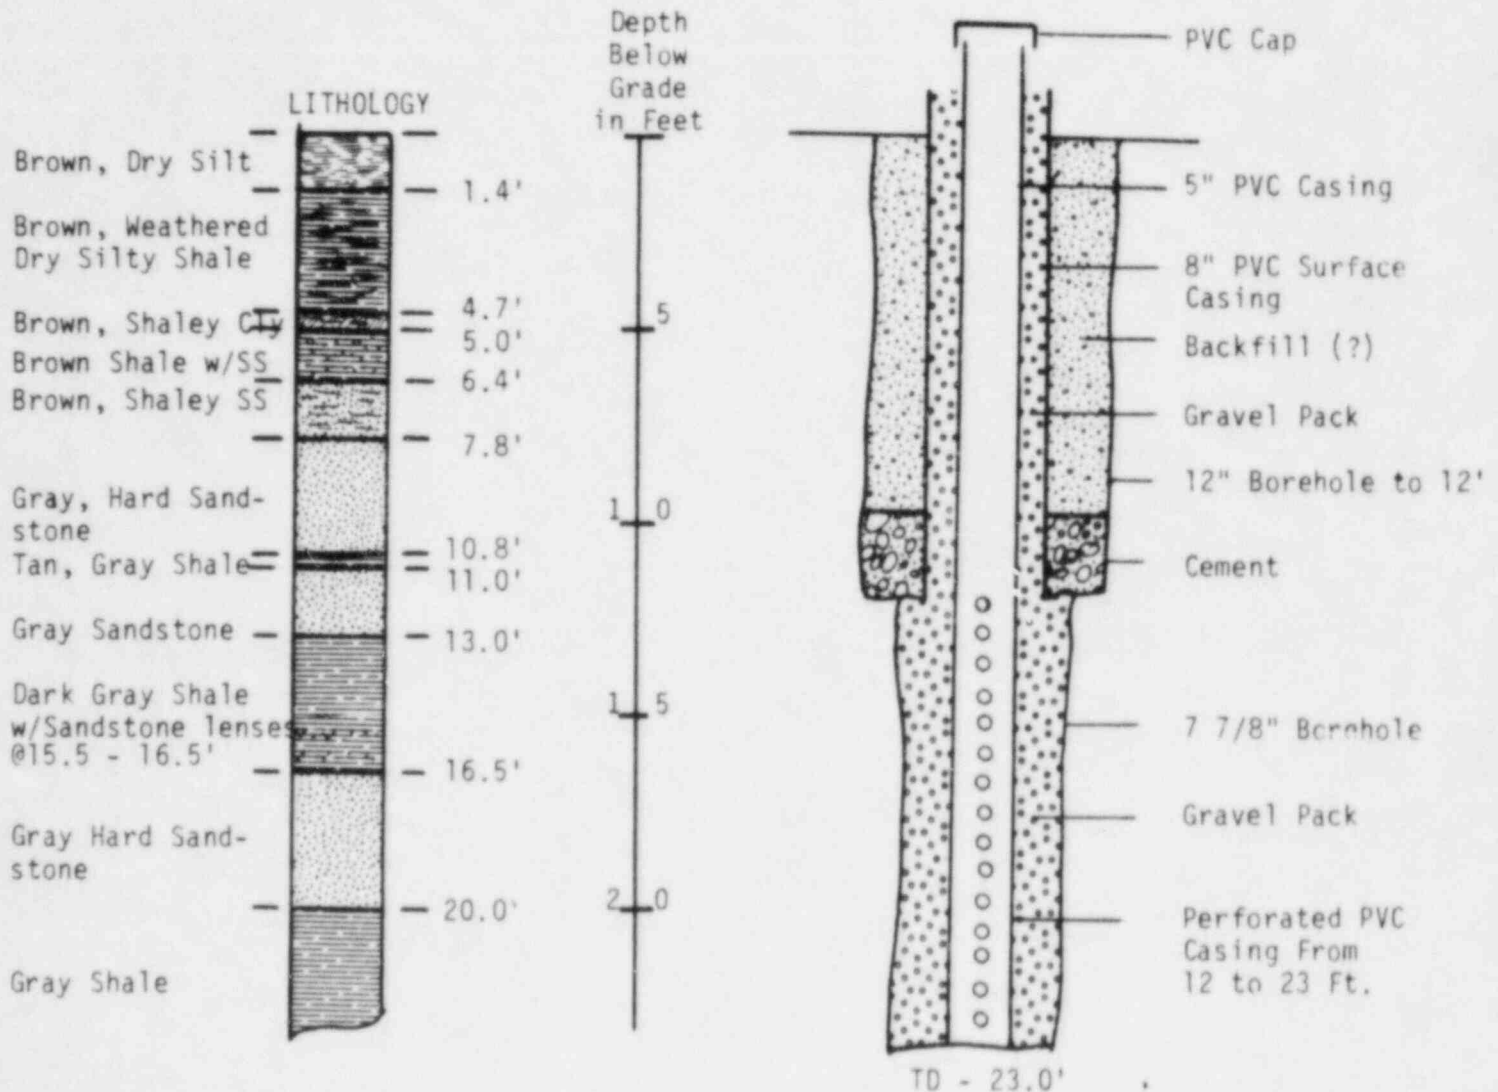
MONITOR WELL FTP-2A
SOUTH OF POND 3
SEQUOYAH FUELS CORPORATION
GORE, OK

2. Replacement well FTP-2A showed several months of background nitrate concentration before exhibiting a sharp increase. The increase was also due to direct introduction of ammonium-nitrate fertilizer solution. Well completion information shows a cemented surface casing to be present, but a gravel pack still exists from the surface to total depth on the outside of the inner well casing.
