U.S. NUCLEAR REGULATORY COMMISSION

Report No: 50-461/97006 (DRP)

Facility: Clinton Power Station

Dates: February 15 - March 29, 1997

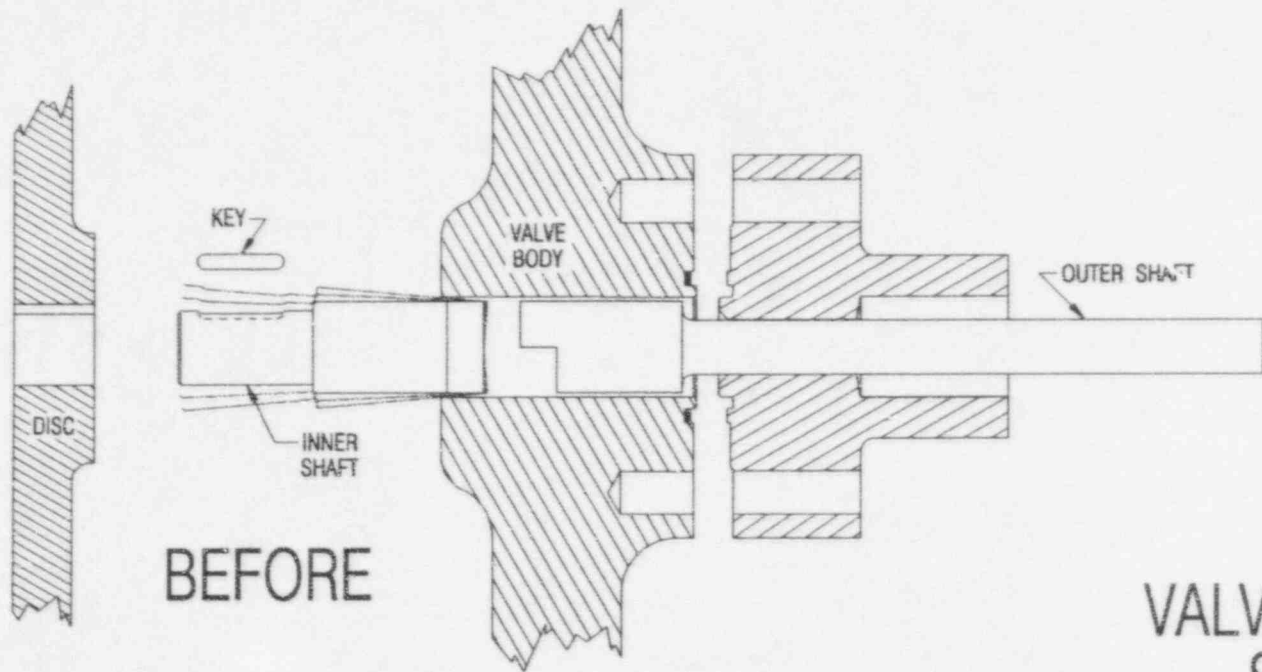
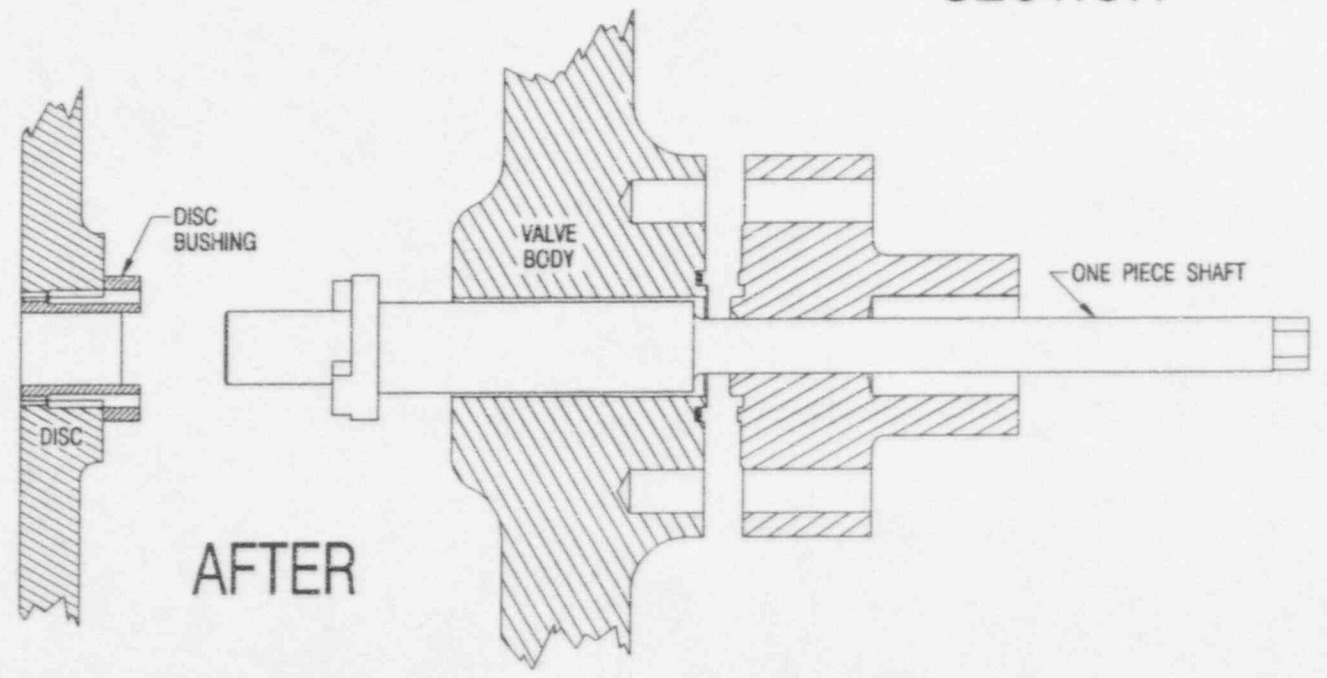
VALVE 1B21-F032A(B)

The inspectors obtained a partial copy of MWR D60080, "RF6 Rework Valve 1B21F032A Due to LLRT Failure," on or about March 19, 1997 to review the status of three discrepancies discussed by the licensee at a morning status meeting. Final reassembly and post modification testing of 1B21F032A had been completed on or about March 8, 1997. The inspectors performed a cursory review of this partial copy of the MWR and identified that at least 40 of the approximately 110 job steps (J/Ss) were not signed as being completed. The inspectors concluded that no more than four of these J/S should have been unsigned based upon the status of the valve work as described in the licensee's status meetings.

The inspectors identified that required documentation was not maintained. The licensee initiated Condition Report (CR) 1-97-03-111 to document the need to disposition three deviations from the fabrication drawings for the new internal components of 1B21F032A. This CR was initiated after the valve had been

The licensee completed post modification testing of 1B21F032A during this reporting period. The check valve passed the tests. The inspectors noted that 1B21F032A had passed previous post-outage local leak rate test (LLRT) surveillances but had failed subsequent as-found LLRTs. These failures were documented in Inspection Report 50-461/96009, and indicate the need for additional confidence in the fabrication and assembly of the valve modification.

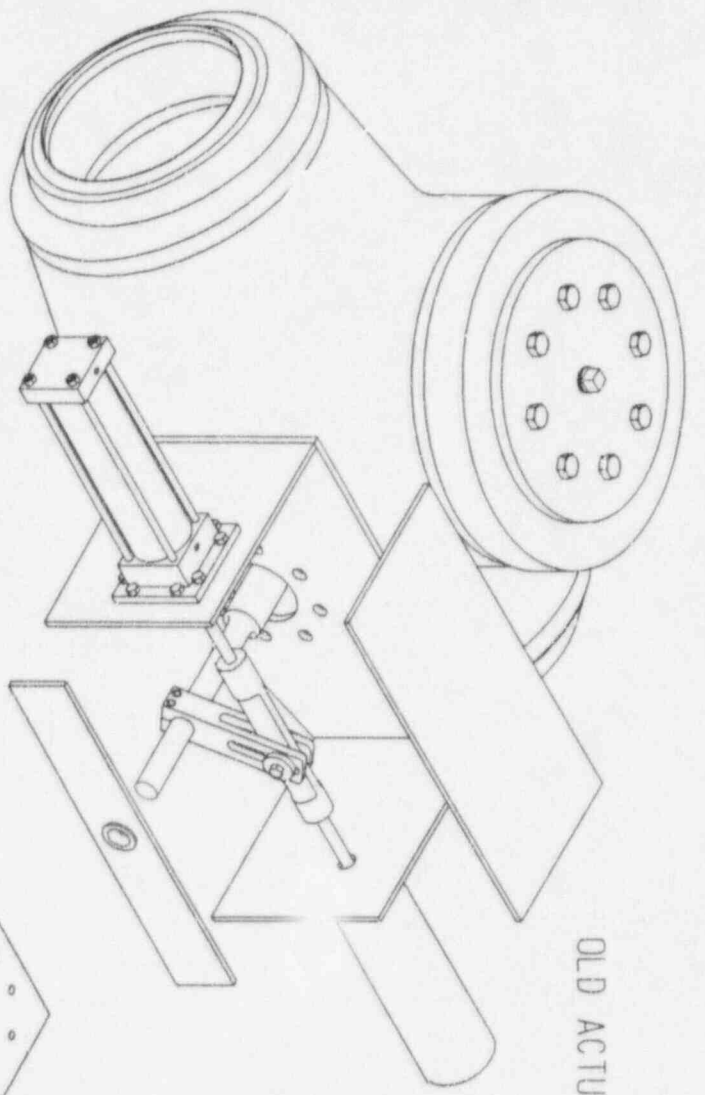
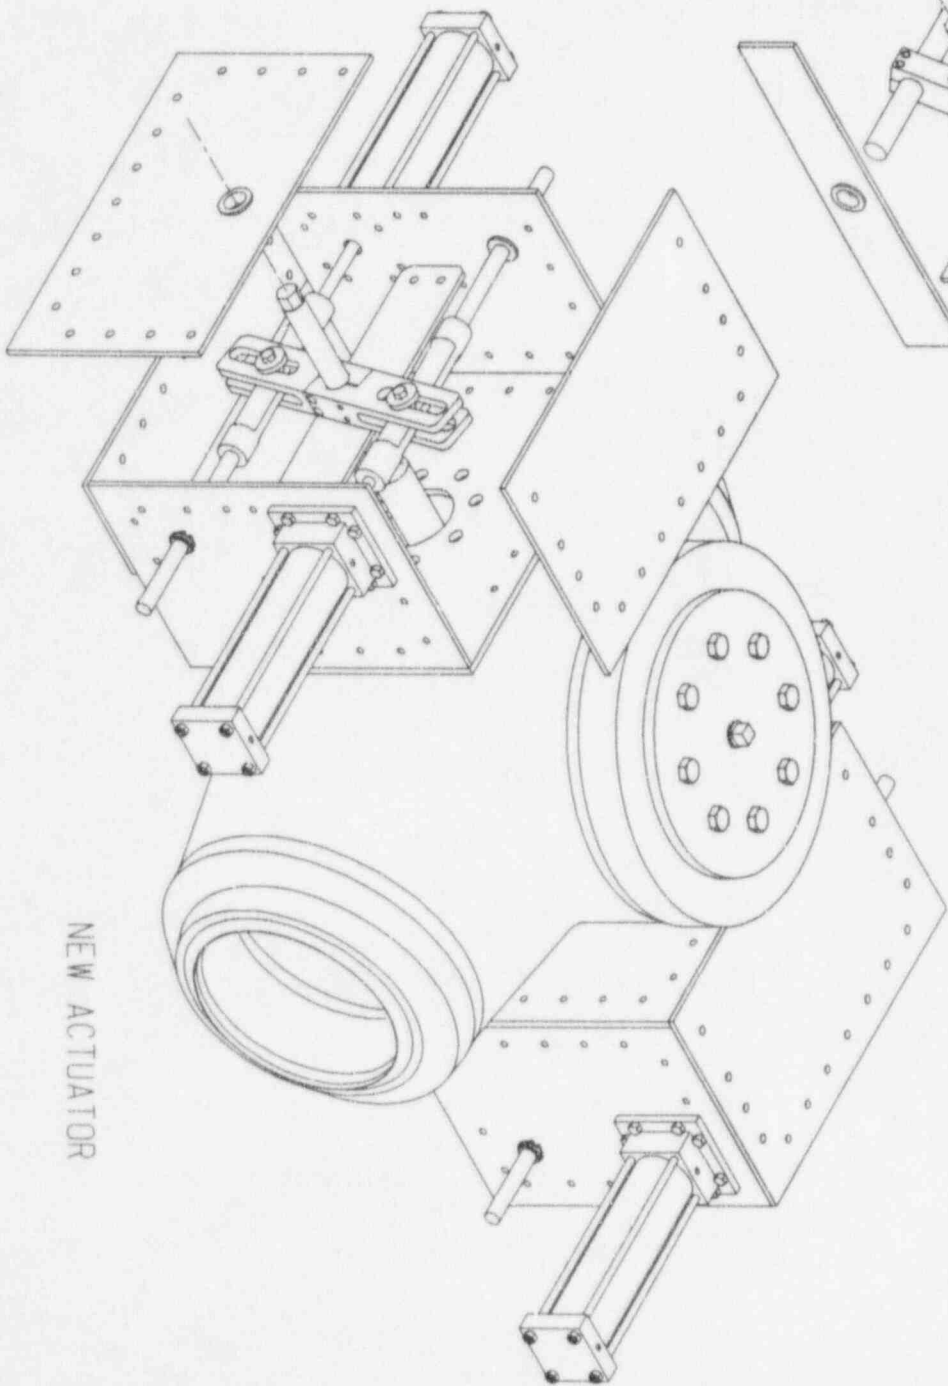
VALVE 1B21-F032A(B)

50-461/97006-03e VIO Failure to reperform and document the additional fabrication work which changed the actuator shaft dimensions.

50-461/97006-03f VIO Failure to document engineering approval to proceed with the "Risk Basis" reassembly of 1B21F032A.
