> MONTICELLO NUCLEAR GENERATING PLANT Docket No. 50-263 License No. DPR-22

Missed Surva llance Requirement Caused by Failure to Include Emergency Service Water Valves in Section XI Testing Program

# LICENSEE EVENT REPORT (LER)

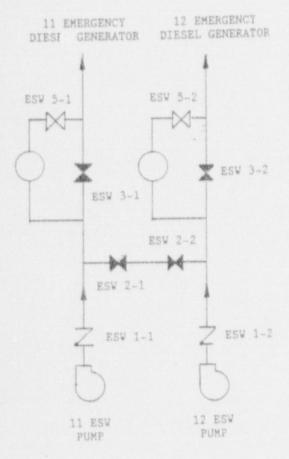
Figure 1

Technical Specification 4.15.B states, in part, that "Inservice Testing of Quality Group A, B, and C pumps and valves shall be performed ...". The four valves not tested are ESW-1-1 (11 ESW Pump Discharge Check; included in Section XI testing program but not for stoppage of reverse flow), ESW-2-2 and ESW-2-1 (ESW System Cross-ties), and ESW-5-1 (12 ESW Pump Strainer Outlet). These valves are used to mitigate a postulated High Energy Line Break in the Feedwater Pump (EIIS System: SJ) area. During this postulated event a loss of off-site power, a failure of 12 Diesel Generator, and damage to the 11 Emergency Service Water Pump power supply must be assumed. The abnormal procedure directs the operators to cross-tie 12 Emergency Service Water Pump discharge to supply cooling water to the 11 Emergency Diesel Generator (See Figure 1, attached). ESW-1-1, ESW-2-1, ESW-2-2, and ESW-5-1 would be required to function to insure adequate cooling to 11 Emergency Diesel Generator. None of the four valves are tested for these specific functions in the ASME Section XI Testing Program.
