UNITED STATES
NUCLEAR REGULATORY COMMISSION
WASHINGTON, D. C. 20555

SUBJECT: RIVER BEND SITE VISIT AND FOLLOW-UP

Members of the staffs of the Offices of Nuclear Reactor Regulation (NRR), Inspection and Enforcement (IE) and Region IV conducted a site visit at the River Bend Station, Unit No. 1 (RBS) on January 28-30, 1986.

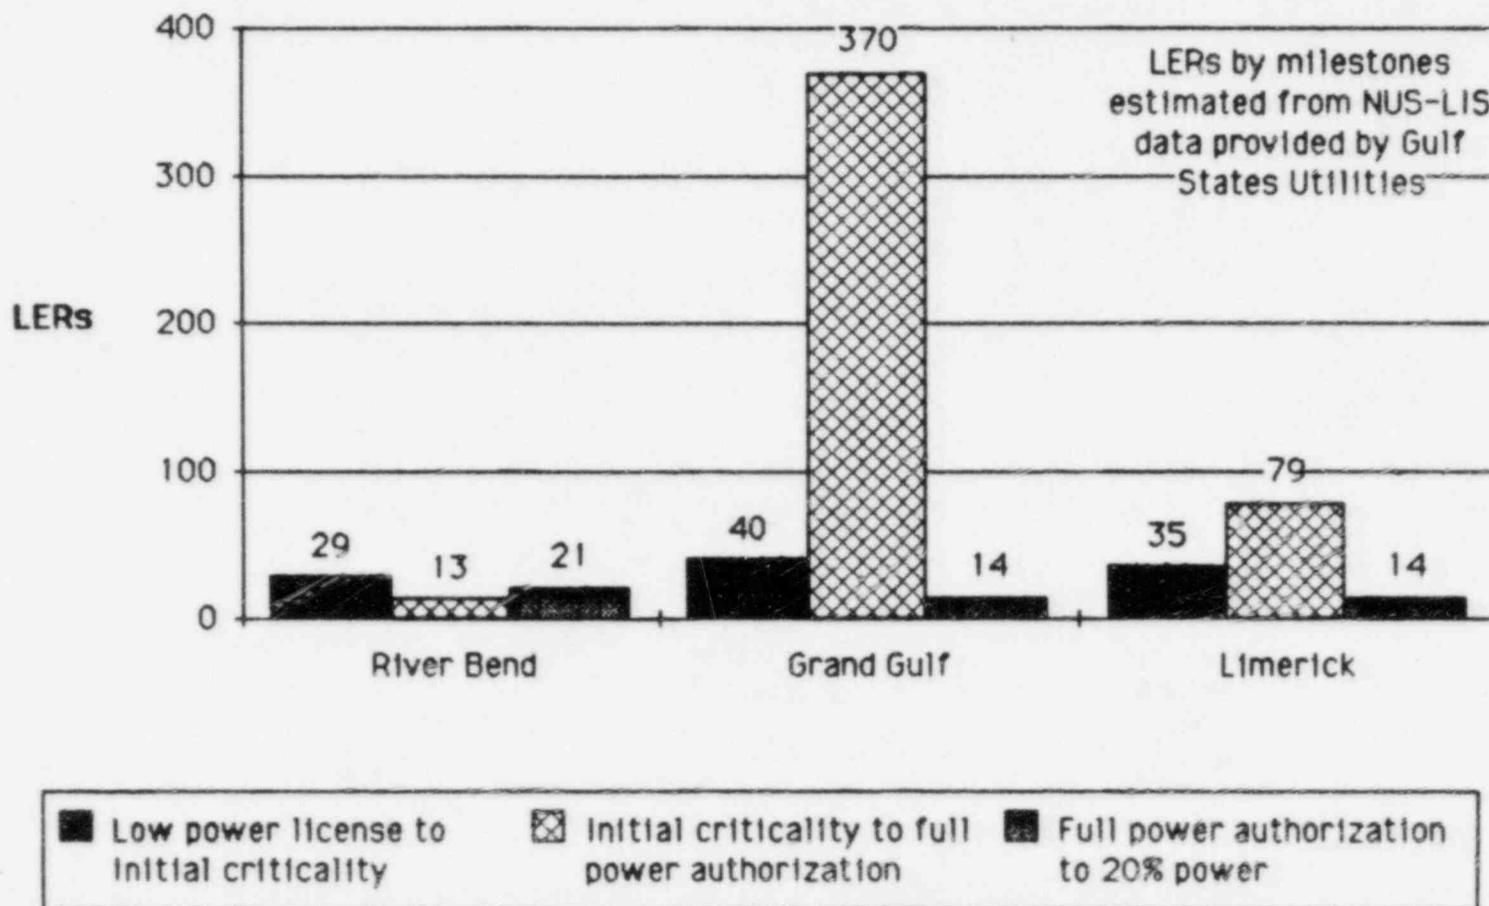
Figure 1A

- River Bend experienced a similar number of events during the low power authorization-to-initial criticality phase of their startup program as Limerick and Grand Gulf. The duration of this phase of the startup program at the three plants was similar--about two months.

- River Bend experienced a significantly smaller number of events during the initial criticality-to-full power authorization phase of startup than Limerick and Grand Gulf. However, the duration of this phase of startup at River Bend was less than a month, contrasted to about seven and one-half months at Limerick and twenty-five months at Grand Gulf.

- River Bend is experiencing a somewhat greater number of events since full power authorization than the comparable phase of startup at Limerick and Grand Gulf. The duration of this phase from full power authorization-to-20% rated power was similar at all three plants--about one month.

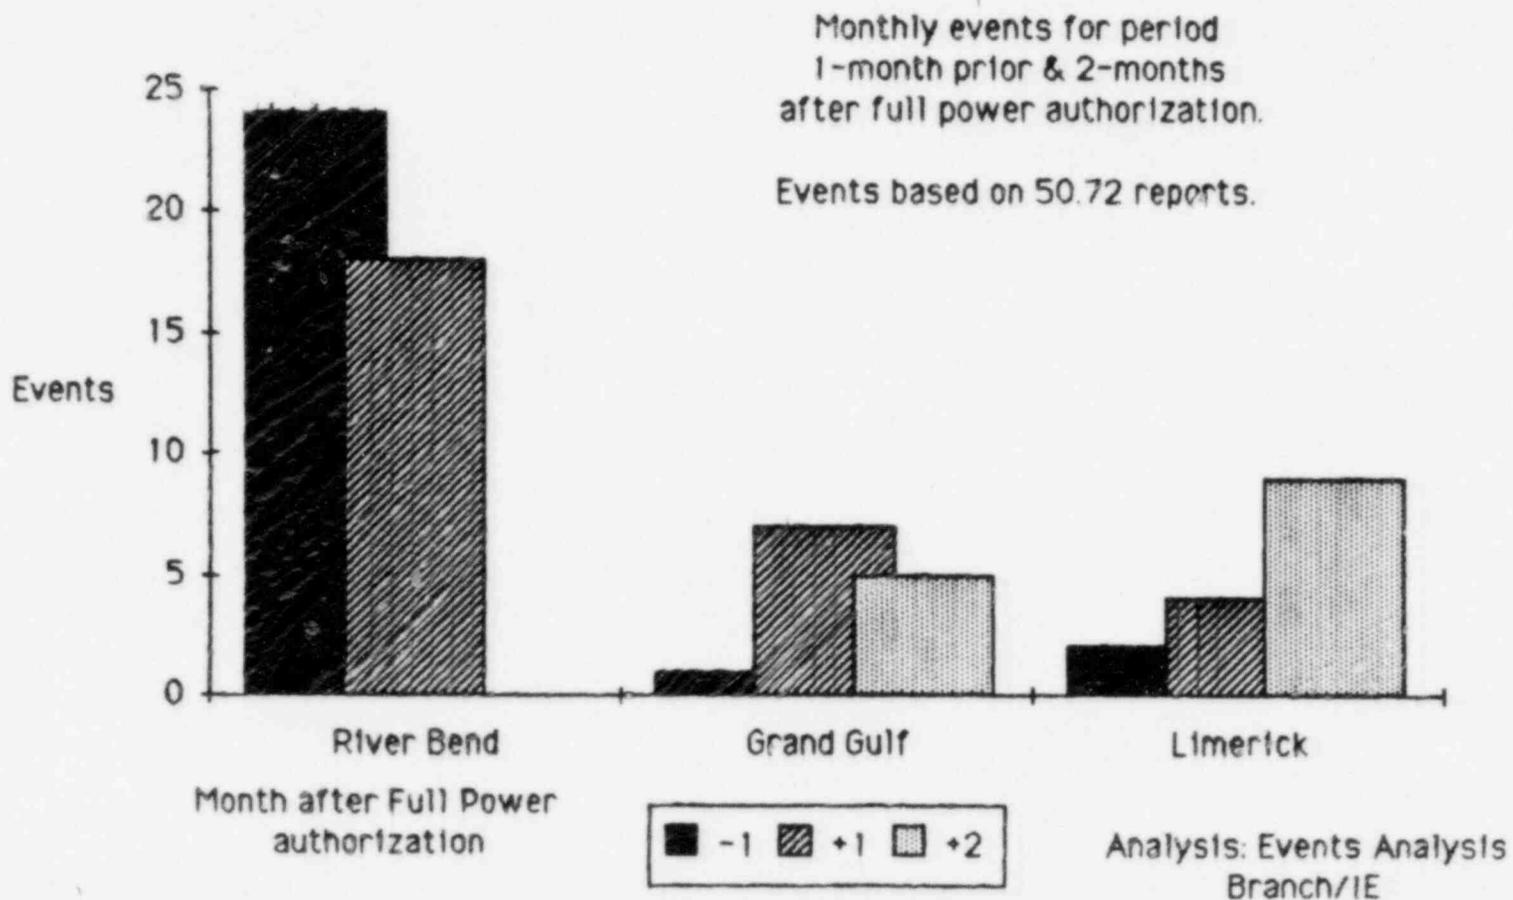
Figure 11

- Evaluated on a month-by-month basis, River Bend is experiencing a larger number of events during the time period near full power authorization (Figures II & III). The number of scrams is similar to those of Grand Gulf, but greater than Limerick's during this period (Figure IV).

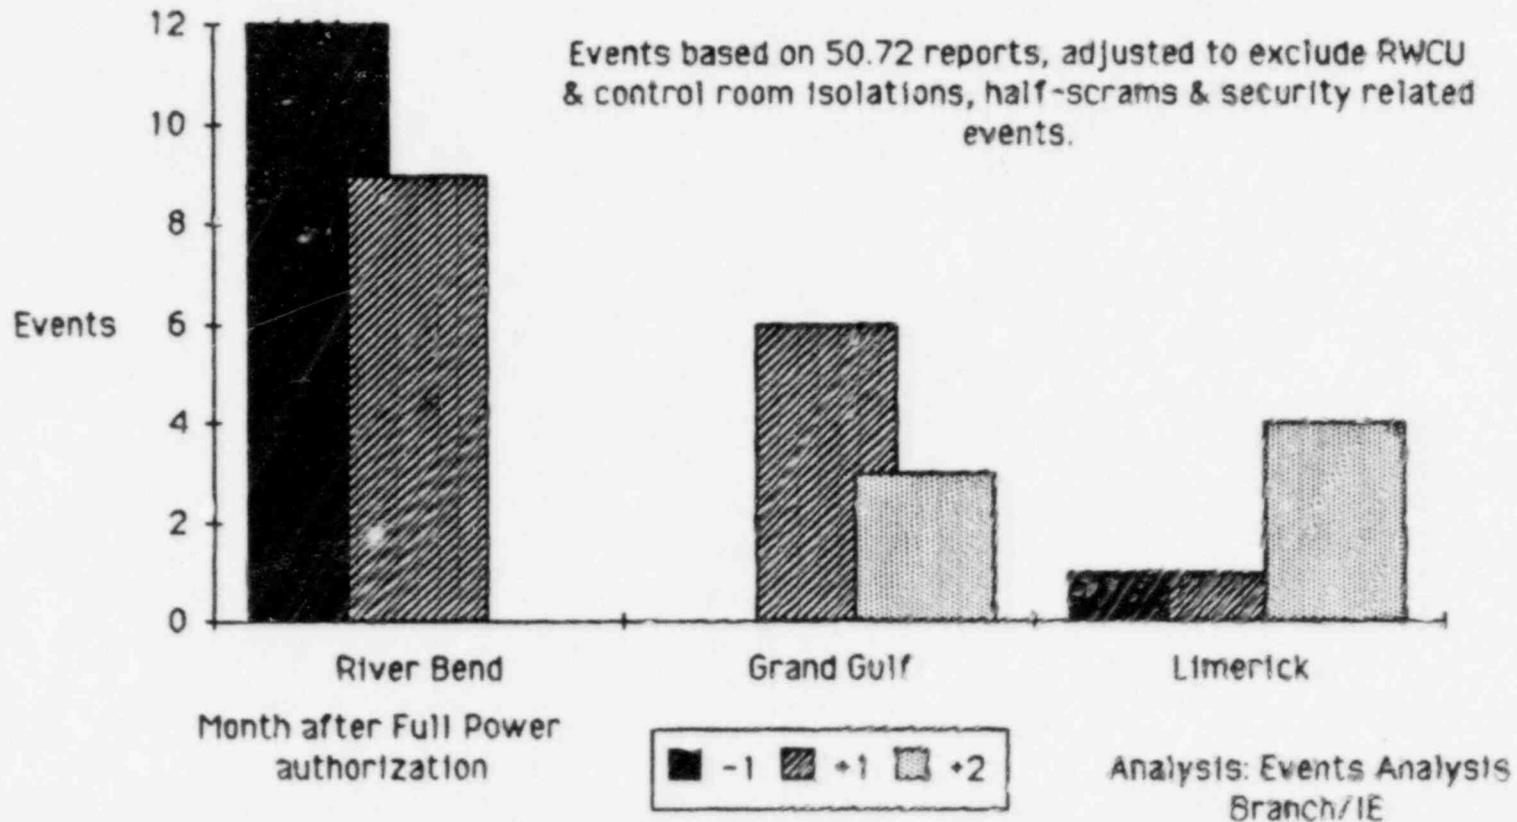
Figure III

Monthly events for period 1-month prior & 2-months after full power authorization.

Events based on 50.72 reports, adjusted to exclude RWCU & control room isolations, half-scrams & security related events.

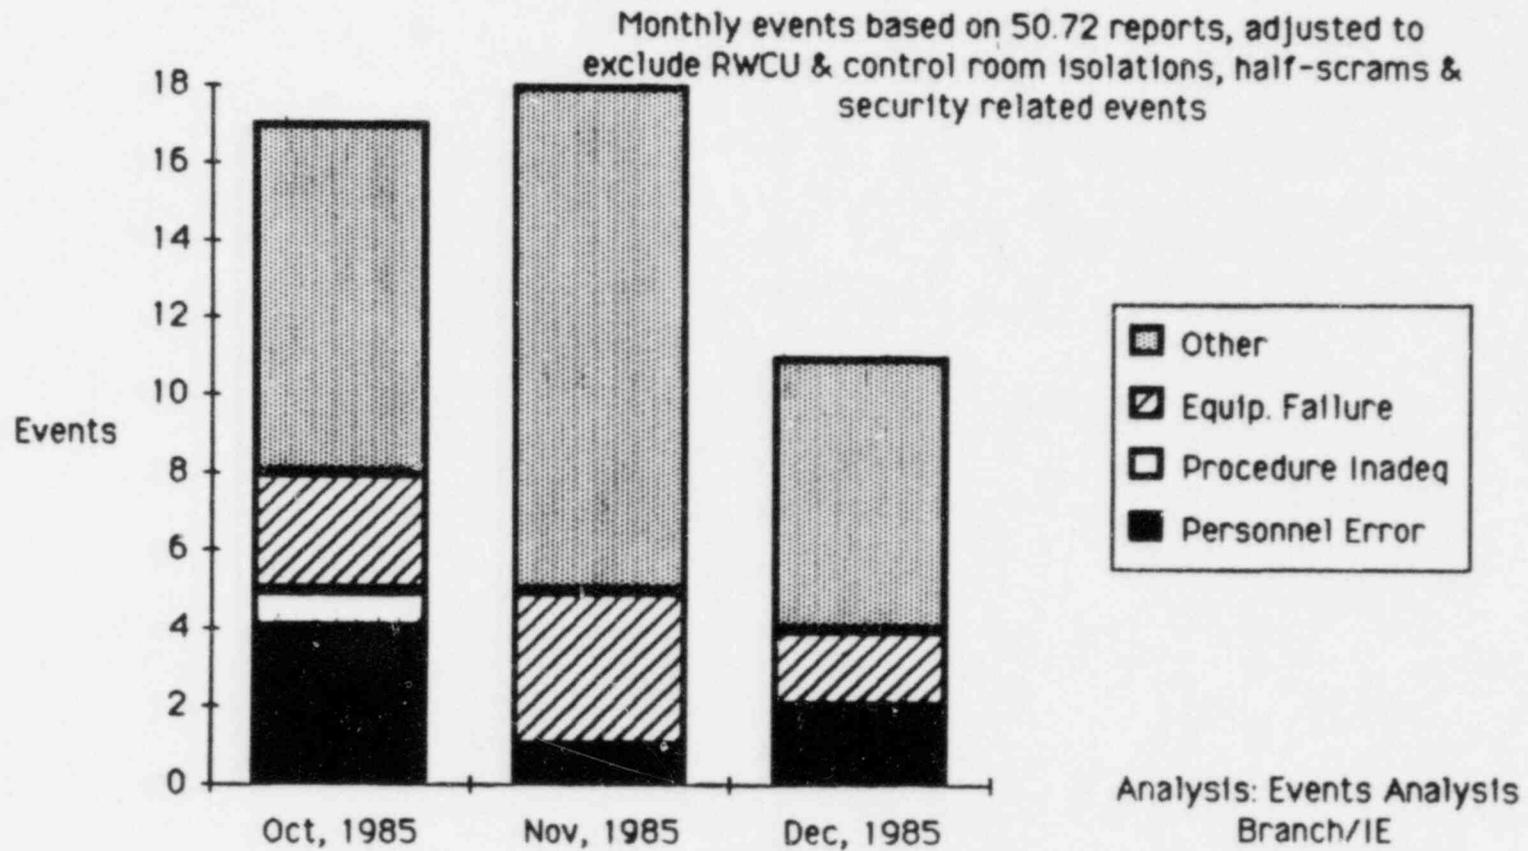
The IE Events Analysis Branch responded with an evaluation of monthly statistics of startup at the three plants on the basis of events reported to NRC according to 10 CFR 50.72 (Attachment). These 50.72 reports are current, but sketchy--the more definitive LERs are not available until about one month after an event. Given the need for a real time assessment on ongoing development at River Bend, the 50.72 reports were the obvious candidate. The IE analysis included filtering event data for RWCU & control room isolations, half scrams and security related events as well as a rough assessment of the cause of the events (see Figure V and the attachment).
