## PRECURSOR DESCRIPTION AND DATA

NSIC Accession Number: 159136

Title: Loss of Offsite Power at Arkansas Nuclear 2

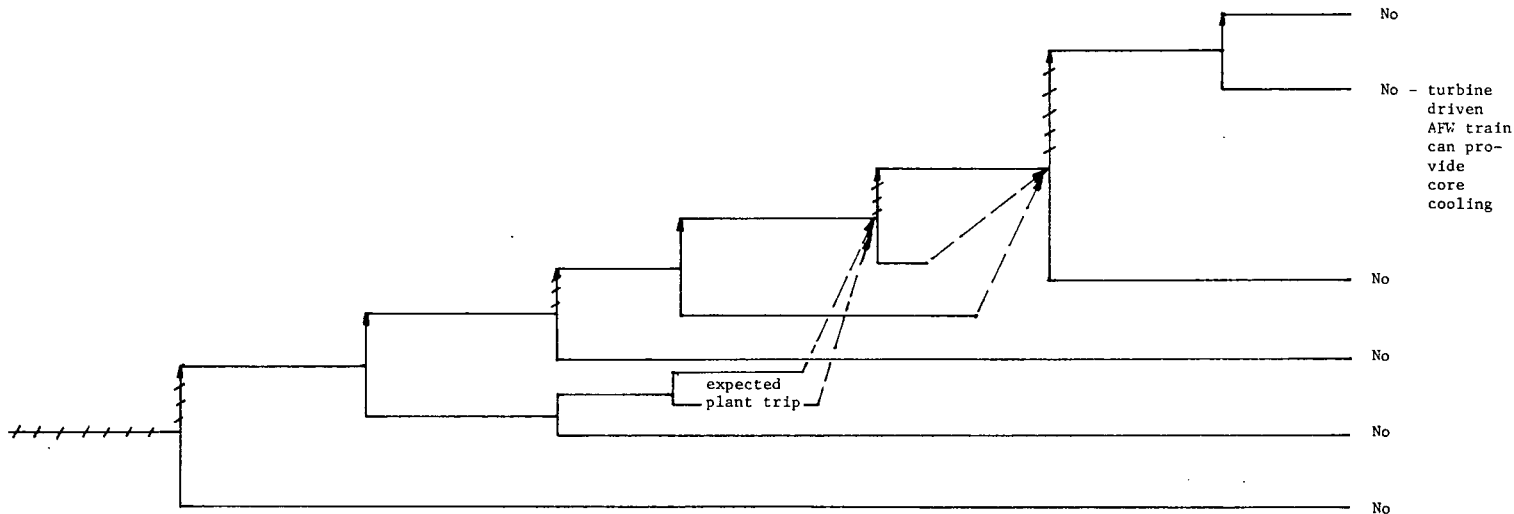
NSIC 159136 - Actual Occurrence for Loss of Offsite Power at Arkansas Nuclear 2

Reactor at 90% power and loss of 500-kV line due to ground fault. (One 500-kV line previously out of service)	Loss of second 500-kV line due to overload	Reactor trip in DNBR due to decreasing RC pump speed because of voltage/frequency problems	Loss of 161-kV line due to overload	Unit auxiliaries transferred to SU transformer #3	Loss of major 6.9-kV loads and 4.16-kV bus loads due to under-voltage	Faulted relay results in SU transformer #3 and Unit 1 SU transformer #1 lockout (loss of voltage in all auxiliary buses)	Diesel generators start and provide power to safety-related loads
---	--	--	-------------------------------------	---	---	--	---

Buses 2 A1 and 2 H1 were manually energized from startup transformer No. 2 four minutes later. Approximately 55 minutes later all house loads were transferred to startup transformer No. 3 and both emergency diesels were secured.

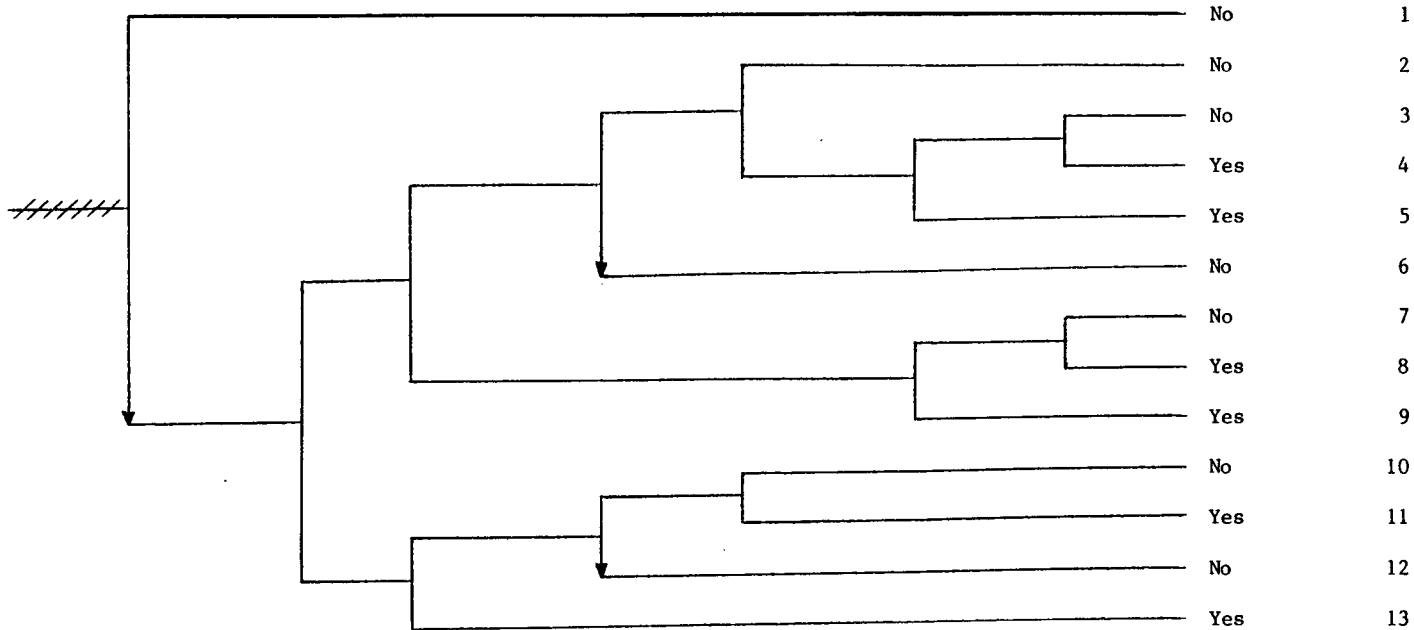
NSIC 159136 - Sequence of Interest for Loss of Offsite Power at Arkansas Nuclear 2

Loss of Offsite Power	Turbine Generator Runs Back and Assumes House Loads	Emergency Power	Auxiliary Feedwater and Secondary Heat Removal	PORV Demanded	PORV or PORV Isolation Valve Closure	High Pressure Injection	Long Term Core Cooling	Potential Severe Core Damage	Sequence No.
-----------------------	---	-----------------	--	---------------	--------------------------------------	-------------------------	------------------------	------------------------------	--------------
