Accident Sequence Precursor Program Event Analysis

LER No:456/88-022Event Description:Loss of offsite power for approximately 2 hDate of Event:October 16, 1988Plant:Braidwood 1

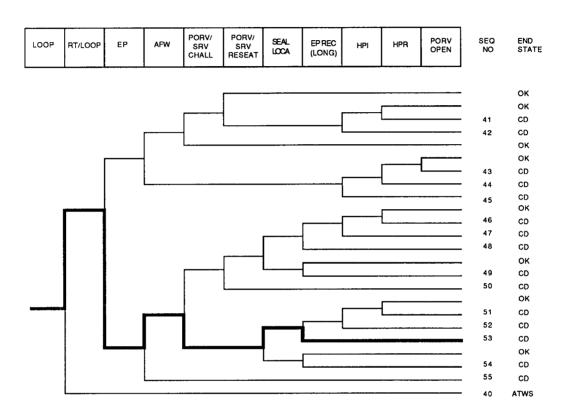
Dominant Core Damage Sequence for LER 456/88-022

The conditional probability of severe core damage estimated for this event is 1.8×10^{-4} . This event is considered significant from an ASP standpoint.

The dominant sequence (highlighted on the following event tree) involves a failure of emergency power ($p = 2.3 \times 10^{-3}$) following the LOOP (a station blackout), a subsequent seal failure (p = 0.23), and failure to recover AC power prior to core uncovery (p = 0.48).
