PRECURSOR DESCRIPTION AND DATA

NSIC Accession Number: 160846

Title: Loss of 24 Volt dc Nonnuclear Instrument Power Supply
at Crystal River 3

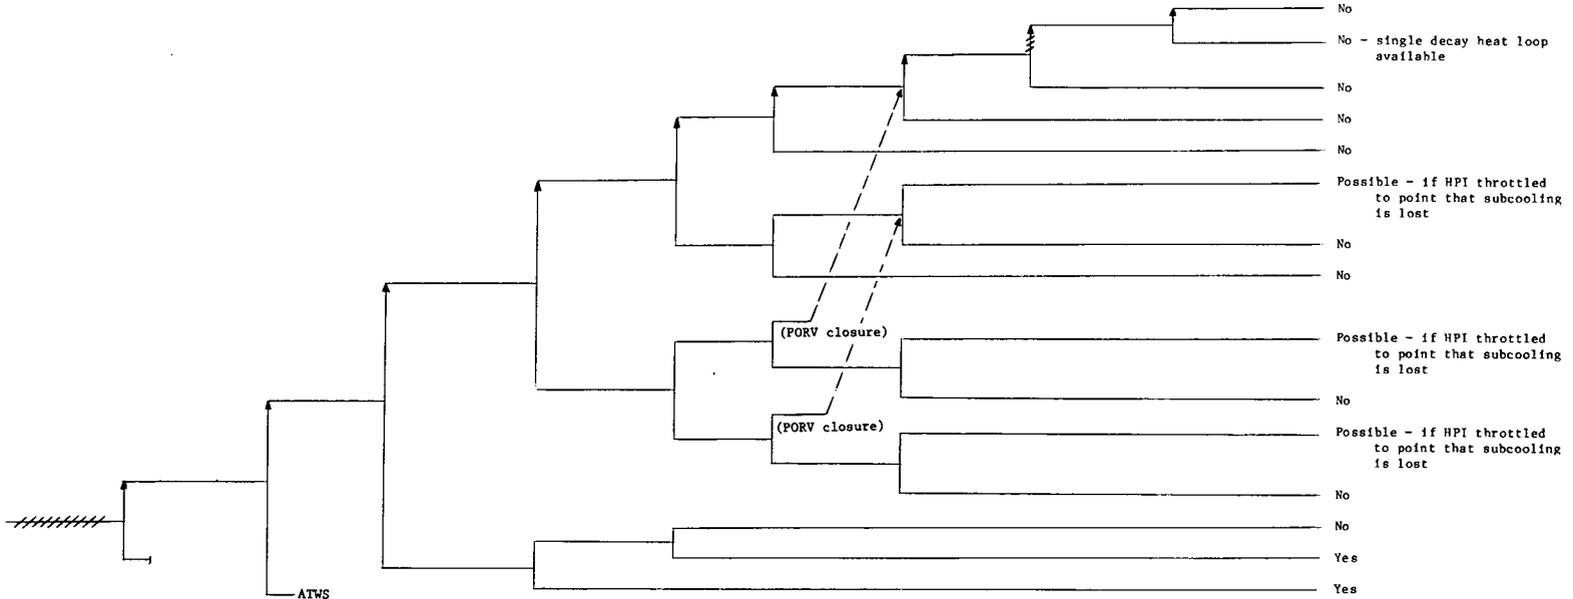
NSIC 160846 - Actual Occurrence for Loss of 24-V Nonnuclear Instrument Power Supply at Crystal River 3

Reactor at power and loss of NNI train X power supply due to failed voltage buffer cord	Consequent erroneous signals to ICS resulting in increased power demand, feedwater runback, and opened PORV	Reactor trip due to high RCS pressure	Safety injection initiated due to decreasing RCS pressure	Operator closes block valve and isolates open PORV	Operator manually initiates emergency feedwater	Power restored to NNI train X	HPI throttled to minimize discharge of containment	Decay heat closed cycle cooling pumps DCP-1A unavailable due to failed motor coupling	Shutdown delayed while pump DCP-1A is repaired	Potential Severe Core Damage
---	---	---------------------------------------	---	--	---	-------------------------------	--	---	--	------------------------------
