PRECURSOR DESCRIPTION AND DATA

NSIC Accession Number: 171667

Title: Loss of Two Instrument Buses at Davis-Besse 1

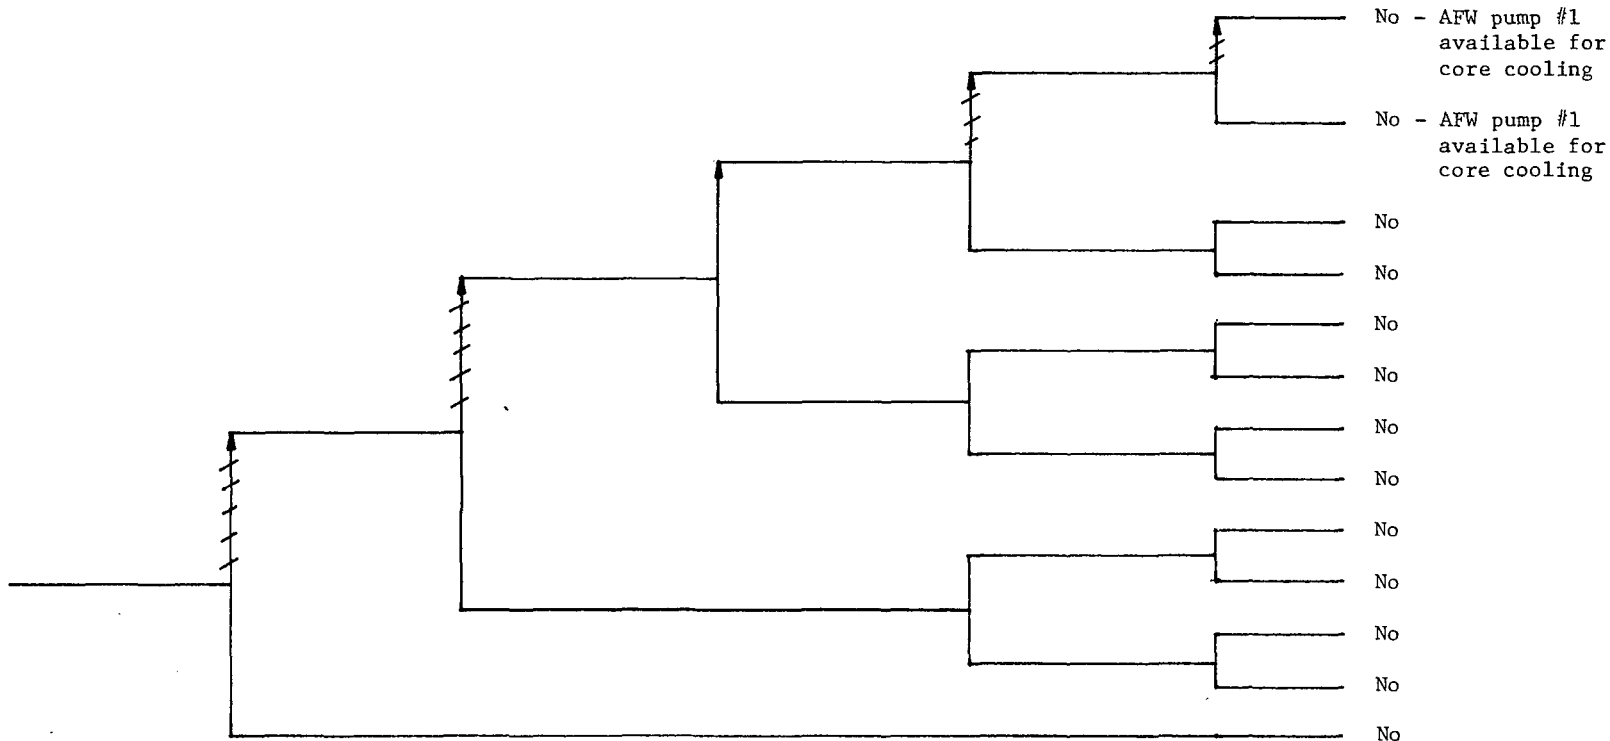
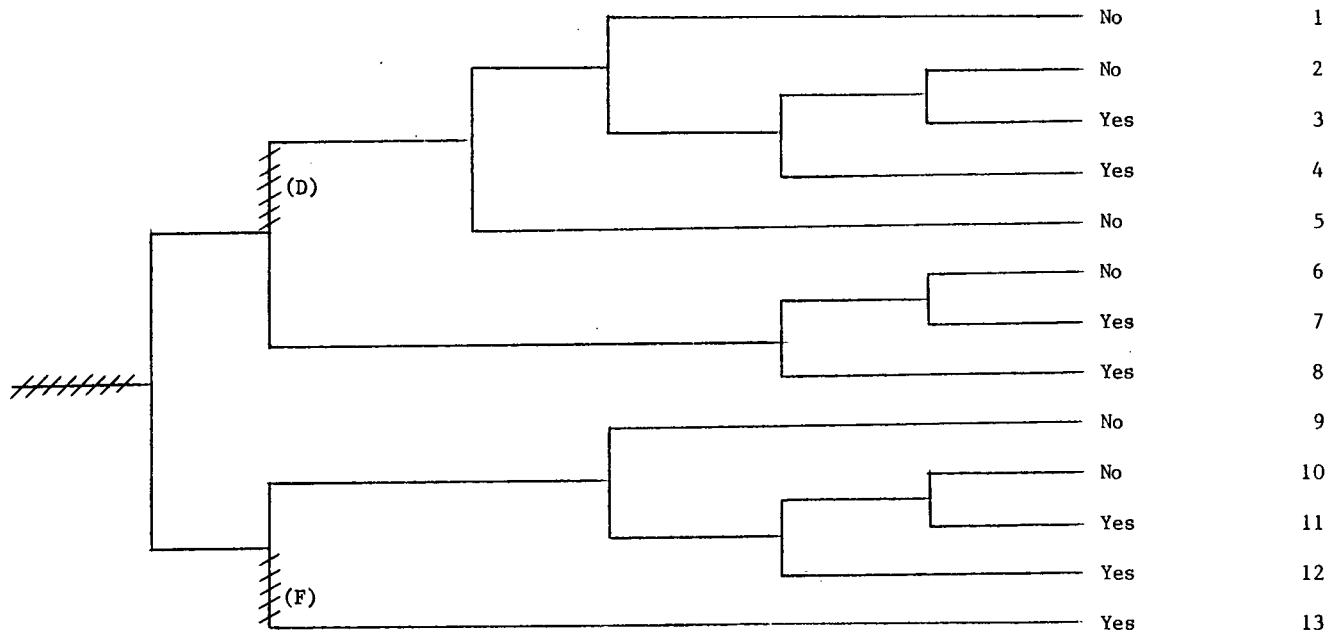
NSIC 171667 - Sequence of Interest for Loss of Two Instrument Buses at Davis-Besse 1

Reactor at 74% power and "A" control rod drive breaker deenergized as part of CRD breaker logic test	Breaker HAAEZ inadvertently struck and trips, resulting in loss of bus E2, deenergization of panel YAR and reactor trip	Inverter supply YVA previously transferred to YAR due to defective static sensing and transfer logic cord	Bus YVA deenergized due to deenergization of YAR. Resultant loss of indication on both saturation meters, loss of AFW pump #1 flow indication, and trip of makeup pump 1-1	AFW pump #2 fails to start when manually actuated due to mis-adjusted governor slip clutch and bent low speed stop pin	Main steam relief valve SPI7B4 fails to fully reset
--	---	---	--	--	---

Loss of Main Feedwater	Reactor Trip	Auxiliary Feedwater and Secondary Heat Removal	PORV Demanded	PORV or PORV Isolation Valve Closure	High Pressure Injection	Long Term Core Cooling	Potential Severe Core Damage	Sequence No.
------------------------	--------------	--	---------------	--------------------------------------	-------------------------	------------------------	------------------------------	--------------
