Accident Sequence Precursor Program Event Analysis

LER No.: 323/88-008
 Event Description: Loss of offsite power with safety injection
 Date of Event: July 17, 1988
 Plant: Diablo Canyon Unit 2

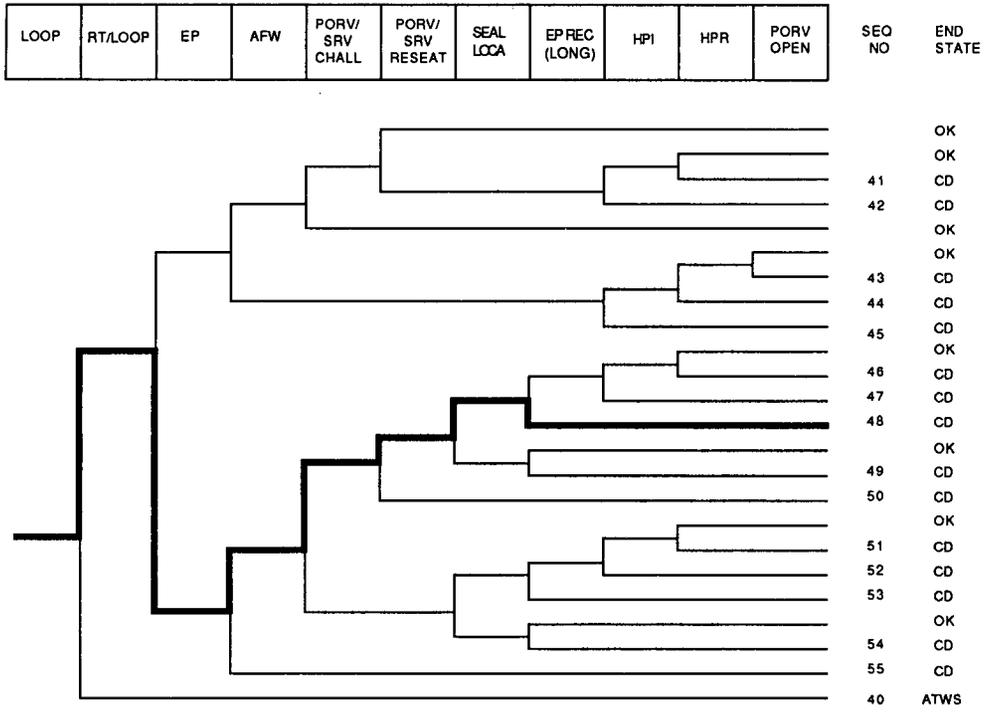
Dominant Core Damage Sequence for LER 323/88-008

The conditional probability of core damage is estimated to be 4.1×10^{-5} . The dominant core damage sequence (highlighted on the following event tree) is associated with RCP seal failure following station blackout: failure to recover from the LOOP ($p = 0.5$), potential emergency power failure (4.3×10^{-4}), seal LOCA ($p = 0.23$), and failure to recover AC power prior to core uncovering ($p = 0.48$). Within the set of all 1984-1987 precursors with conditional probabilities $\geq 1.0 \times 10^{-6}$, this event ranks as a mid-range event.
