U.S. NUCLEAR REGULATORY COMMISSION
REGION IV

Docket No.: 40-8902
License No.: SUA-1470
Report No.: 40-8902/97-01
Licensee: Atlantic Richfield Company (ARCO)
Facility: Former Bluewater Mill Facility
Location: Grants, Cibola County, New Mexico
Date: January 6-7, 1997
Inspector: Robert J. Evans, P.E., Health Physicist
Nuclear Materials Inspection and
Fuel Cycle/Decommissioning Branch
Division of Nuclear Materials Safety
Approved By: Charles L. Cain, Acting Deputy Director
Division of Nuclear Materials Safety

Former Bluewater Mill Facility NRC Inspection Report 40-8902/97-01

ATTACHMENT 2 - PHOTOGRAPHS TAKEN AT THE BLUEWATER MILL FACILITY

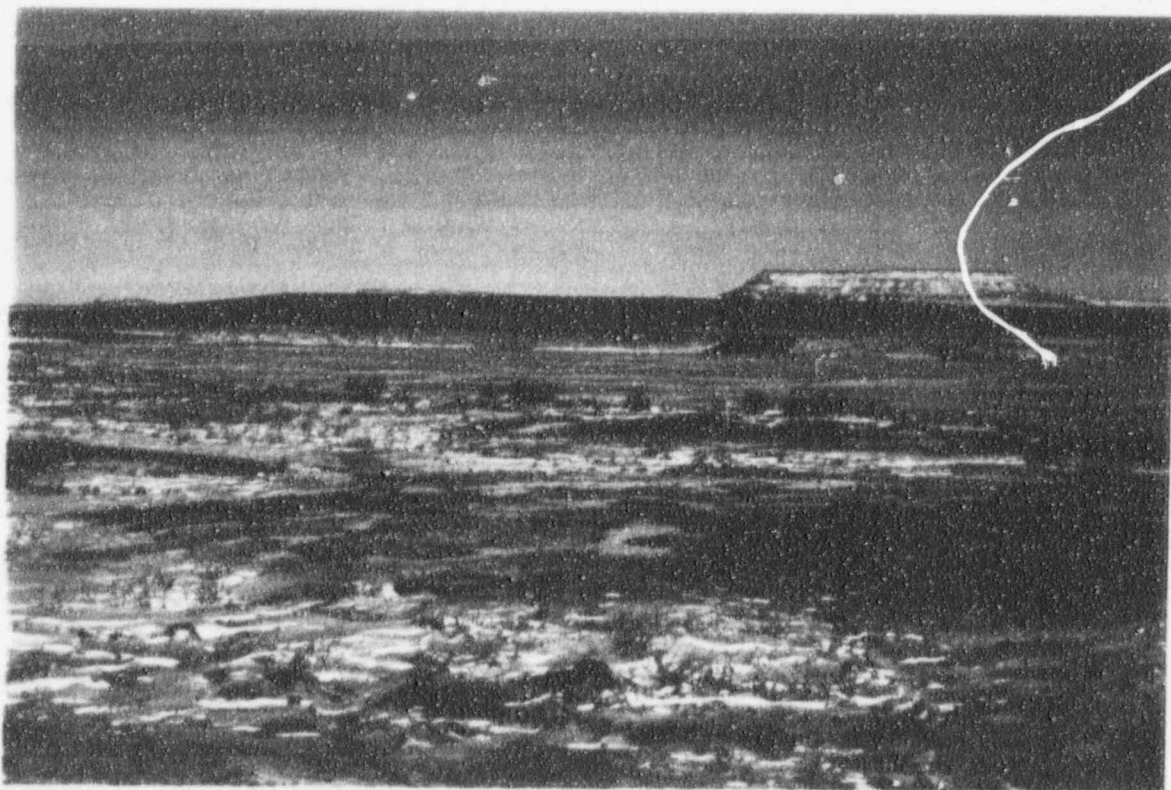
Photograph 1 - The Main Tailings Pile at the ARCO site.

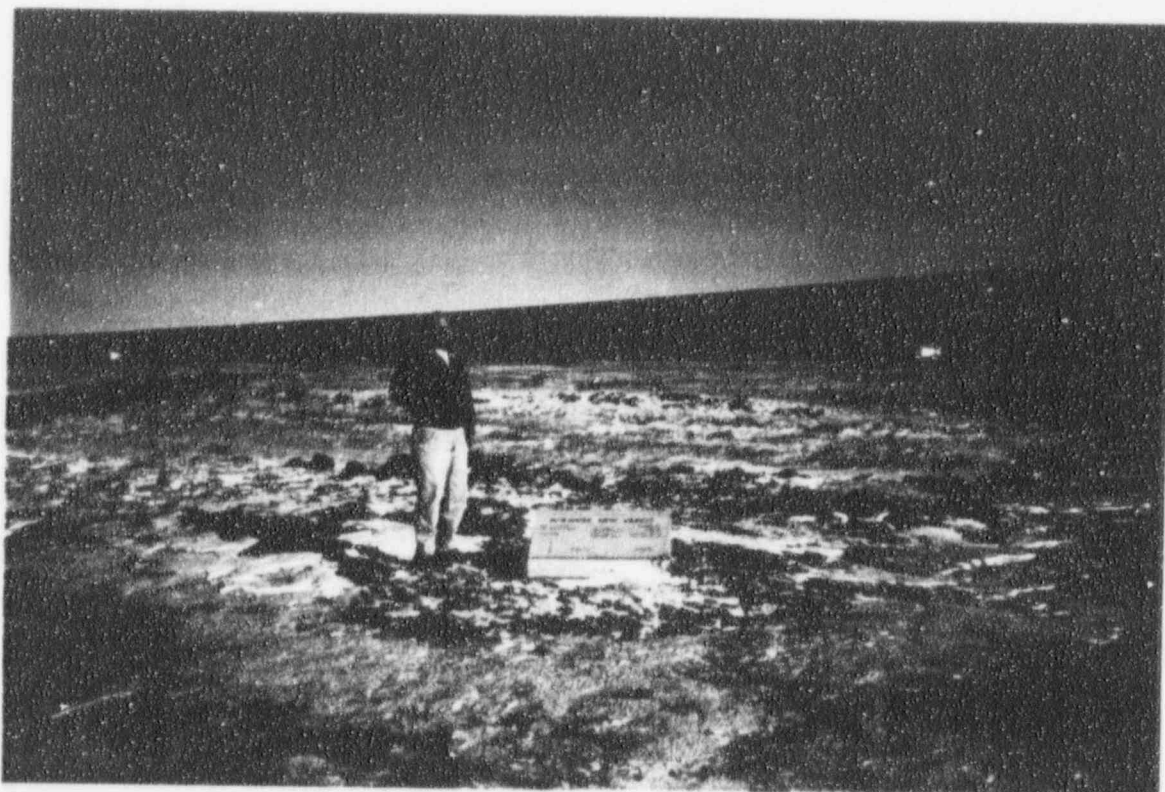
Photograph 2 - NRC Inspector adjacent to the Location Marker with Main Tailings Pile in background.

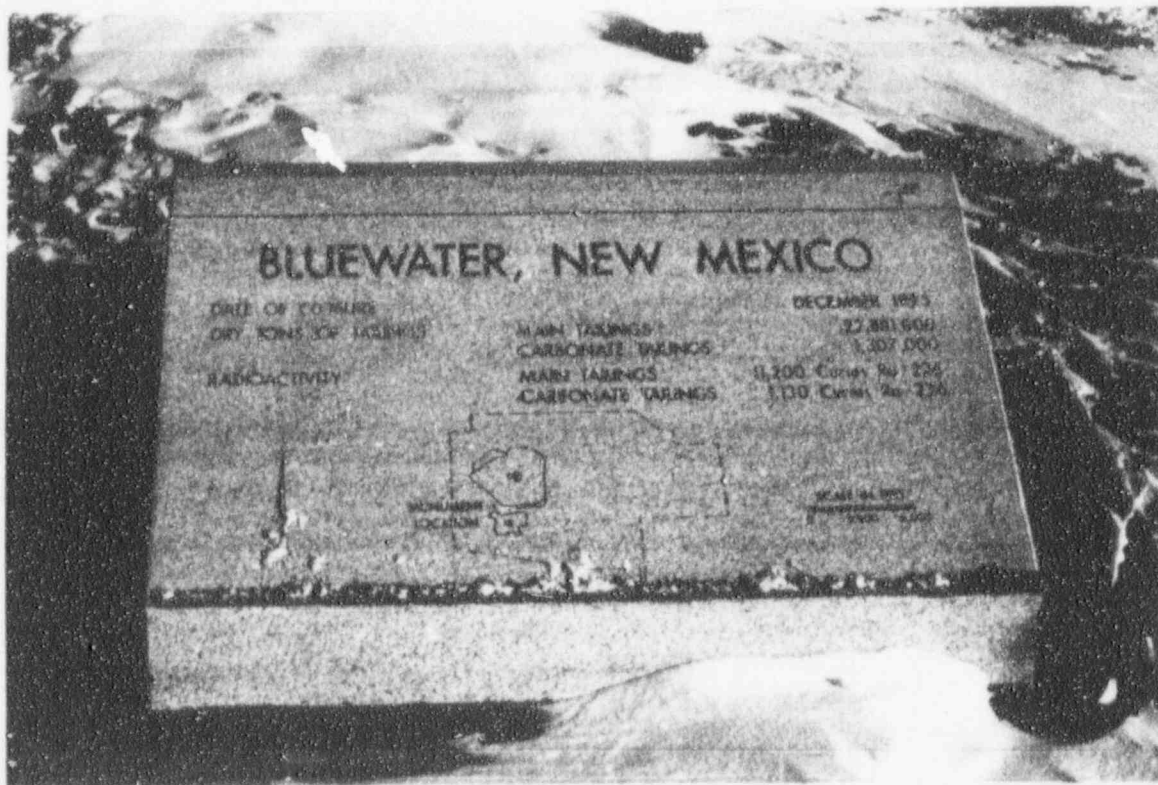
Photograph 3 - Closeup of the Location Marker.

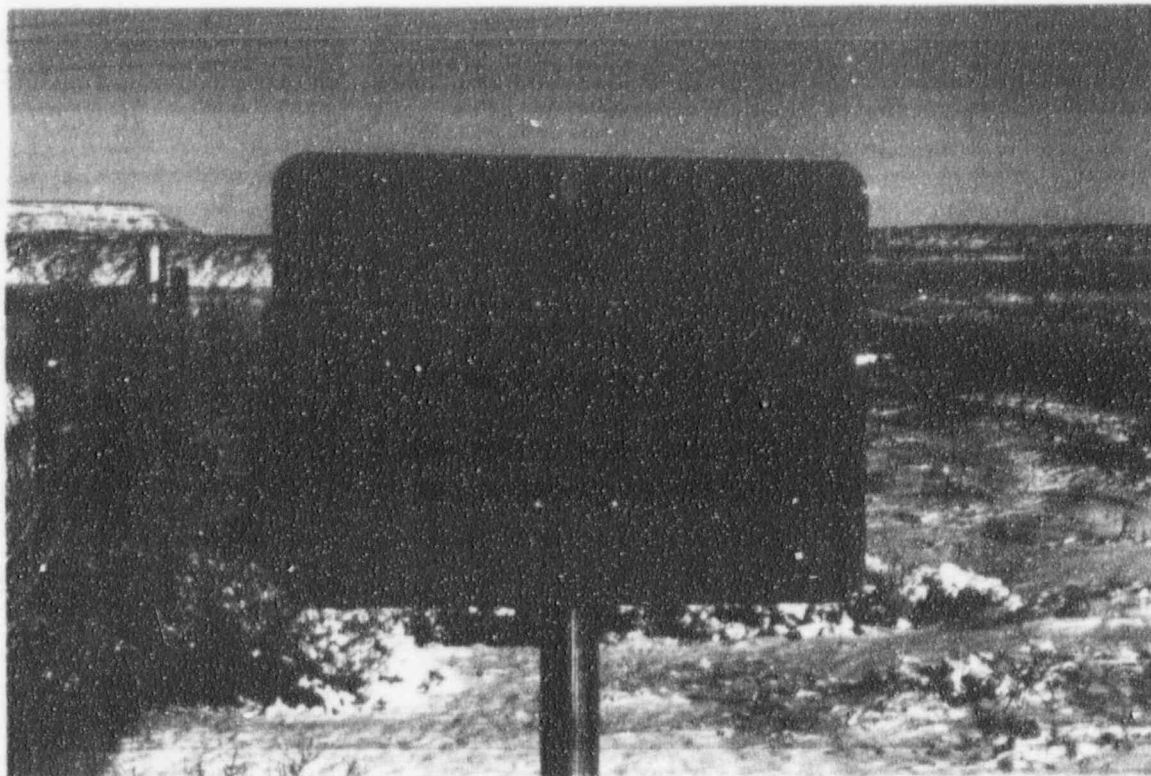
Photograph 4 - One of 52 signs recently installed on site property.

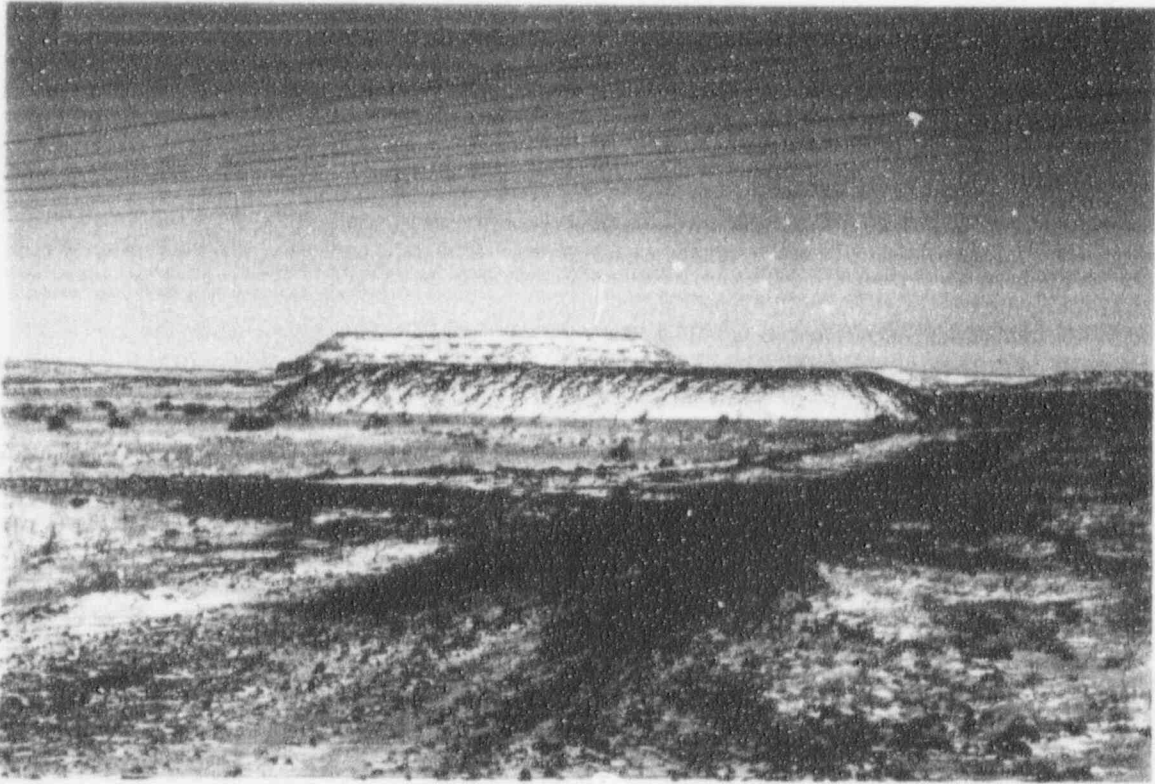
Photograph 5 - Rock (pile left of gate) available for future road maintenance activities.
