LICENSEE EVENT REPORT (LER)

FACILITY NAME (1) Hope Creek Generating Station DOCKET NUMBER (2) 050003541 OF 015 PAGE (3)

TITLE (4) Reactor Water Cleanup System Isolation When Pressurizing The "B" Filter/Demineralizer Due To F/D Inlet Design Deficiency

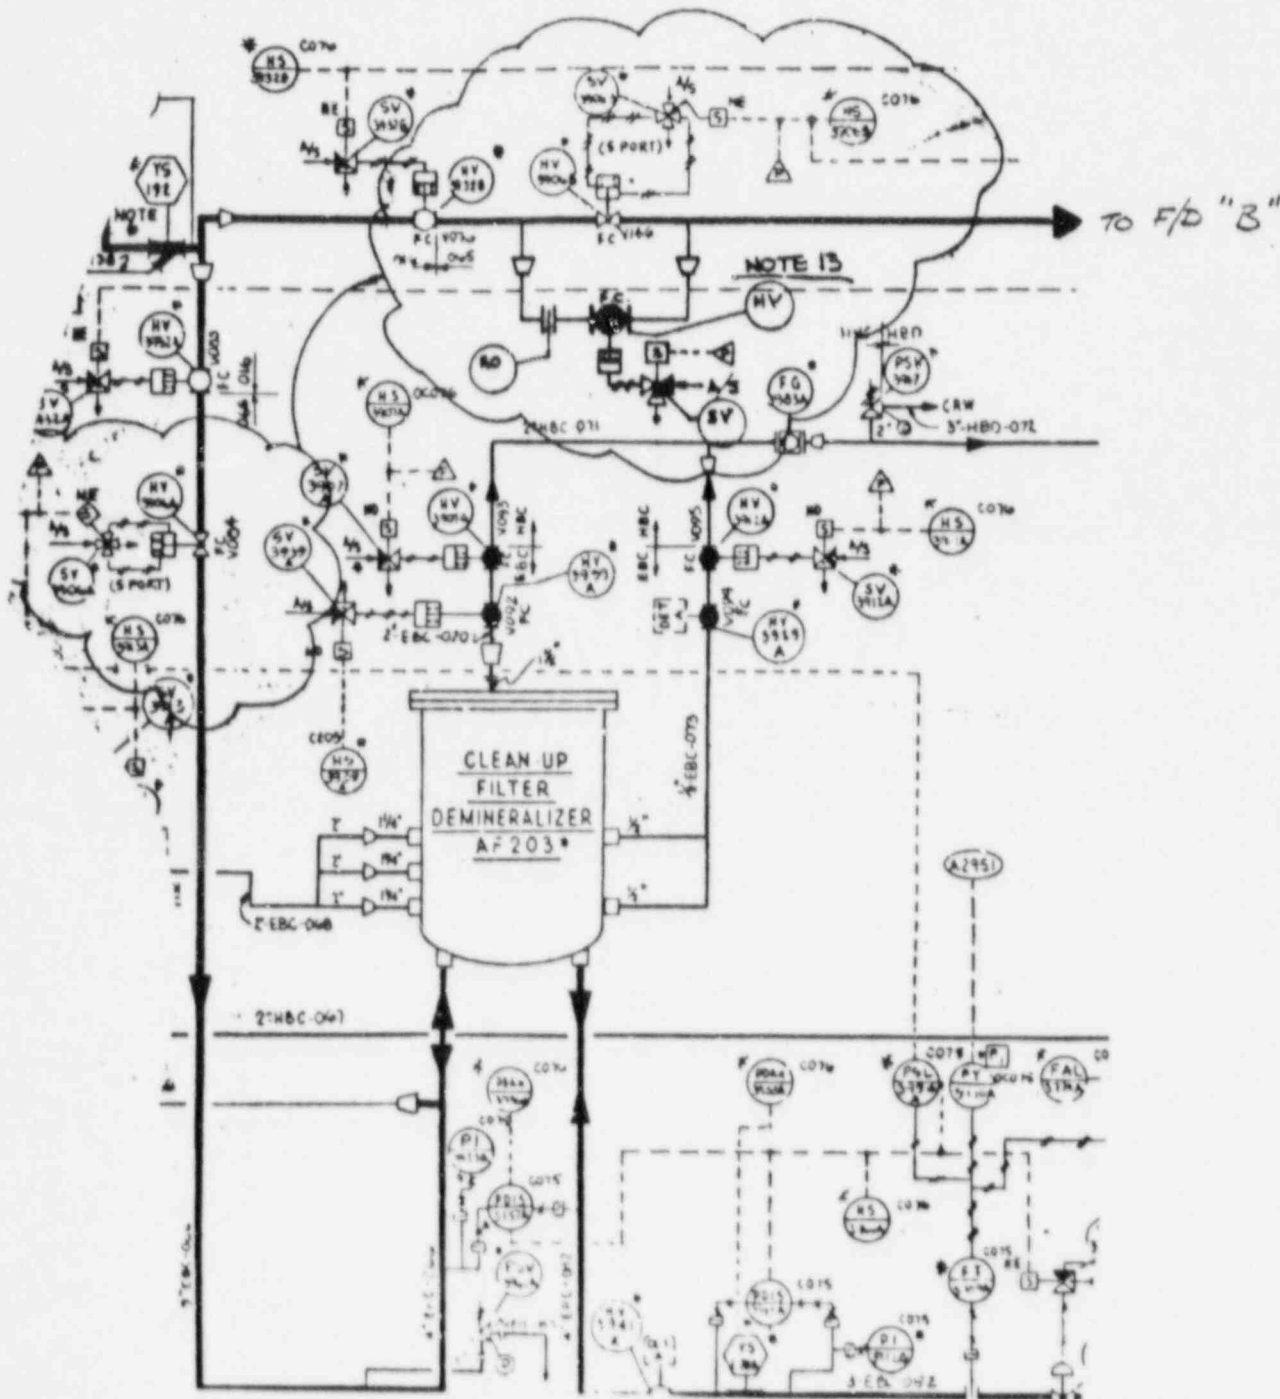
ATTACHMENT 1

A deficiency exists in the design of the F/D vessel inlet
piping and valves configuration such that the possibility of a
high differential flow initiation of the RWCU Steam Leak
Isolation timer exists every time a vessel is placed in the
"Hold" cycle during pressurization. If the high differential
flow condition does not clear within 45 seconds of timer
initiation, the RWCU system isolates.

Refer to Attachment 1 for a schematic of a typical F/D inlet piping arrangement. Following a backwash/precoat cycle, the F/D is placed in the "Hold" mode to pressurize the vessel. (After a backwash/precoat, the filter is at atmospheric pressure while the remainder of the RWCU system is between 250 PSIG and 1300 PSIG, depending on plant conditions.) When the "Hold" cycle is initiated, several actions occur. The automatic precoat step programmer, after cycling through various steps, automatically opens HV-3906 to pressurize its associated vessel.

F/D Inlet Arrangement
(Design Change For F/D "B" Shown; F/D "A" Similar)

Vessel pressurization occurs rapidly when HV-3906 beings moving off its seat. Though the stroke speed of HV-3906 is adjustable, stroke speed has little effect on pressurization rate. As such, a design modification has been initiated to provide a small bypass line, restricting orifice, and valve around the existing F/D inlet valves. This design will allow for controlled pressurization of the F/Ds prior to opening the inlet valves.
