## LICENSEE EVENT REPORT (LER)

FACILITY NAME (1) Oyster Creek, Unit 1										DOCKET NUMBER (2) 0 5 0 0 0 2 1 1 9										PAGE (3) 1 OF 0 4				
TITLE (4) REACTOR SAFETY VALVE LEAKED DURING HYDRO TEST DUE TO MANUAL LIFTING NUT COTTER PIN FAILURE																								
EVENT DATE (5)				LER NUMBER (6)				REPORT DATE (7)				OTHER FACILITIES INVOLVED (8)												
MONTH	DAY	YEAR	YEAR	SEQUENTIAL NUMBER	REVISION NUMBER	MONTH	DAY	YEAR	FACILITY NAMES					DOCKET NUMBER(S)										
1	1	1	8	7	8	7	0	4	6	0	0	1	0	7	8	8	0	5	0	0	0	0	0	
OPERATING MODE (9)		N		THIS REPORT IS SUBMITTED PURSUANT TO THE REQUIREMENTS OF 10 CFR § (Check one or more of the following) (11)																				
POWER LEVEL (10)		0 0 1 0		20.402(b)				20.406(e)				50.73(a)(2)(iv)				73.71(b)

Subject: Oyster Creek Nuclear Generating Station  
Docket No. 50-219  
Voluntary Licensee Event Report

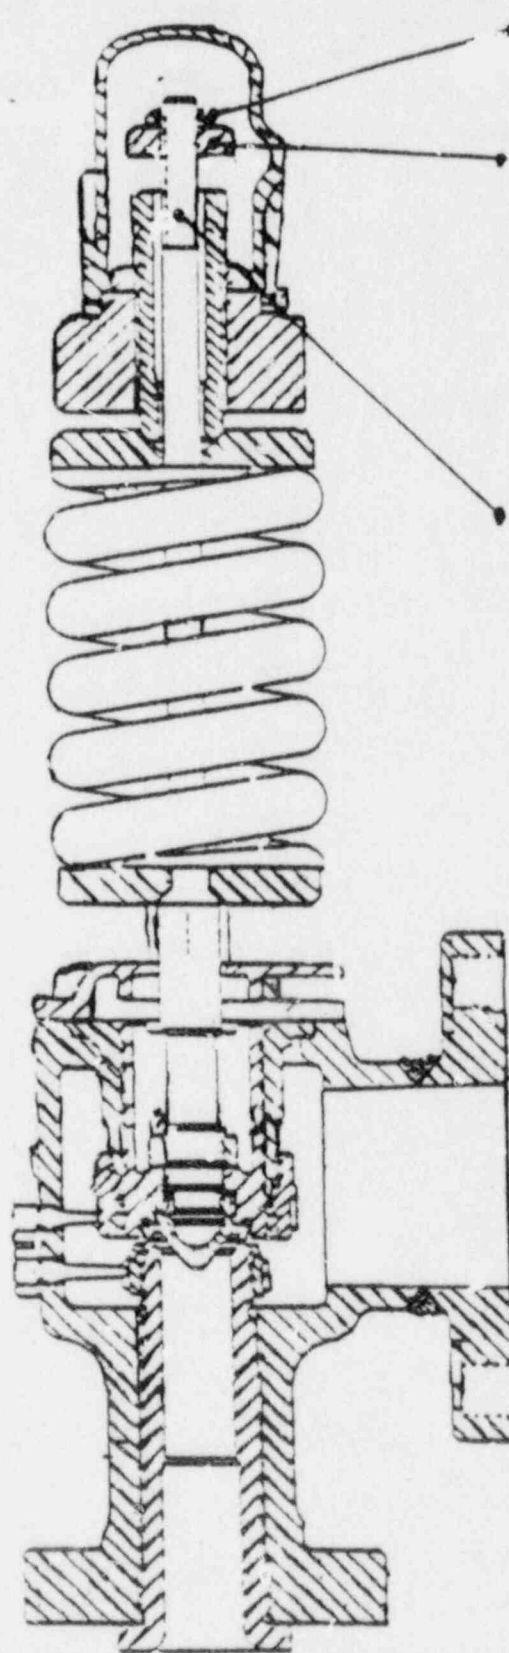
TYPICAL  
SAFETY  
VALVE

The cause of this event was the mechanical fatigue failure of the manual lift nut cotter pin and subsequent manual lift nut repositioning which restricted valve stem thermal contraction, thus decreasing the closing spring tension. Vibration and thermal cycling were the mechanisms that caused the cotter pin failure and nut movement. (See attached drawing for details.) This resulted in the valve disk

position at pressures greater than 200 psig being slightly off the seat causing seat leakage. As the safety valve would start to lift in this condition, the stem thermal contraction preload force on the closing spring tension would be relieved within mils of stem movement.

Cotter Pin (which failed)

Manual Lift Nut (which rotated down, causing a valve opening preload tension when the valve cooled.

Threaded valve stem

The valve that leaked at approximately 200 psig during the reactor hydrostatic pressure test was replaced with a bench tested safety valve. The manual lift nuts were removed from all other installed reactor safety valves to prevent this event from recurring. The maintenance procedure for the installation of reactor safety valves will be revised to include steps requiring the manual lift nut be verified removed prior to installation.
