SUBJECT: THE OPERATING REACTORS EVENTS MEETING  
February 23, 1988 - MEETING 88-08

OPERATING REACTORS EVENTS BRIEFING 88-08

INDIAN POINT 2  
POTENTIAL COMMON MODE FAILURE OF SERVICE WATER SYSTEM

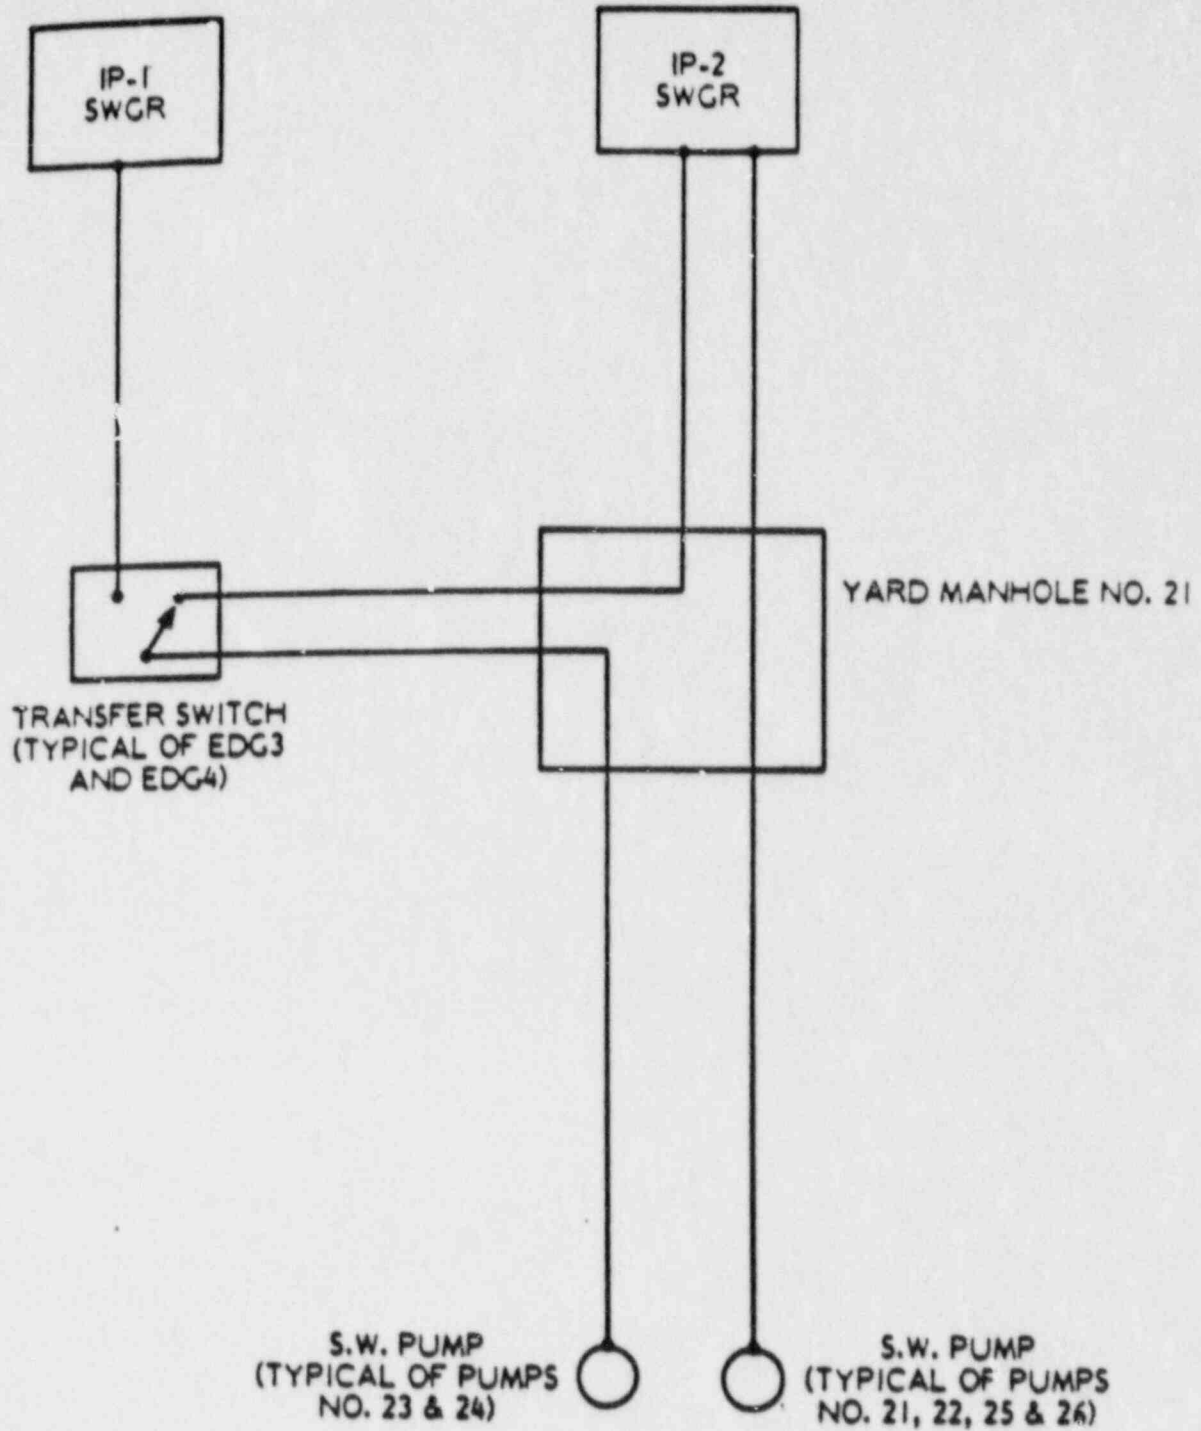
**FIGURE 4.15-1**  
**TYPICAL ARRANGEMENT - SERVICE WATER**  
**PUMP POWER CABLES - ONE LINE**

POTENTIAL COMMON MODE FAILURE OF SERVICE WATER PUMPS DUE TO ENERGETIC FAILURE OF THE ASSOCIATED POWER CABLING.

DEGRADATION DUE TO WATER INTRUSION IN CABLE SPLICES.

POTENTIAL LOSS OF ULTIMATE HEAT SINK.

- o RECENT SAFETY SYSTEM FUNCTIONAL INSPECTION IDENTIFIED POTENTIAL COMMON MODE FAILURE.
- o ALL SERVICE WATER PUMP POWER CABLES RUN FROM PLANT SWITCHGEAR TO ALL SIX PUMPS THROUGH ONE MANHOLE.
- o CABLES SPLICED IN ONE MANHOLE - ONE CONFIGURATION FOR TWO ALTERNATE SHUTDOWN PUMPS, ONE CONFIGURATION FOR FOUR REMAINING PUMPS.
- o ALTERNATE SHUTDOWN PUMPS HAVE EXPERIENCED TWO ENERGETIC FAILURES SINCE 1985 DUE TO WATER INTRUSION.
- o MANHOLE PARTIALLY FILLED WITH SAND IN 1985 FOR FIRE PROTECTION.
- o MANHOLE OFTEN FLOODED.

- o THE LICENSEE IS EVALUATING.
- o LICENSEE TO PRESENT SHORT- AND LONG-TERM CORRECTIVE ACTIONS TO RESOLVE PROBLEM AND JUSTIFICATION FOR CONTINUED OPERATION AT MEETING AT REGION I - 02/26/88.
