FACILITY: Nine Mile Point Nuclear Station Unit No. 1

SUBJECT: SUMMARY OF TELEPHONE CONVERSATION OF APRIL 3, 1997, REGARDING  
RECIRCULATION PIPING WELD

## RECIRCULATION SYSTEM WELD INDICATION RESPONSES TO NRC QUESTIONS

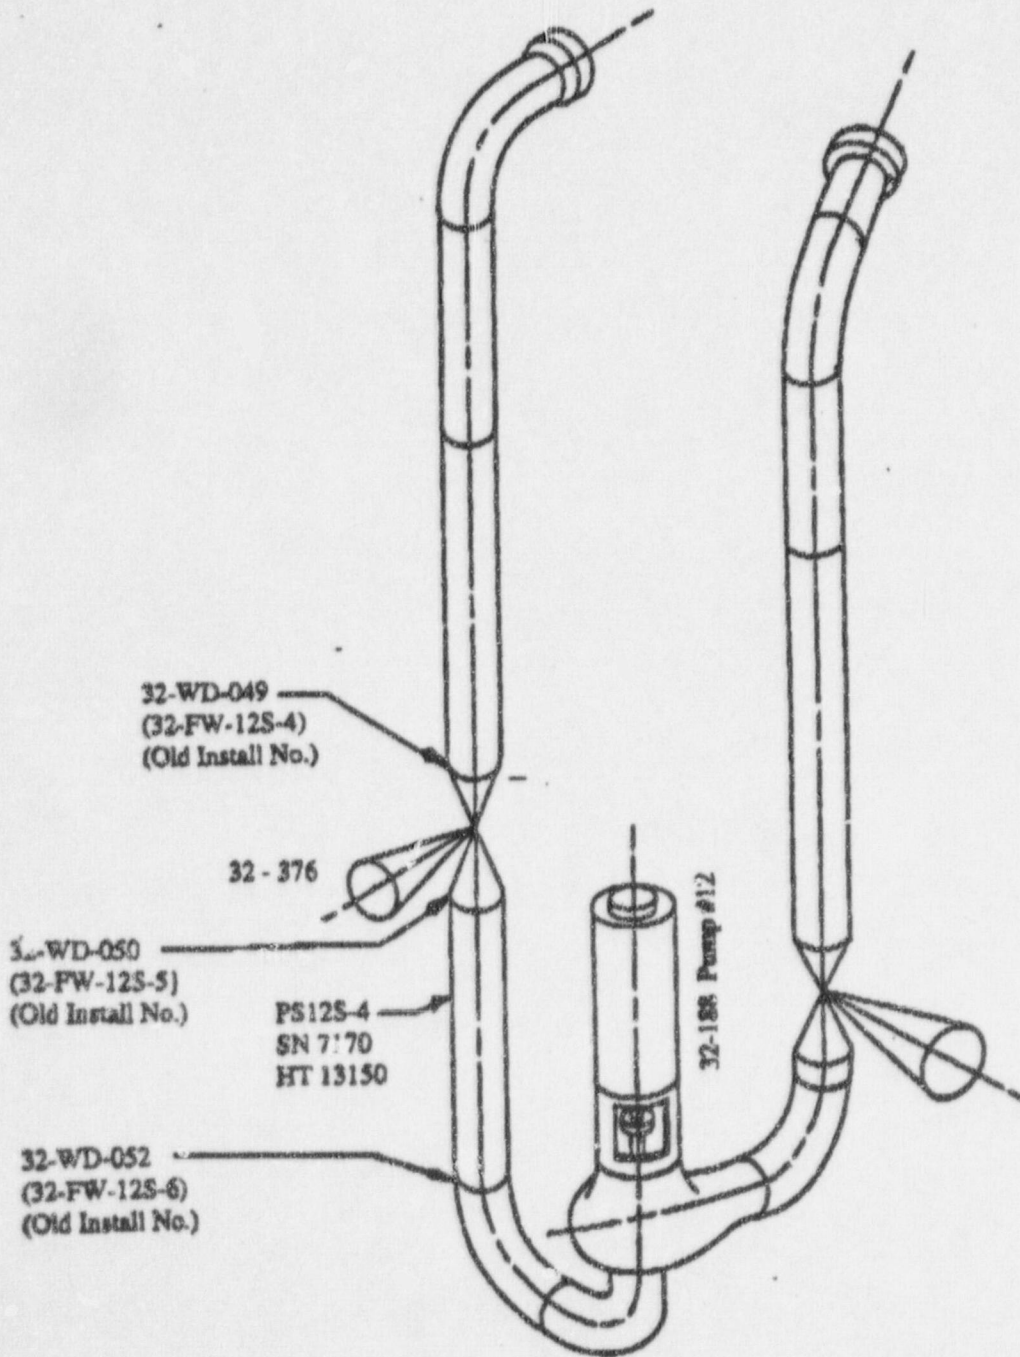
NMP1  
Loop 12  
Reactor Recirculation

See simplified sketch. Upstream of weld 32-WD-050 is the loop 12 suction blocking valve 32-376 and downstream is a 11'-5.5" length of 28" pipe.

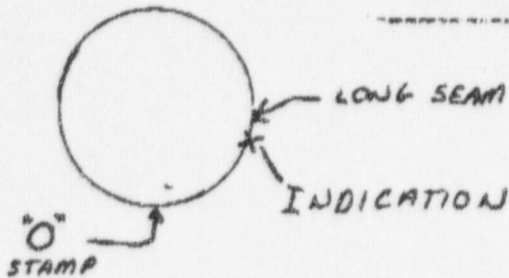
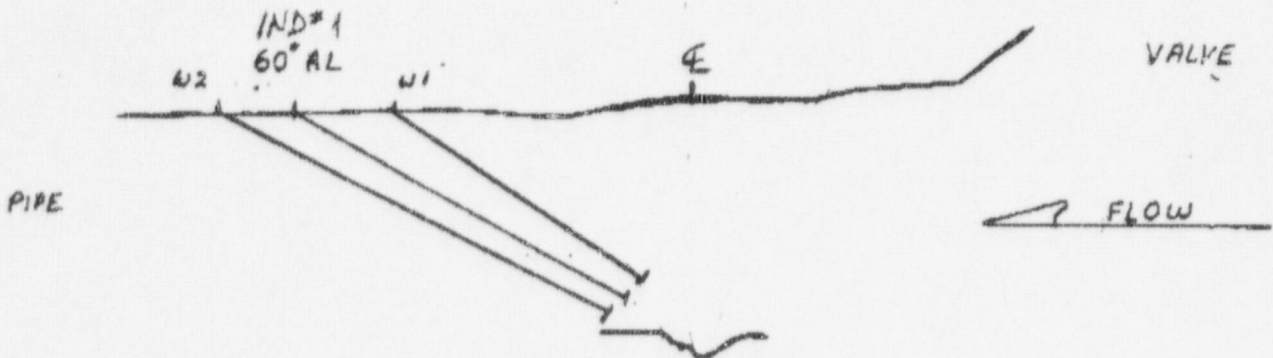
NDE Report: 1-6.03-97-0219  
 Work Document: NMP-151-002 R.O  
 Page 3 of 4  
 Exam Item: 32-WD-050  
 Procedure/Rev.: 6.03 REV-11

NOTE: PEAK AMPLITUDE ATTAINED BY SKEWING TRANSDUCER  
 10"-15" BACK TOWARD "0"

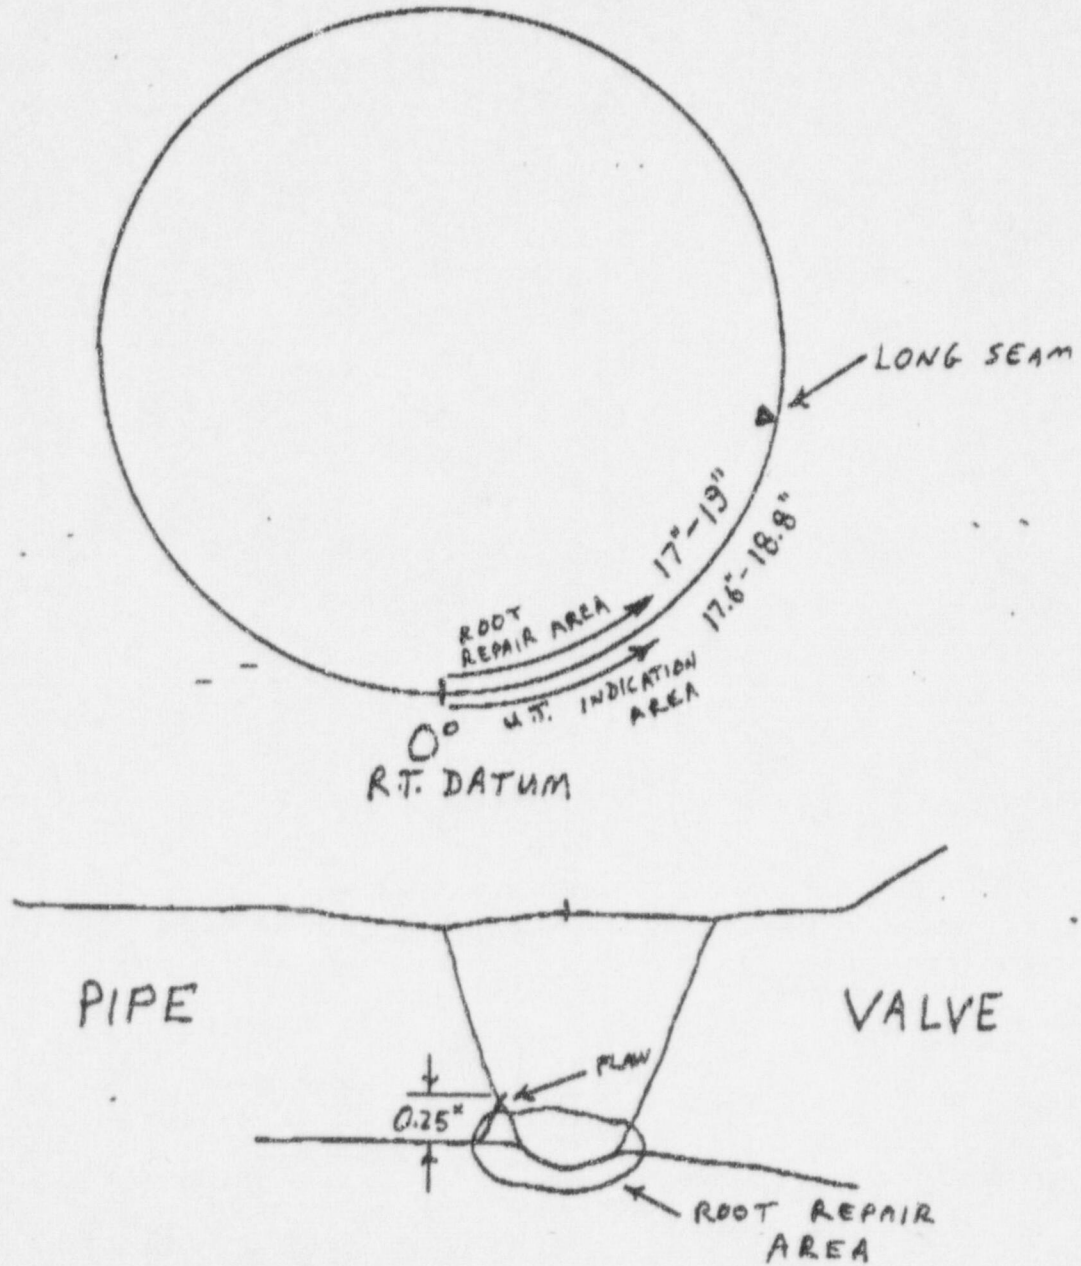
NDE Report: INFORMATION SKETCH: FLAW LOCATION  
 Work Document: RELATIVE TO ROOT  
 Page 1 of 1 REPAIR AREA  
 Exam Item: WELD # 32-WD-050  
 Procedure/Rev: N/A

**RT:** 1983 root pass info - lack of fusion noted between 17"-19" location markers - repaired, re-shot and accepted. Final ASME Section III RT accepted on 1-25-83. It should be noted that the present UT indication is at the same location as the root repair area discussed above. 1997 supplemental RT - performed supplemental RT on this indication this outage. Indication was not seen with conventional or enhanced digitization of the RT film. Installation and supplemental RT film was digitized, however, the areas of interest did not positively reveal this indication.

See response to question 4. NMPC has verified that area of incomplete fusion identified and repaired in 1983 (installation) is in the same location as indication found in RFO14. UT performed in 1986 following IHSI identified "no relevant indications found."
