U.S. NUCLEAR REGULATORY COMMISSION

Report No: 50-282/97005, 50-306/97005, 72-10/97005

Facility: Prairie Island Nuclear Generating Plant

Dates: February 21 - April 4, 1997

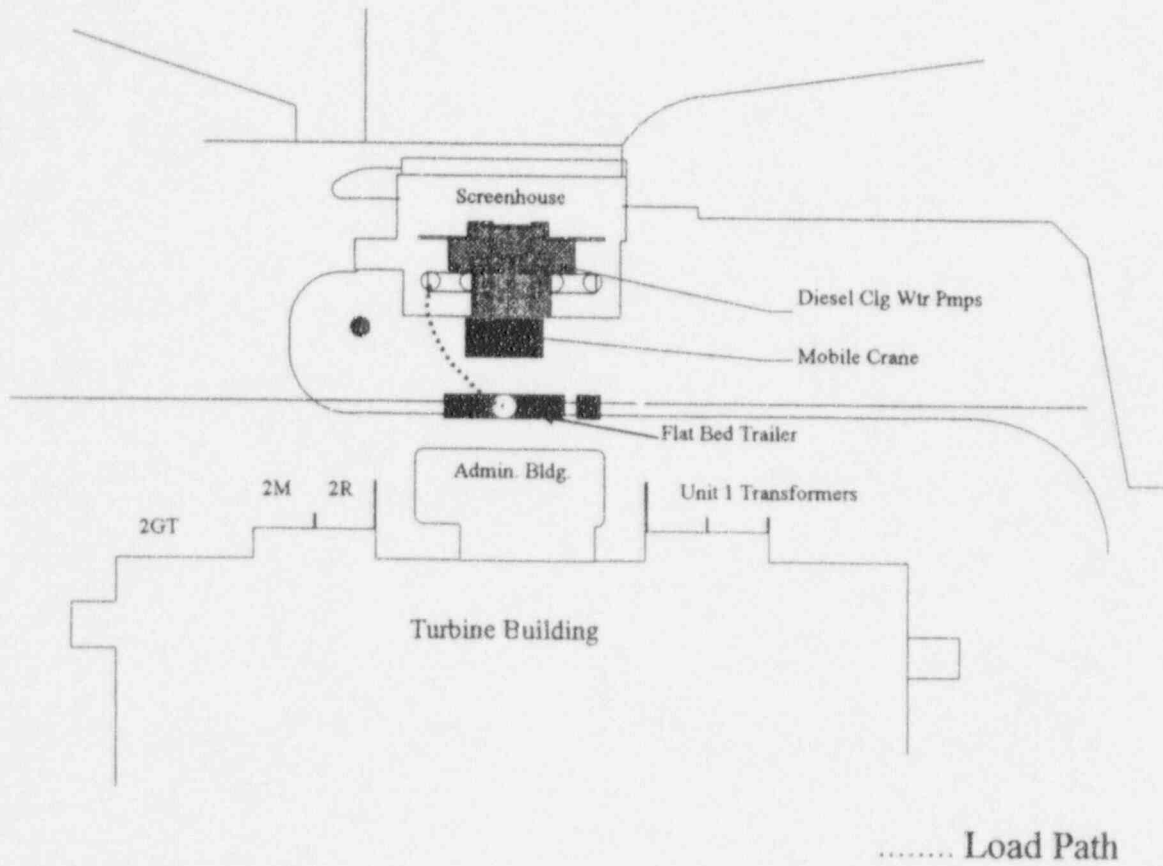
FIGURE 2

Plant Screenhouse

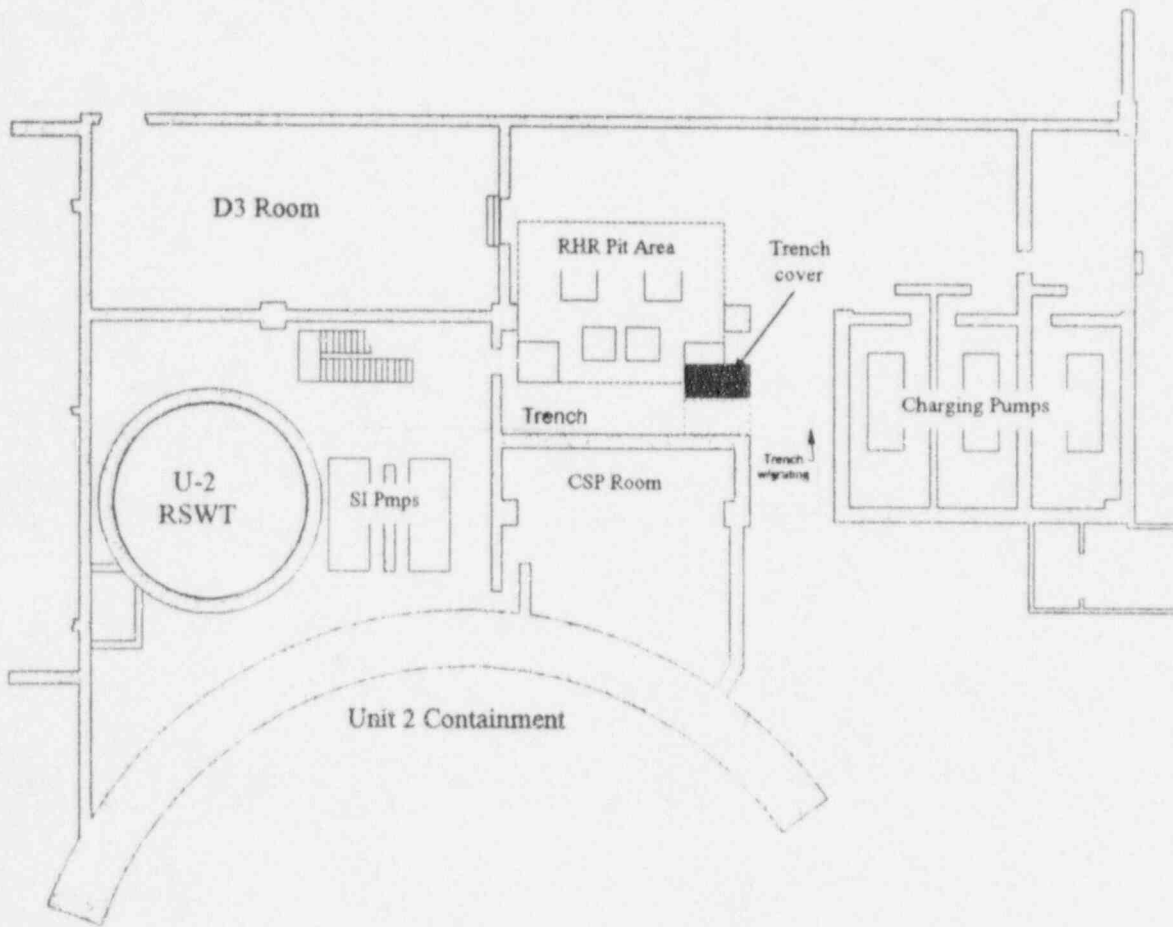
FIGURE 3

On February 25, 1997, a licensee quality services inspector identified that the maintenance workers had used a forklift to remove a concrete trench cover over a pipe chase containing residual heat removal and safety injection system piping. The licensee determined that the heavy cover had been removed without implementing the controls in licensee Procedure D58, "Control of Heavy Loads," Revision 26. The inspectors reviewed the circumstances of the event.

This event was very similar to one which had occurred a few days earlier on February 19, 1997. That event was discussed in Inspection Report 282(306)/97002, Section M3.1. In both cases, the licensee's procedure, D58, was inadequate in that it did not contain instructions for controlling heavy load lifts with other than permanently installed lifting devices. For the February 19 event, the NRC issued a Notice of Violation dated February 25, 1997. In addition, during a pre-decisional enforcement conference on March 18, 1997, regarding another heavy load lifting event which occurred on February 3, 1997, discussed in Inspection Report 282(306)/97002, Section M1.2, the licensee also discussed the two additional events. Licensee corrective actions discussed in the pre-decisional enforcement conference, in the response to the Notice of Violation, and in the associated LER (282(306)/97-01), addressed all three heavy load events and the heavy load control program in general.

Unit 2 Aux Bldg Trench
