IOWA STATE  
UNIVERSITY

September 27, 1973

Docket: 50-116

Subject: Malfunction of the UTR-10 Shim-safety Rod

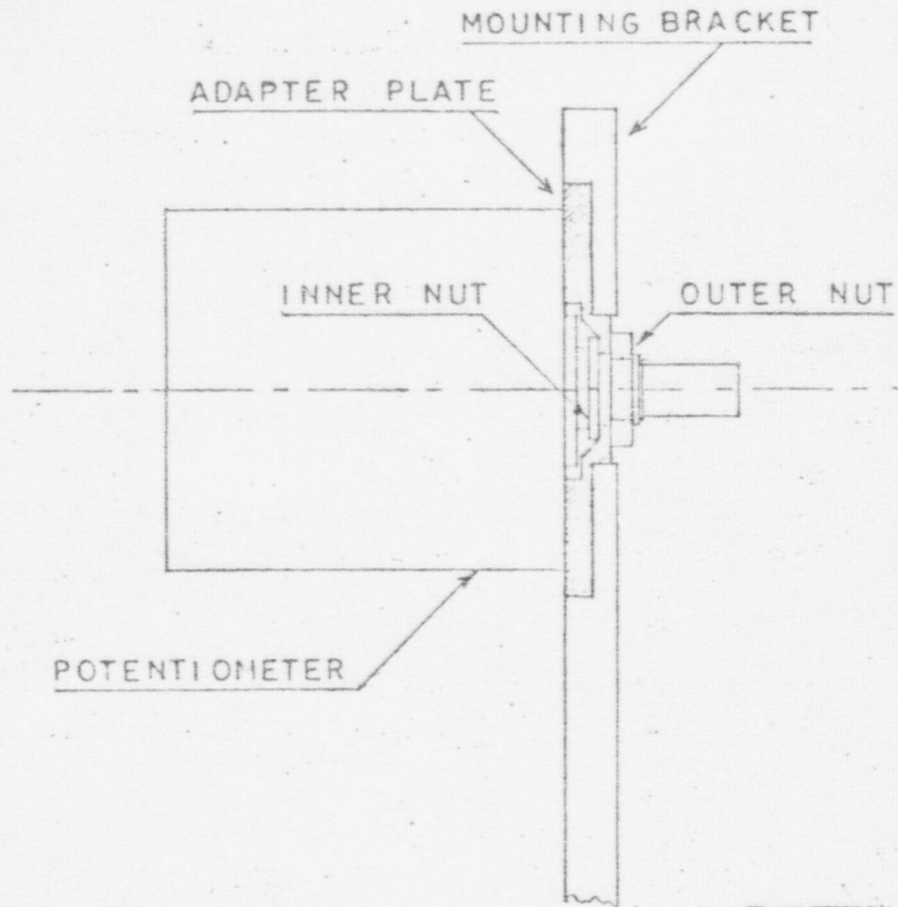
FIGURE 1a

Inspection of the rod drive unit showed that the position potentiometer mounting nut was loose allowing the potentiometer gear to mismatch with the rod drive gear. The mismatch prevented normal spring-force insertion.

BEFORE

Two modifications were initiated. The potentiometer mounting hardware was changed to permit use of a lock washer. See Figures 1a and 1b. A fiducial mark was added to the nut and mounting bracket

to indicate during visual inspection if nut rotation has occurred. Second, the inspection interval has been reduced to six months.

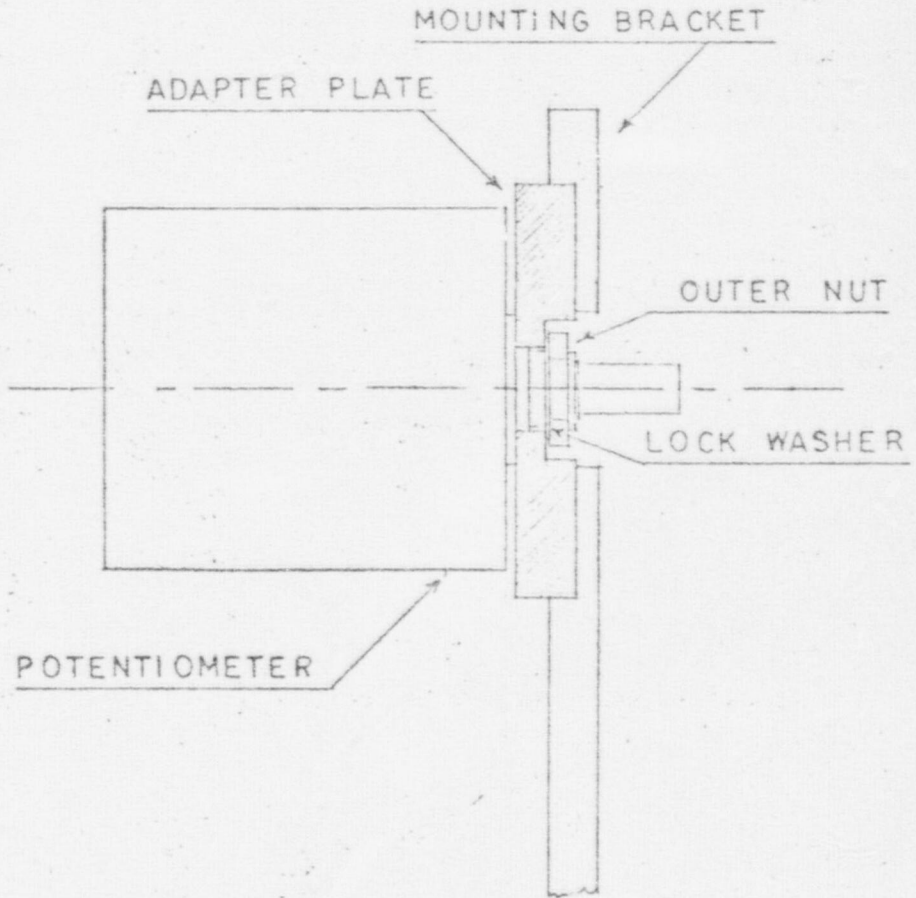
FIGURE 1b

AFTER
