U.S. NUCLEAR REGULATORY COMMISSION
REGION IV

Report No.: 50-445/97-09
50-446/97-09

Facility: Comanche Peak Steam Electric Station, Units 1 and 2

Dates: March 17-21, 1997

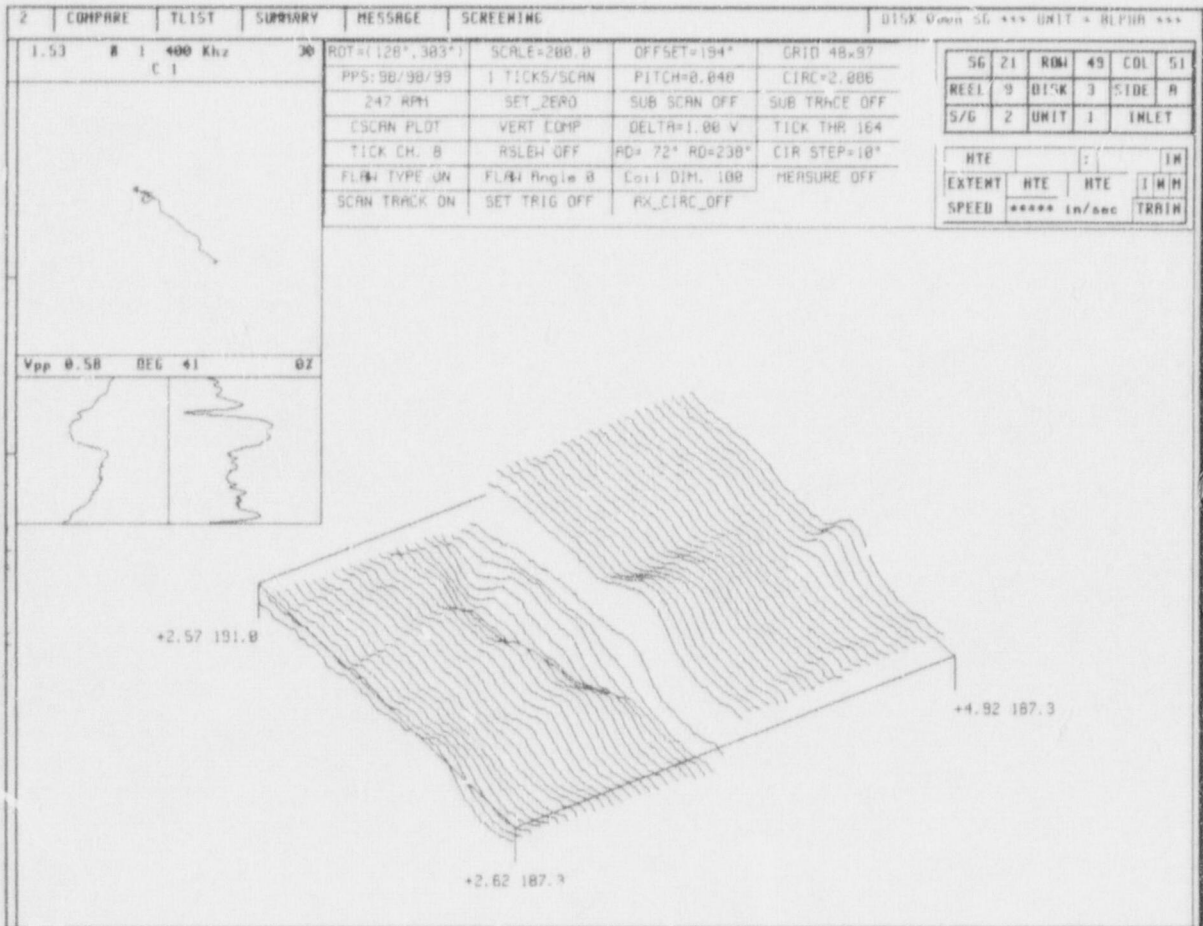
sensitive coil. These tubes showed long signals in the axial direction that had "bumps" at regular intervals. The NRC consultant reviewed the 1995 data from the following Steam Generator 2 tubes that exhibited this anomaly: R45, C43; R47, C55; R49, C51; and R49, C61. The phase of these signals was observed to not rotate like a defect above or below the tube sheet as the frequency was changed. However, the intersection of these signals with the expansion transition region did produce a signal on some of the frequencies that could be interpreted to represent a defect with an approximate inside diameter location. The licensee concluded in 1995, after detailed review and performance of supplementary ultrasonic examinations, that the signal anomalies were not evidence of the presence of defects. The NRC consultant reviewed the data produced for the same tubes in the 1996 Refueling Outage 1RF05 examinations. These examinations were performed using a probe containing a plus point coil and two pancake coils. (See Section E1.1 below for additional probe information). The signal was noted to be present in the data from the pancake coils, and greatly reduced in the plus point data (particularly away from the expansion transition region). Figure 1 shows an example of the signal anomaly as exhibited by the plus point coil. Figure 2 shows the phase for an anomaly at different frequencies. In some instances, a small, low-voltage defect-like signal could be found on the plus-point channel in this region, but it was well within the noise. The NRC consultant concurred with the licensee position that the available information did not support classification of these signal anomalies as defects. The inspector considered the only feasible method for determination of the reasons for the anomalies would be removal of a tube sample from a steam generator for laboratory examination.

Figure 1 Anomaly at the top of the tube sheet for tube Row 49 Col 51

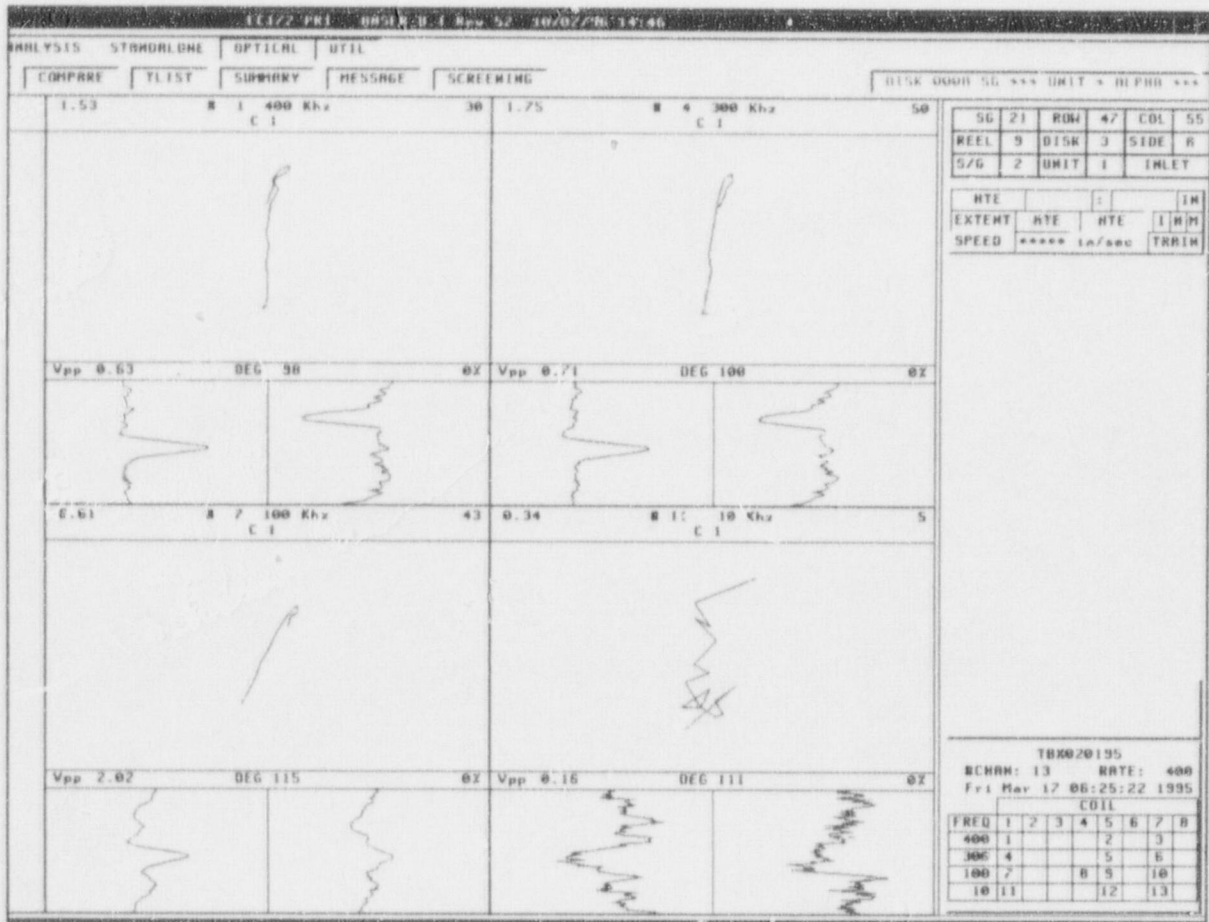
Figure 2 Phase at different frequencies for a anomaly

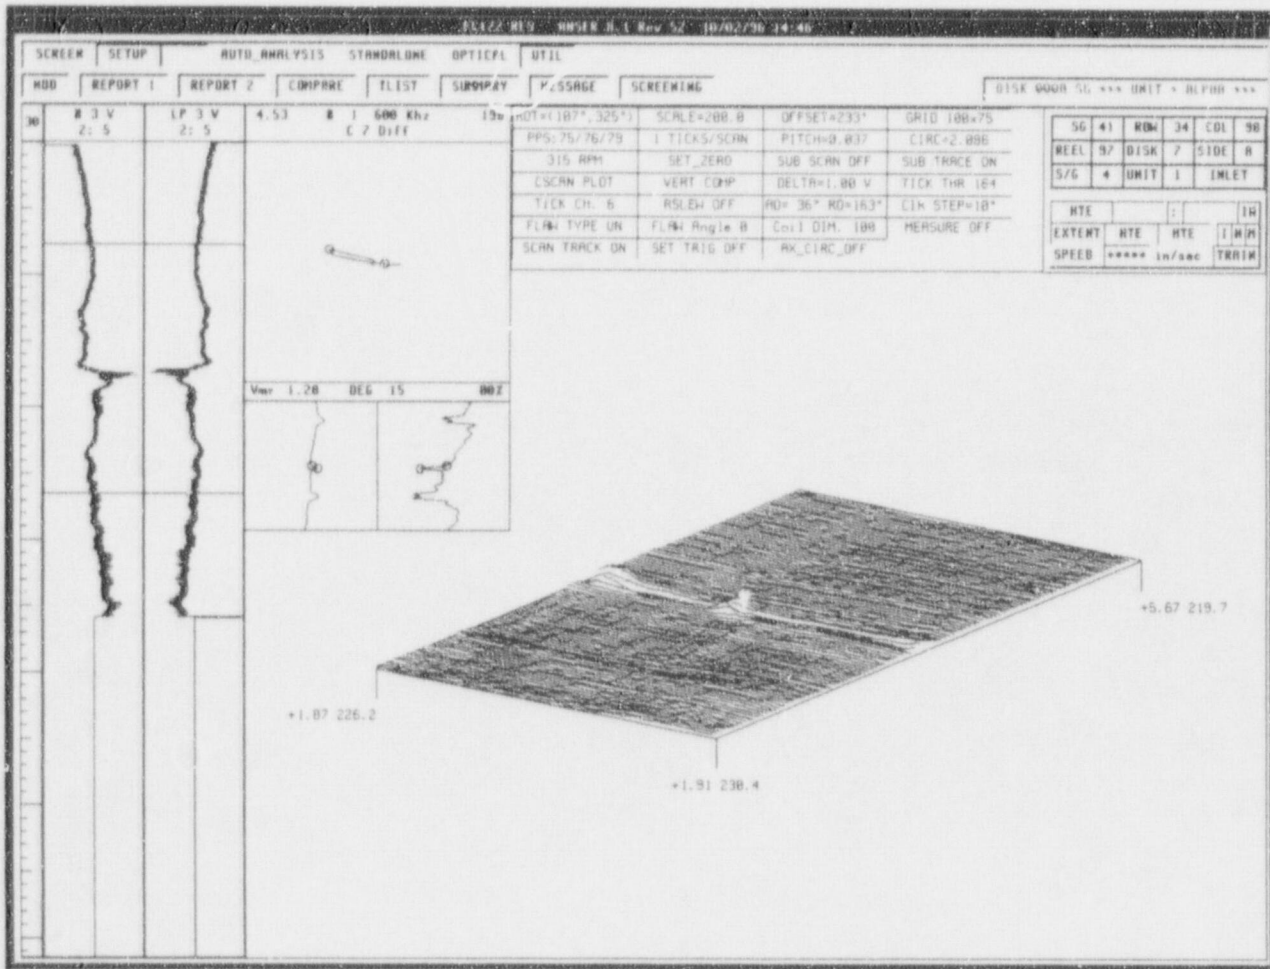
The NRC consultant reviewed the eddy current data from the following tubes, which had been called as containing defect indications and subsequently plugged: Steam Generator 2 - Tubes R23, C44, R43, C47, and R1, C98; Steam Generator 4 - R26, C104 and R34, C98. All of the calls appeared to be correct with one exception. The NRC consultant determined that Tube R34 C98 of Steam Generator 4 appeared to contain an inside diameter axial crack rather than the outside diameter axial crack that was called. Eddy current information for this defect indication is shown in Figures 3 and 4. There were two axial cracks noted to be present, with one of them close to 100 percent through the wall. Most of the data indicated an inside diameter indication, with the 0.080-inch pancake coil further confirming inside diameter cracking by exhibiting a larger signal at a 800 kHz frequency than that shown at 600 kHz.

Figure 3 Defect at the top of the expansion transition showing an id phase at 600 kHz

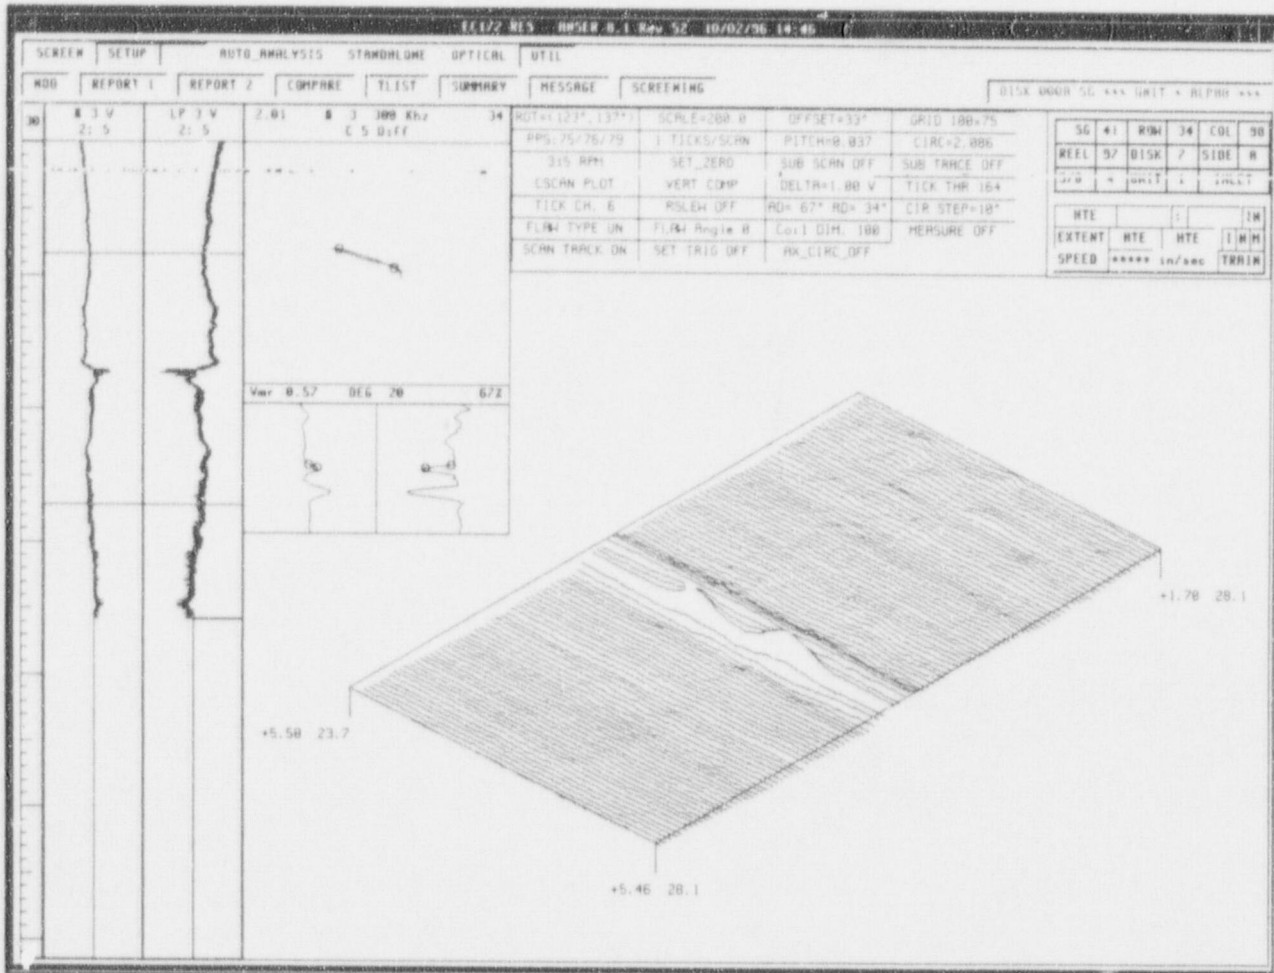
Figure 4 Defect at the top of the tube support showing an id phase at 300 kHz
