HYDRAULIC TRANSIENT
IN MAIN FEEDWATER
DURING FILLING OF STEAM
GENERATORS

SOUTH TEXAS PROJECT
DOCKET NO. STN-50-498
HOUSTON LIGHTING AND POWER COMPANY

JANUARY 1988

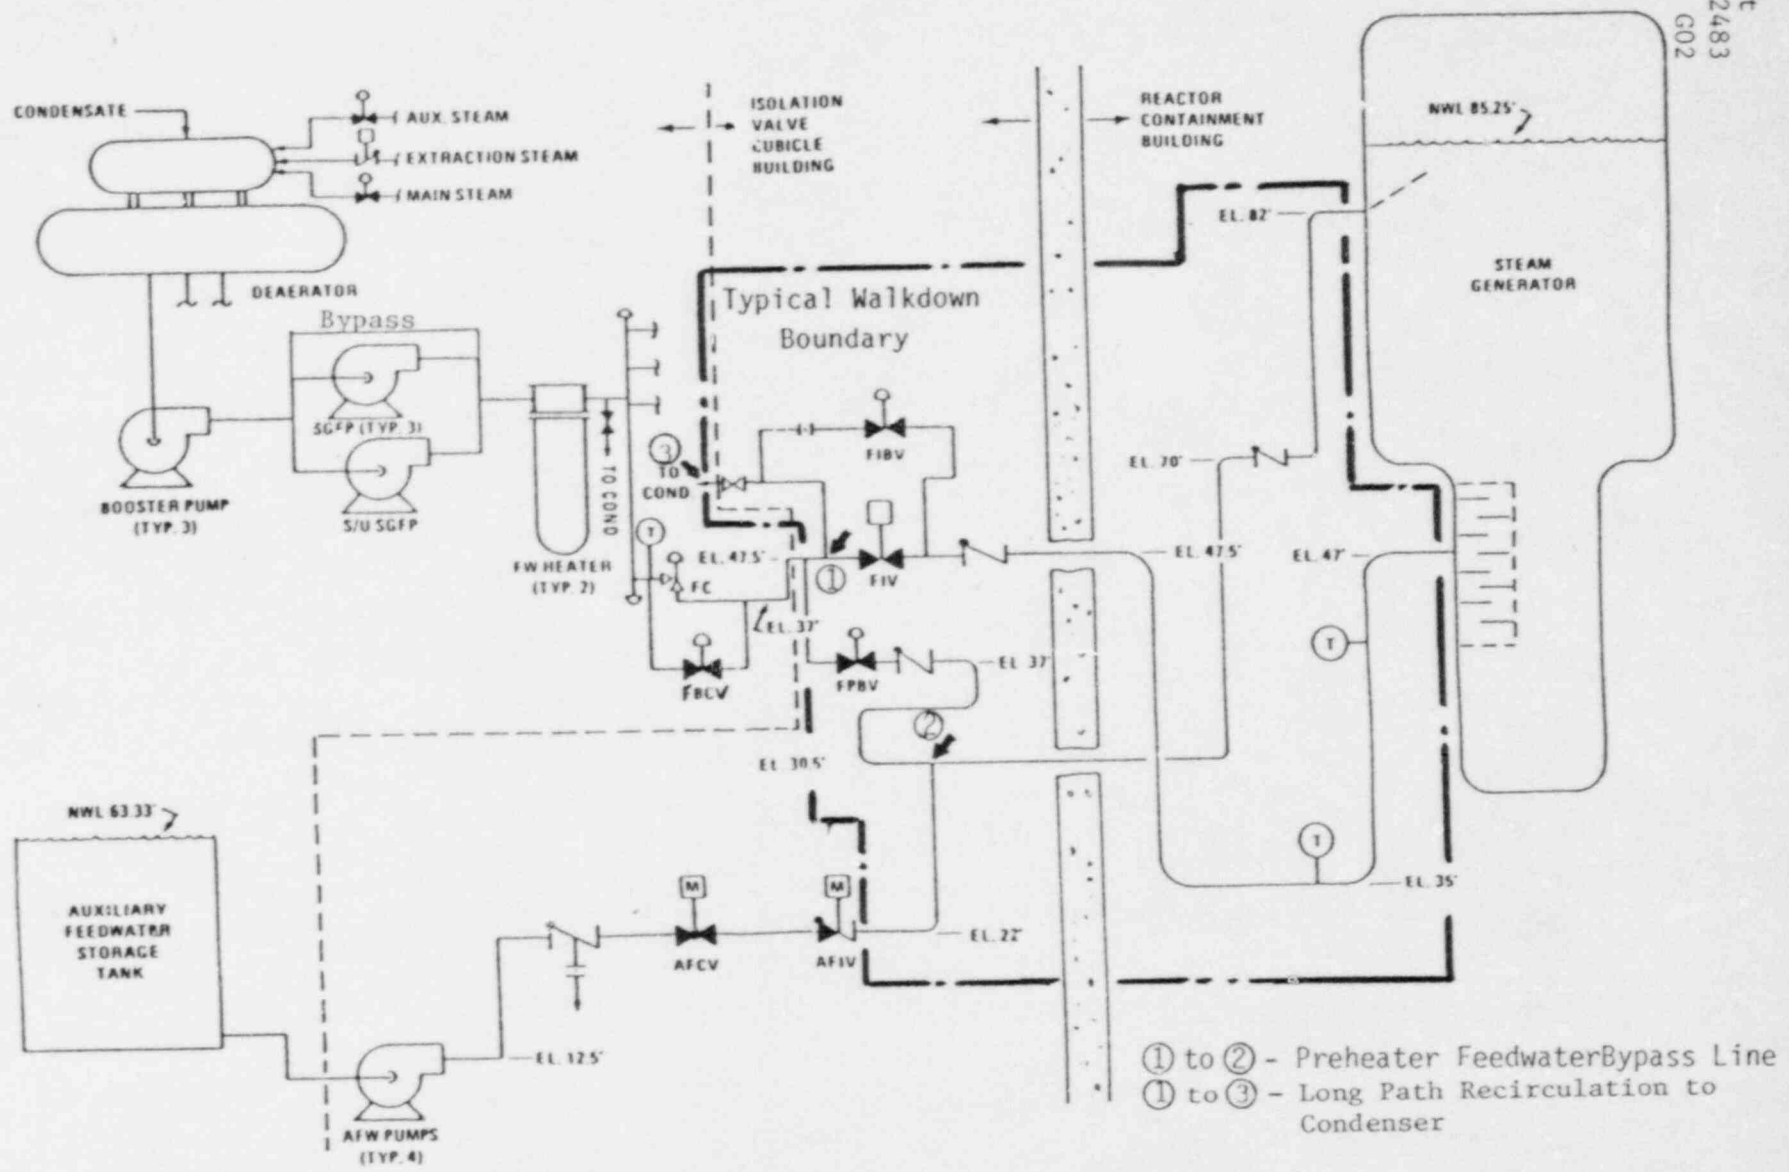
Figure 1 depicts the applicable portions of the main feedwater and auxiliary feedwater systems that are required for makeup to the steam generators. The upper nozzle of the steam generator can be fed from either the main feedwater system via the FPBV or the auxiliary feedwater system. Makeup to the steam generators from main feedwater to the lower steam generator nozzle is prohibited if the feedwater temperature is less than 250 °F.

The hydraulic transients were of short duration and no damage was observed. A walkdown was performed of pipe supports on the affected piping (see Figure 1). Vents and drains were inspected at the welds and heat affected zones for cracks. Also inspected were locations where the piping is routed in close proximity to other commodities i.e., elec/HVAC supports, penetrations, pipe supports, for evidence of damage to pipe or insulation that would indicate excessive movement. No evidence of physical damage or excessive movement was identified.

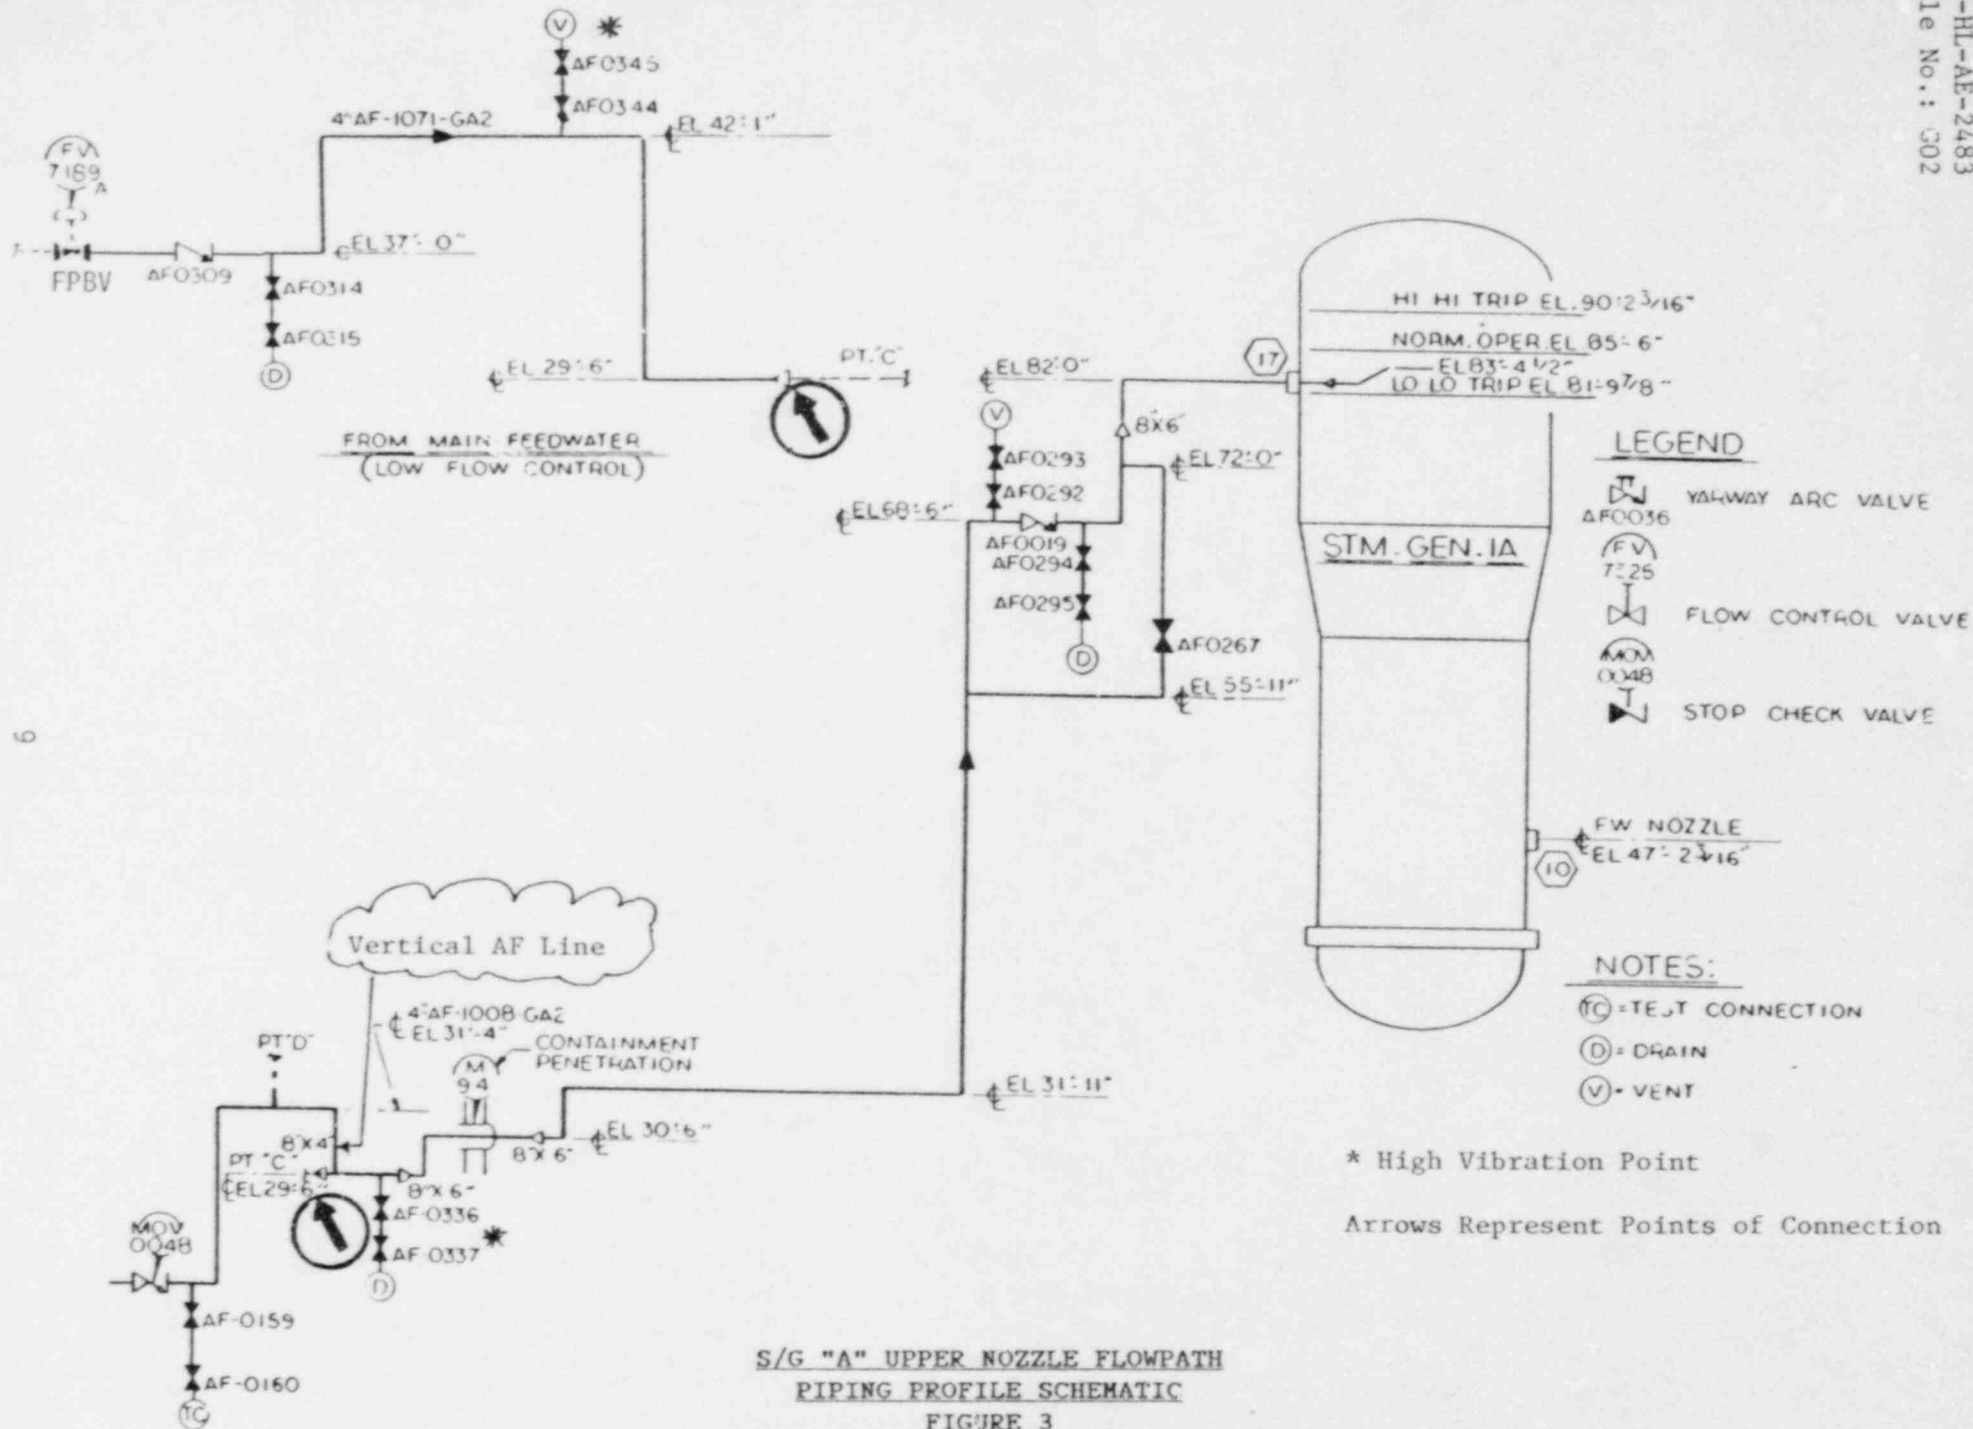
The piping profile schematic for each of three upper nozzle flowpaths in use during the events are shown in Figures 3, 4 and 5. The figures identify the areas where the greatest vibration was observed as well as the auxiliary feedwater and main feedwater interface. As can be seen from these diagrams, there is 52.5 feet of static head between the upper nozzle and the interface. Also, the configuration of A and B at this interface is different than C. The auxiliary feedwater line in flowpath C connects horizontally to the feedwater line, whereas on A and B the auxiliary feedwater line connects vertically. This has significance as explained in Subsection (C) of this section as to why C did not experience a hydraulic transient while feeding the upper nozzle.

Vents and drains in the affected piping were visually inspected. No damage was found. Non-Destructive Examination (NDE) was performed at two locations, one vent and one drain valve, specifically identified by the operators as having the largest displacements (See Figure 3). No damage was found.
