Fort St Vrain

REPORT OF HELIUM CIRCULATOR
S/N C-2101 AND INLET PIPING S/N 2001
REPAIR AND MODIFICATION ACTIVITIES

January 22, 1988

FORT ST. VRAIN
NUCLEAR GENERATING STATION
Public Service Company of Colorado

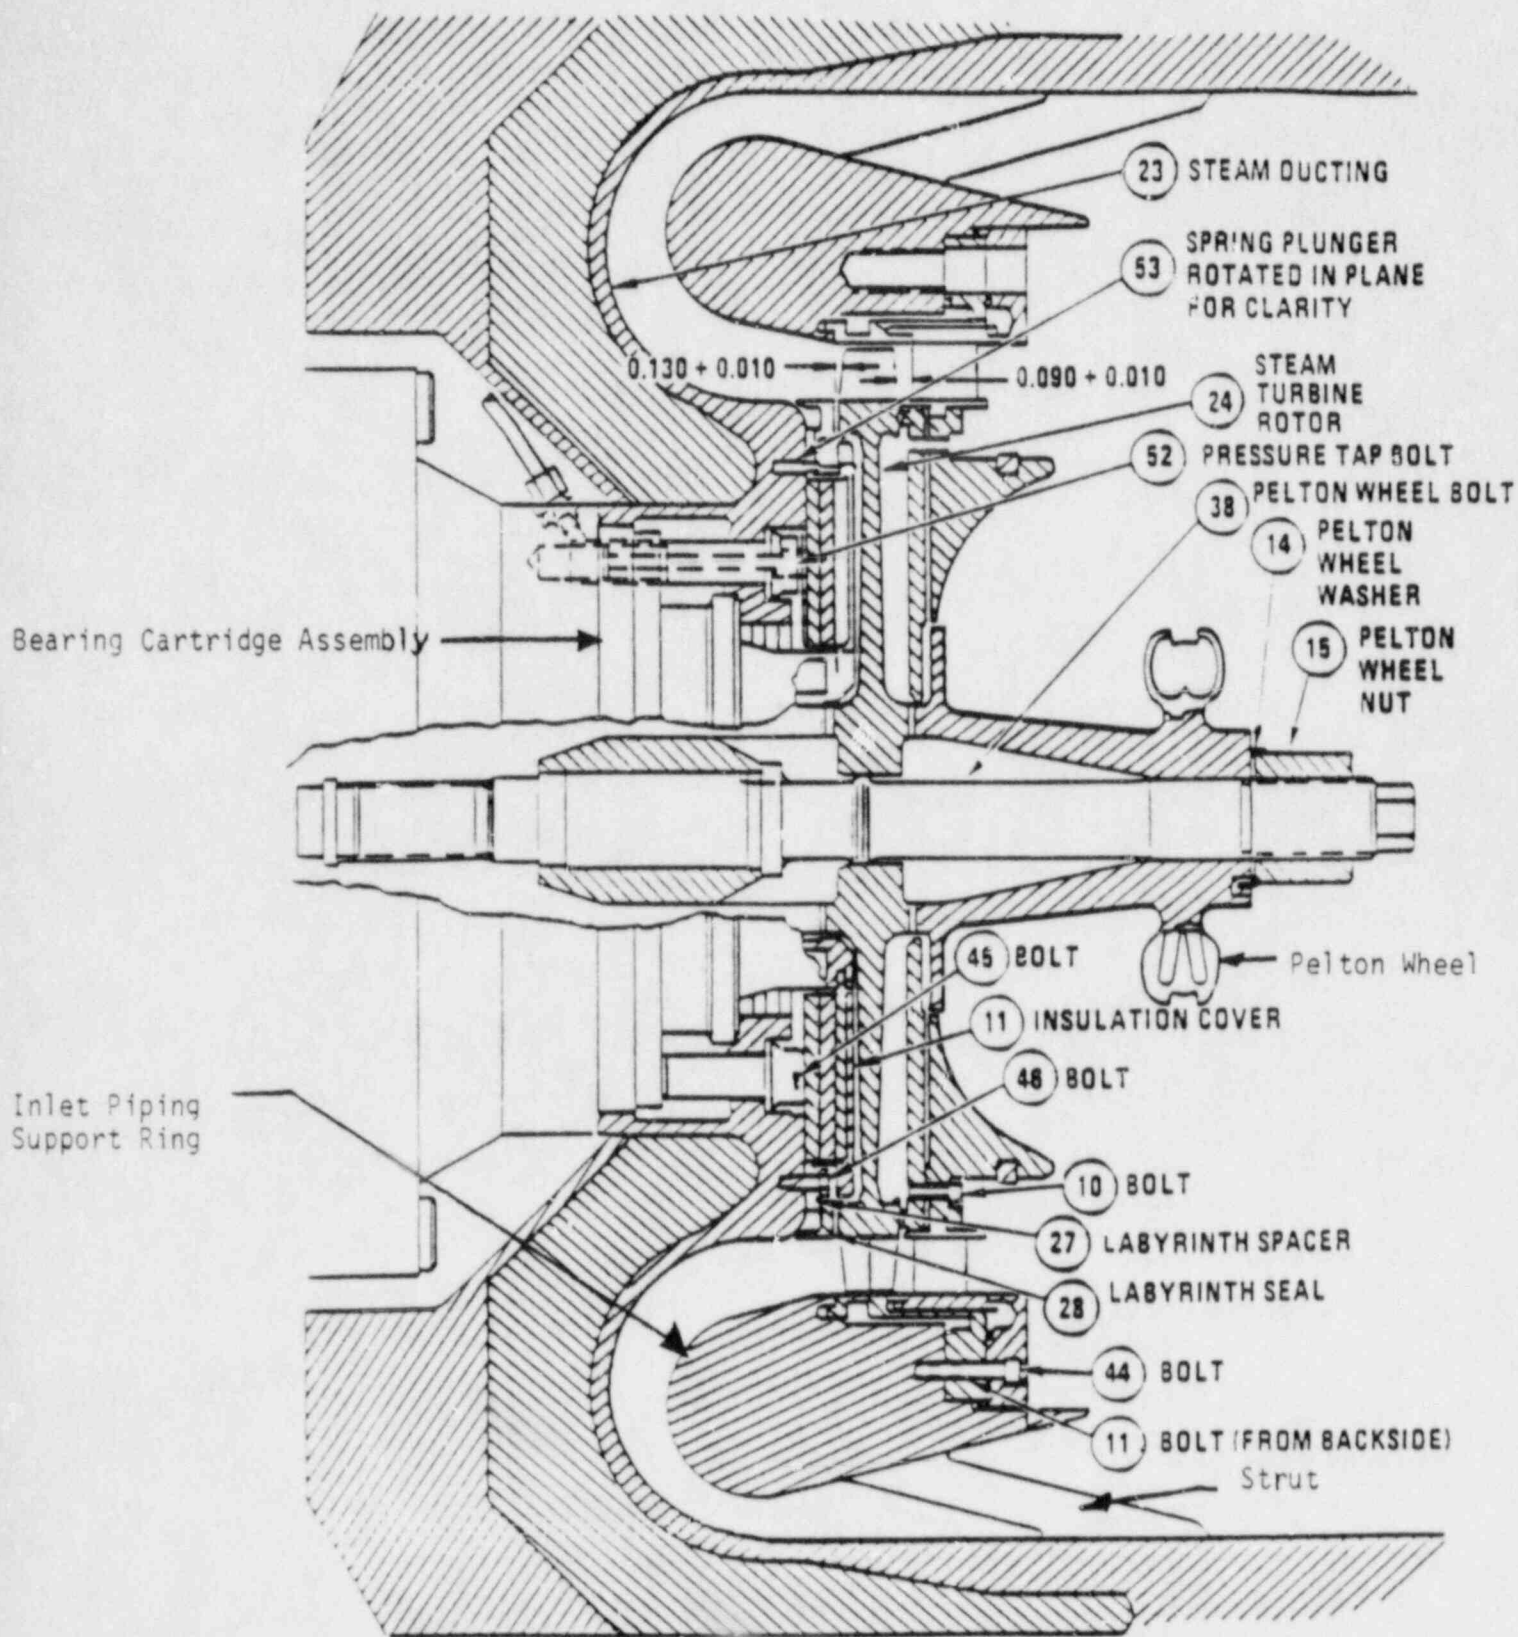
FIGURE 1

Two of the fifteen 3/4 inch diameter bolts (14 solid core, 1 center drilled), which secure the bearing cartridge to the steam ducting, were broken off with their head sections missing and their threaded sections still present in their locating holes. One of the fourteen solid core bolts (90-C2101-300-45) had failed in the shank. After removal, one more -45 bolt was found cracked near total failure in the shank approximately 1" below the bottom of the head. The pressure tap bolt (90-C2101-300-52) had failed in the shank above the first thread. This center drilled bolt provides the means of sensing the static pressure on the downstream side of the turbine wheel.

CIRCULATOR STEAM TURBINE/PELTON WHEEL DETAIL

Part of the metallic debris trapped in the upper dished face of the turbine wheel was identified as the remnant of the head of either the missing -45 or -52 bolt previously referenced. During inspection of the vacant steam ducting counterbore hole for the missing -52 bolt head, a fine hair-like crack was observed, running the length of the bore. The crack did not extend to the apex of the collar where the interspace seal is made nor did it penetrate through the steam ducting weldment to have caused an interspace leak.

The counter bores in which the 3/4" bolt heads seat, (C2101-300-45, -52) currently have a square edge on them. This edge contacts the fillet radius at the bolt shank to head interface, which could result in a line of stress concentration upon contact. To eliminate this stress concentration point, the counter bore edge will be chamfered. This modification will be implemented during the initial bolt replacement program.

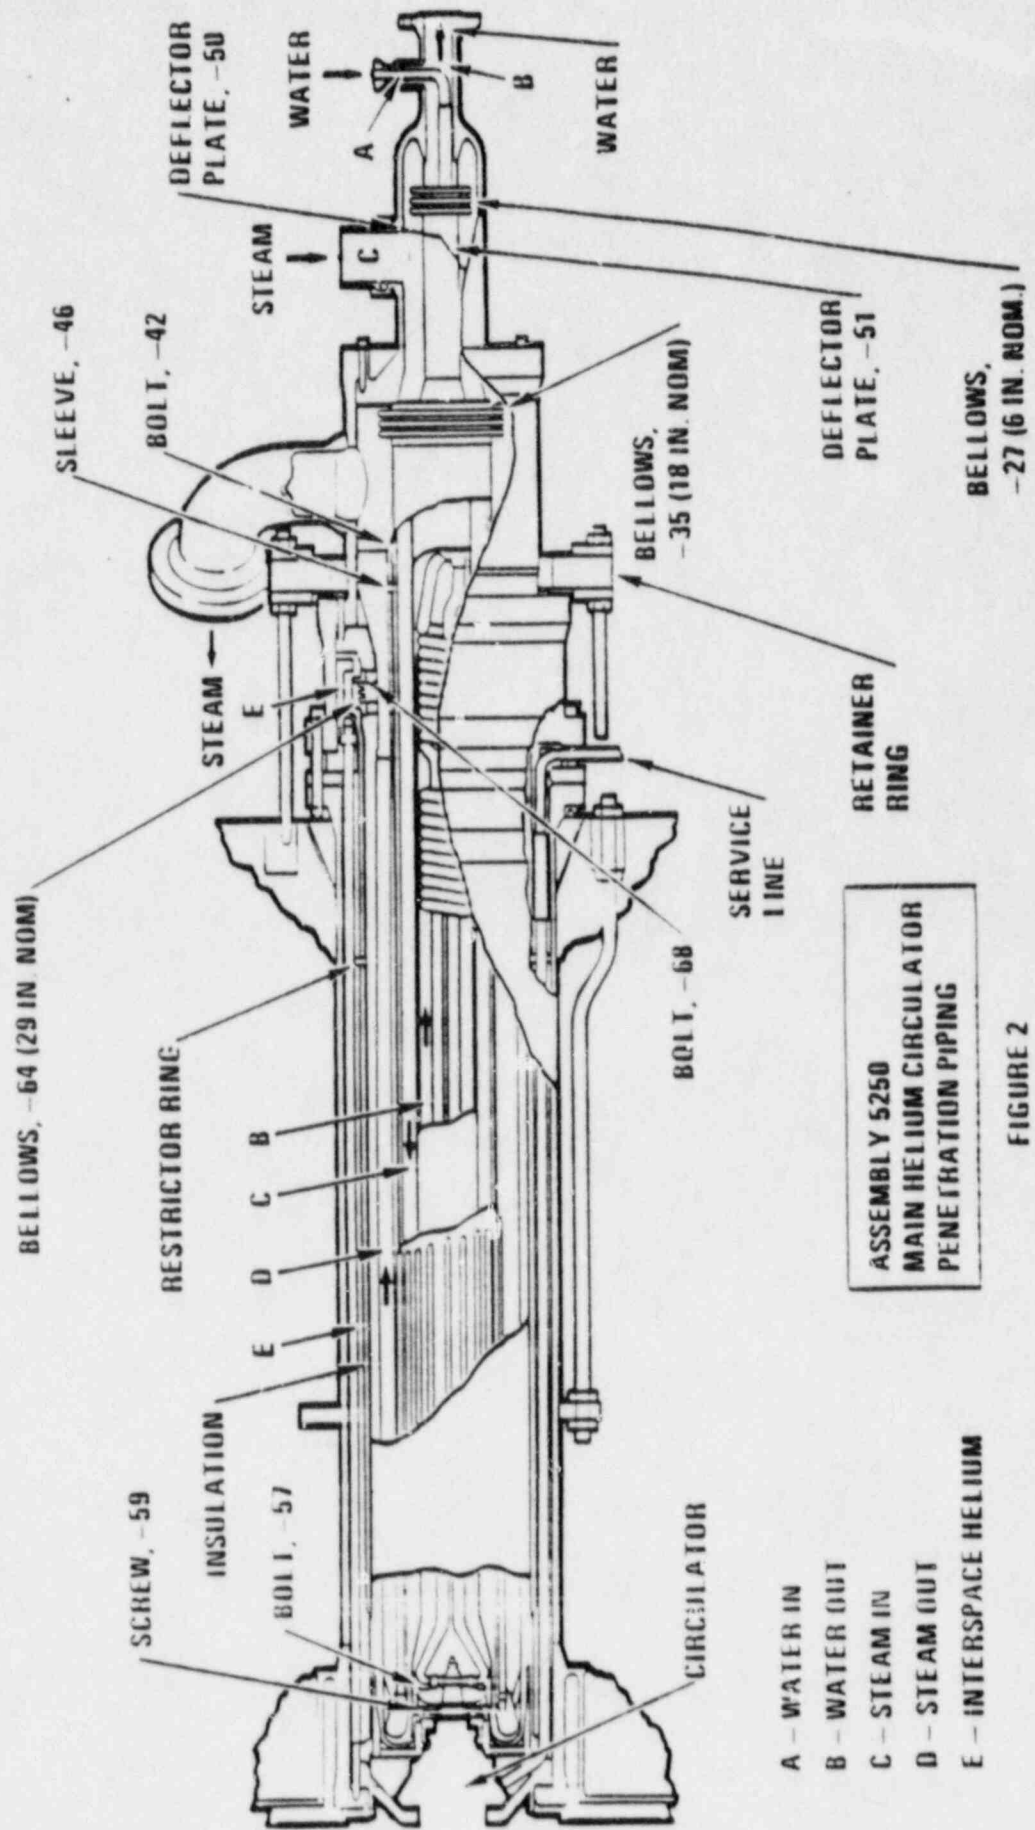
Inner piping assembly S/N 2001 was also sent to GA Technologies for inspection, repair and certain previously identified modifications. No failures were observed in bolts and fasteners associated with the inner piping. Each of the convolutions in the 6" bellows was found cracked. This failure is common to all inner piping assemblies repaired to date. Modification of the expansion joint is being implemented to eliminate this type of failure. A crack in the steam deflector weld was also found. This weld cracked due to insufficient weld depth and has been repaired. Figure 2 shows details of the penetration and inner piping.
