UNITED STATES
NUCLEAR REGULATORY COMMISSION
REGION V

1. IE Circular No. 78-18
2. List of IE Circulars
Issued in 1978

UL FIRE TEST

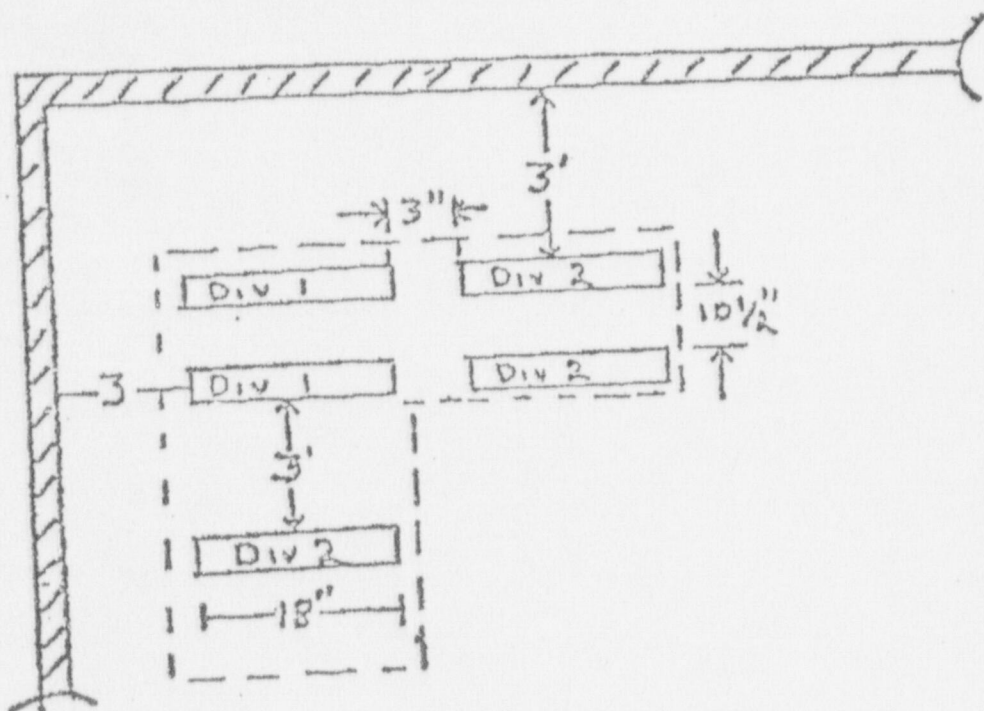
Figure 1

Vertical Tray Corner Test

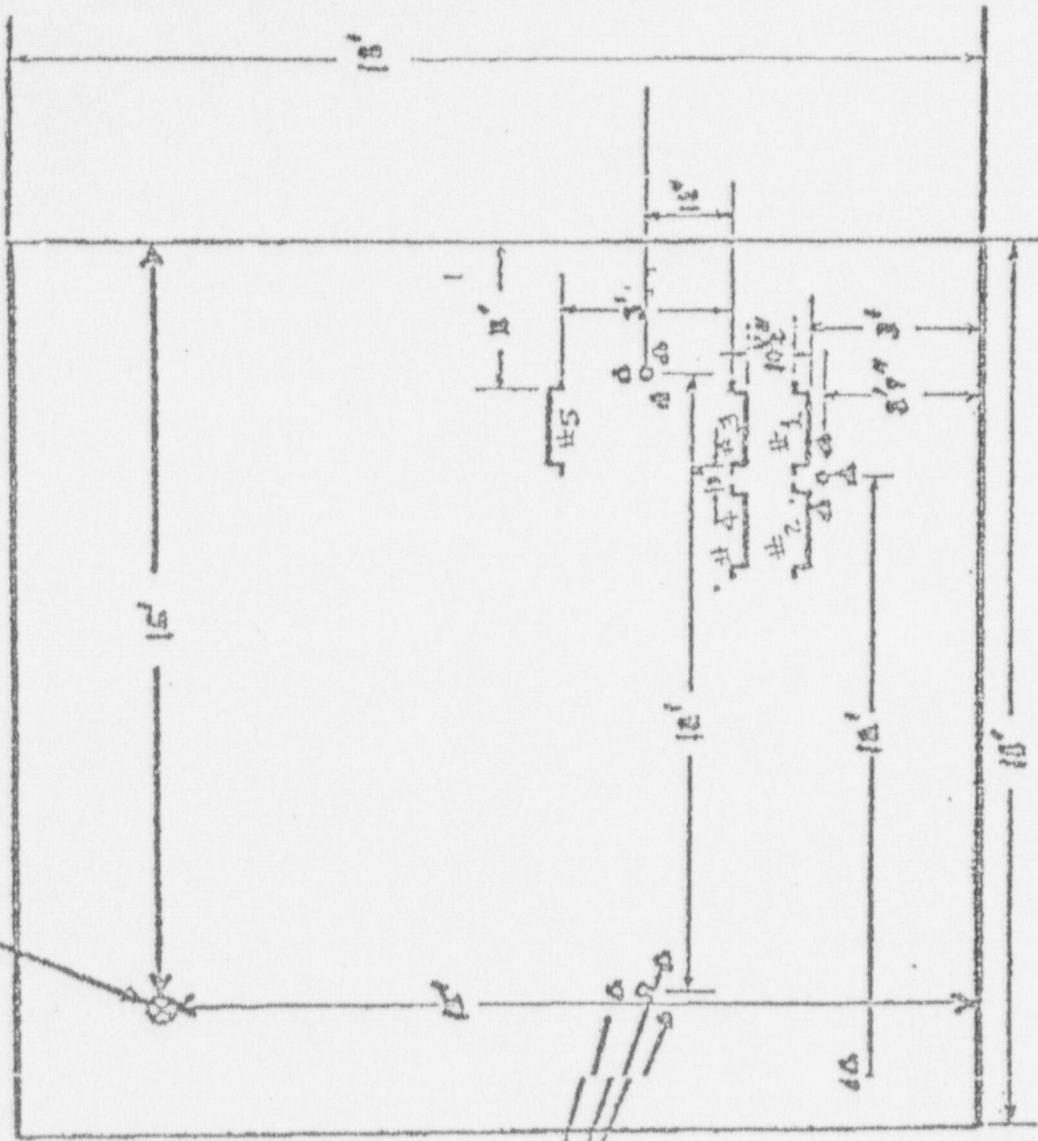
FIGURE 2
TOP VIEW GENERAL

Each sprinkler location in the test arrangement contained three nominally identical temperature sensing sprinkler heads with fusible links adjacent to an open sprinkler head which was connected to a manual water supply valve. The temperature sensing heads were wired to signal when their links fused. After all three temperature sensing heads at a given location activated, then the water supply for the open head was to be manually admitted. The sprinklers were of a type which actuate at the slow end of acceptance for reaction time. The test procedure required that all three temperature sensing heads had to activate before water would be turned on. In this way, it was expected to get some data on variability in the response time of identical sprinklers.
