UNITED STATES
NUCLEAR REGULATORY COMMISSION
OFFICE OF INSPECTION AND ENFORCEMENT
WASHINGTON, D. C. 20555

IE Circular 78-18

UL FIRE TEST

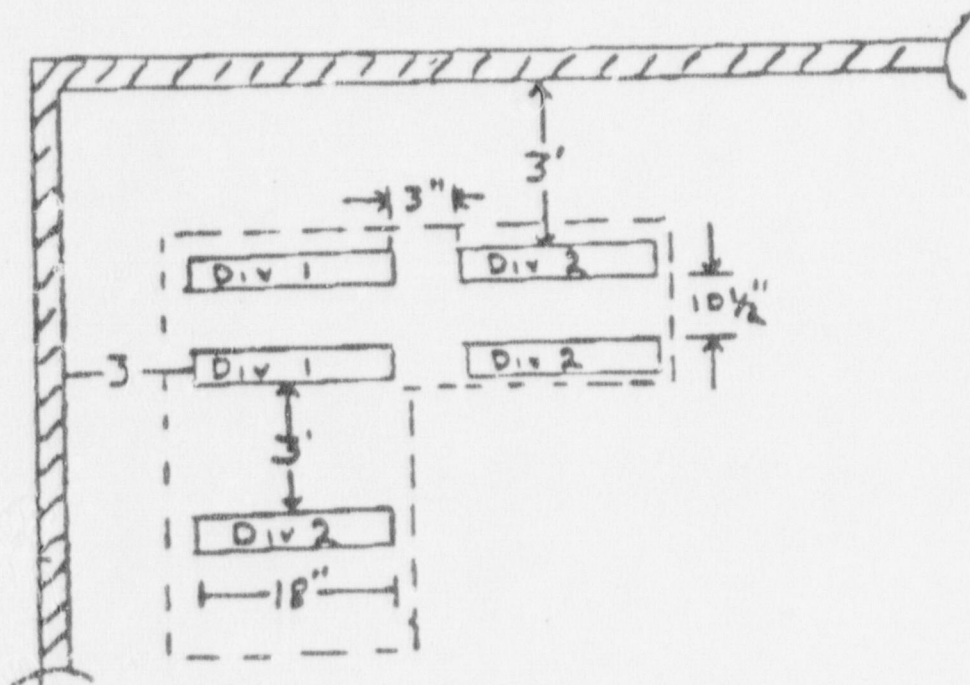
Figure 1

Preliminary information indicates that the flammable liquid or flames penetrated the protective barriers at the bottom of the vertical trays and caused fire damage to the polyvinyl chloride insulation on cables in four of the five trays.

The most probable cause of the fire damage in certain cable trays appears to be related to the absorption or seepage of heptane under the ceramic fiber blanket at the juncture with the floor. Once the heptane entered the interior regions of the cable tray, then ignition apparently occurred via the small opening at the floor or through a vapor/air path within the joints. There is some indication that some cable damage was caused by absorption of heptane on the inside of the barrier (wicking effect) and its ignition which heated a cable tray ladder rung, causing damage to a cable in contact with the rung. The ingress of the heptane into the ceramic fiber needs to be further evaluated since this appears to be the most significant failure mode.

Vertical Tray Corner Test

1. To protect against spills of flammable liquids, barriers or curbs may be needed to prevent entry of the flammable liquid behind fire barriers. A wick effect may also need to be considered in the design of fire barriers.
2. Some small fires may not actuate sprinkler heads. To reduce this possibility in sprinkler systems to be installed, fast response sprinkler heads should be considered (less than approximately 3 minutes in the UL Standard 199 "Automatic Sprinklers for Fire Protection Service").
3. The location of the fire detection devices and the sprinkler heads relative to the fire and components being protected is of great importance. The path of the air movement in the area influences the actuation of such devices and should be considered in the system layout.

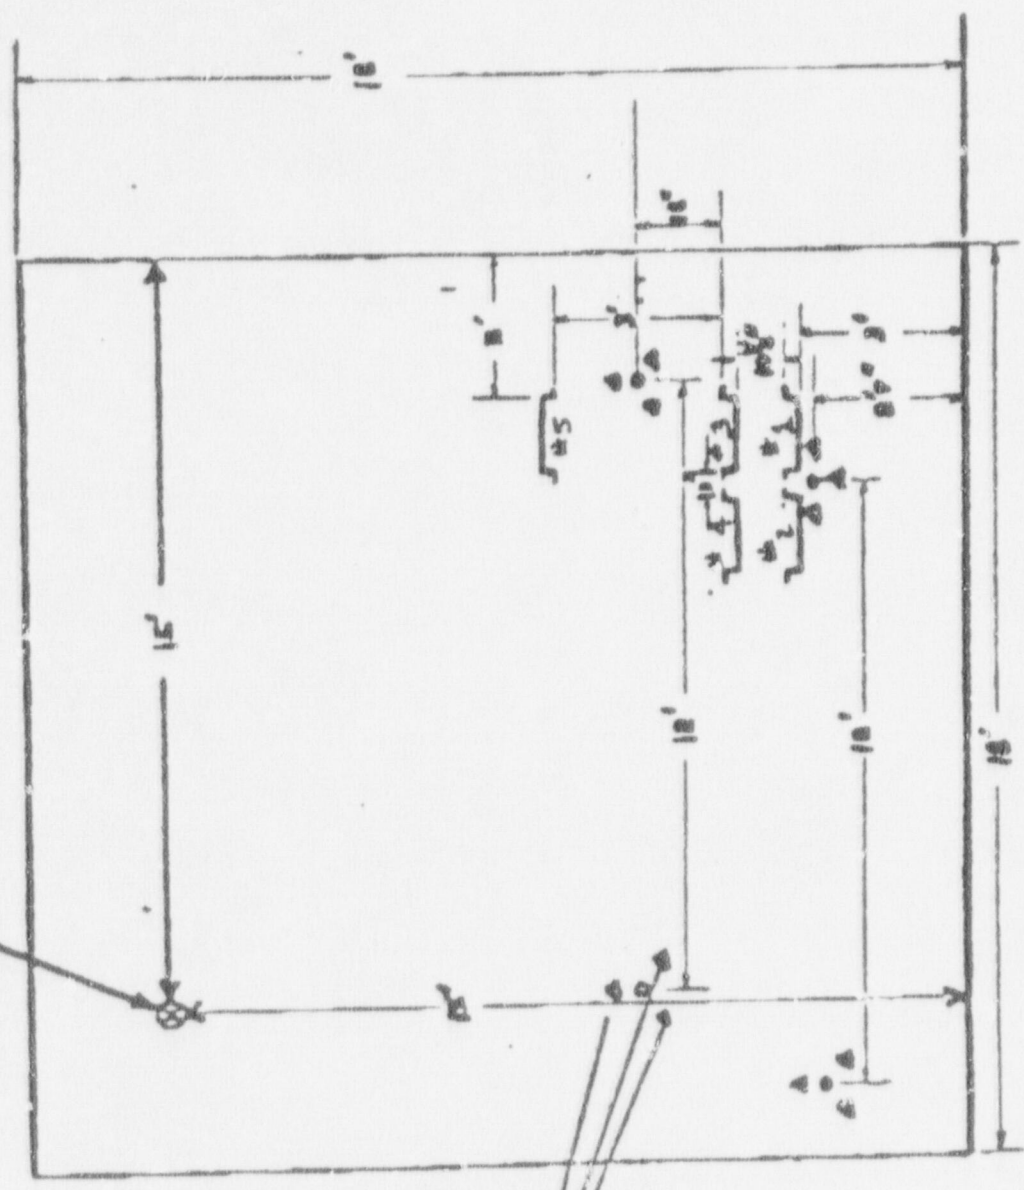
FIGURE 2
TOP VIEW GENERAL

Each sprinkler location in the test arrangement contained three nominally identical temperature sensing sprinkler heads with fusible links adjacent to an open sprinkler head which was connected to a manual water supply valve. The temperature sensing heads were wired to signal when their links fused. After all three temperature sensing heads at a given location activated, then the water supply for the open head was to be manually admitted. The sprinklers were of a type which actuate at the slow end of acceptance for reaction time. The test procedure required that all three temperature sensing heads had to activate before water would be turned on. In this way, it was expected to get some data on variability in the response time of identical sprinklers.

The test was started by igniting the two gallons of heptane that was poured into the floor pan. A fully developed fire occurred almost immediately. The ceiling smoke detector alarmed in about 15 seconds. In about 50-60 seconds, two of the three temperature sensing sprinklers located between the wall and cable trays 1 and 2 activated. The fire between cable trays 1, 2, 3, and 4 appeared most intense, apparently because of a chimney effect between the four trays. The flames between cable trays 3 and 5 did not appear to be so intense. The ceramic fiber blanket absorbed some of the heptane so that after the heptane in the pan burned, most of the flame seemed to come from the bottom outside surface of the ceramic fiber blanket. No additional temperature sensing sprinkler heads at any location activated; thus, the sprinkler water supply was not turned on for any of the three sprinkler locations. The apparent slow response of the third temperature sensing sprinkler is being investigated, since this was not intended to be a slow response sprinkler.
