SG-88-03-016

NORTH ANNA 2 STEAM GENERATOR  
TUBE FATIGUE EVALUATION AND  
REMEDIAL ACTIONS REPORT

MARCH 16, 1988

PREPARED BY:  
WESTINGHOUSE ELECTRIC CORPORATION  
SERVICE TECHNOLOGY DIVISION

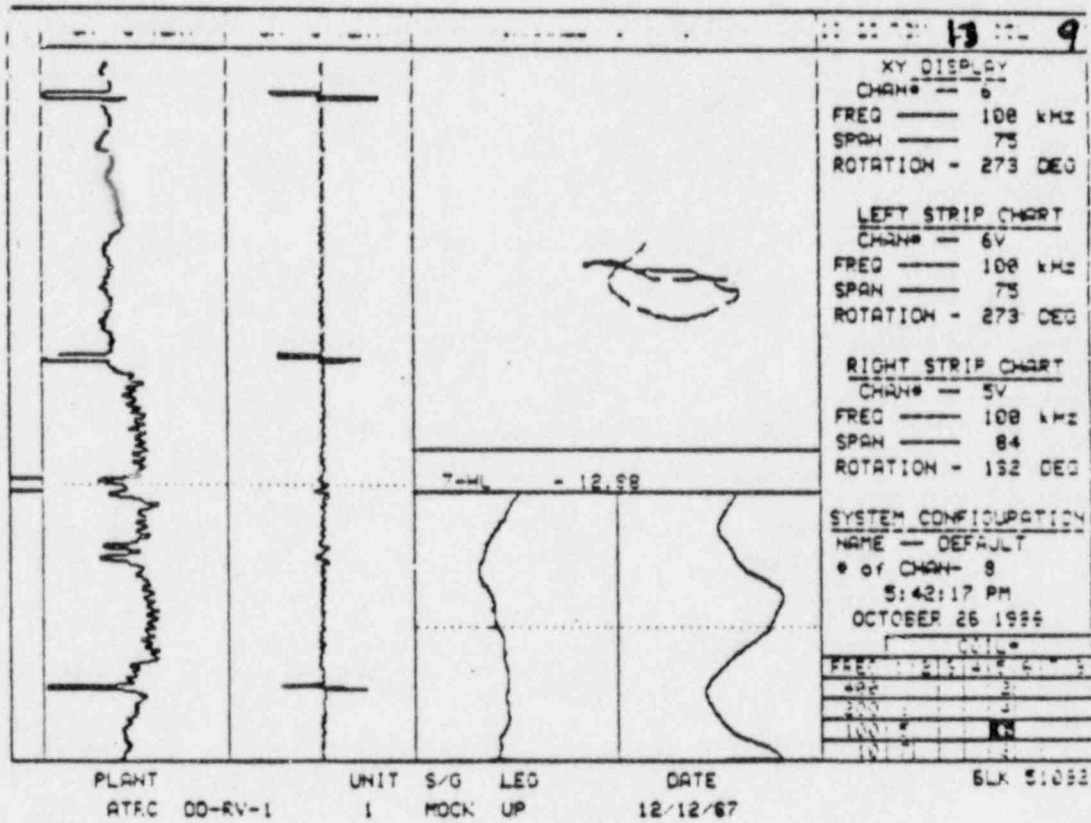
FIGURE 3-1 Typical Eddy Current Signal for AVBs

Since tube supports limit tube vibration potential, an evaluation of the presence or absence of AVB support was needed for each North Anna #2 tube. The minimum depth of AVB insertion in the Series 51 steam generator is to tube Row 11, and in most cases, the actual depth of insertion went to Row 10, 9, 8, and sometimes Row 7. Direct visual or fiberoptic observation of AVB positions would have been difficult and potentially unreliable, therefore, eddy current test information was used to evaluate presence of AVBs. A typical ECT data trace indicating the intersection of an AVB with the tube is shown in Figure 3-1.

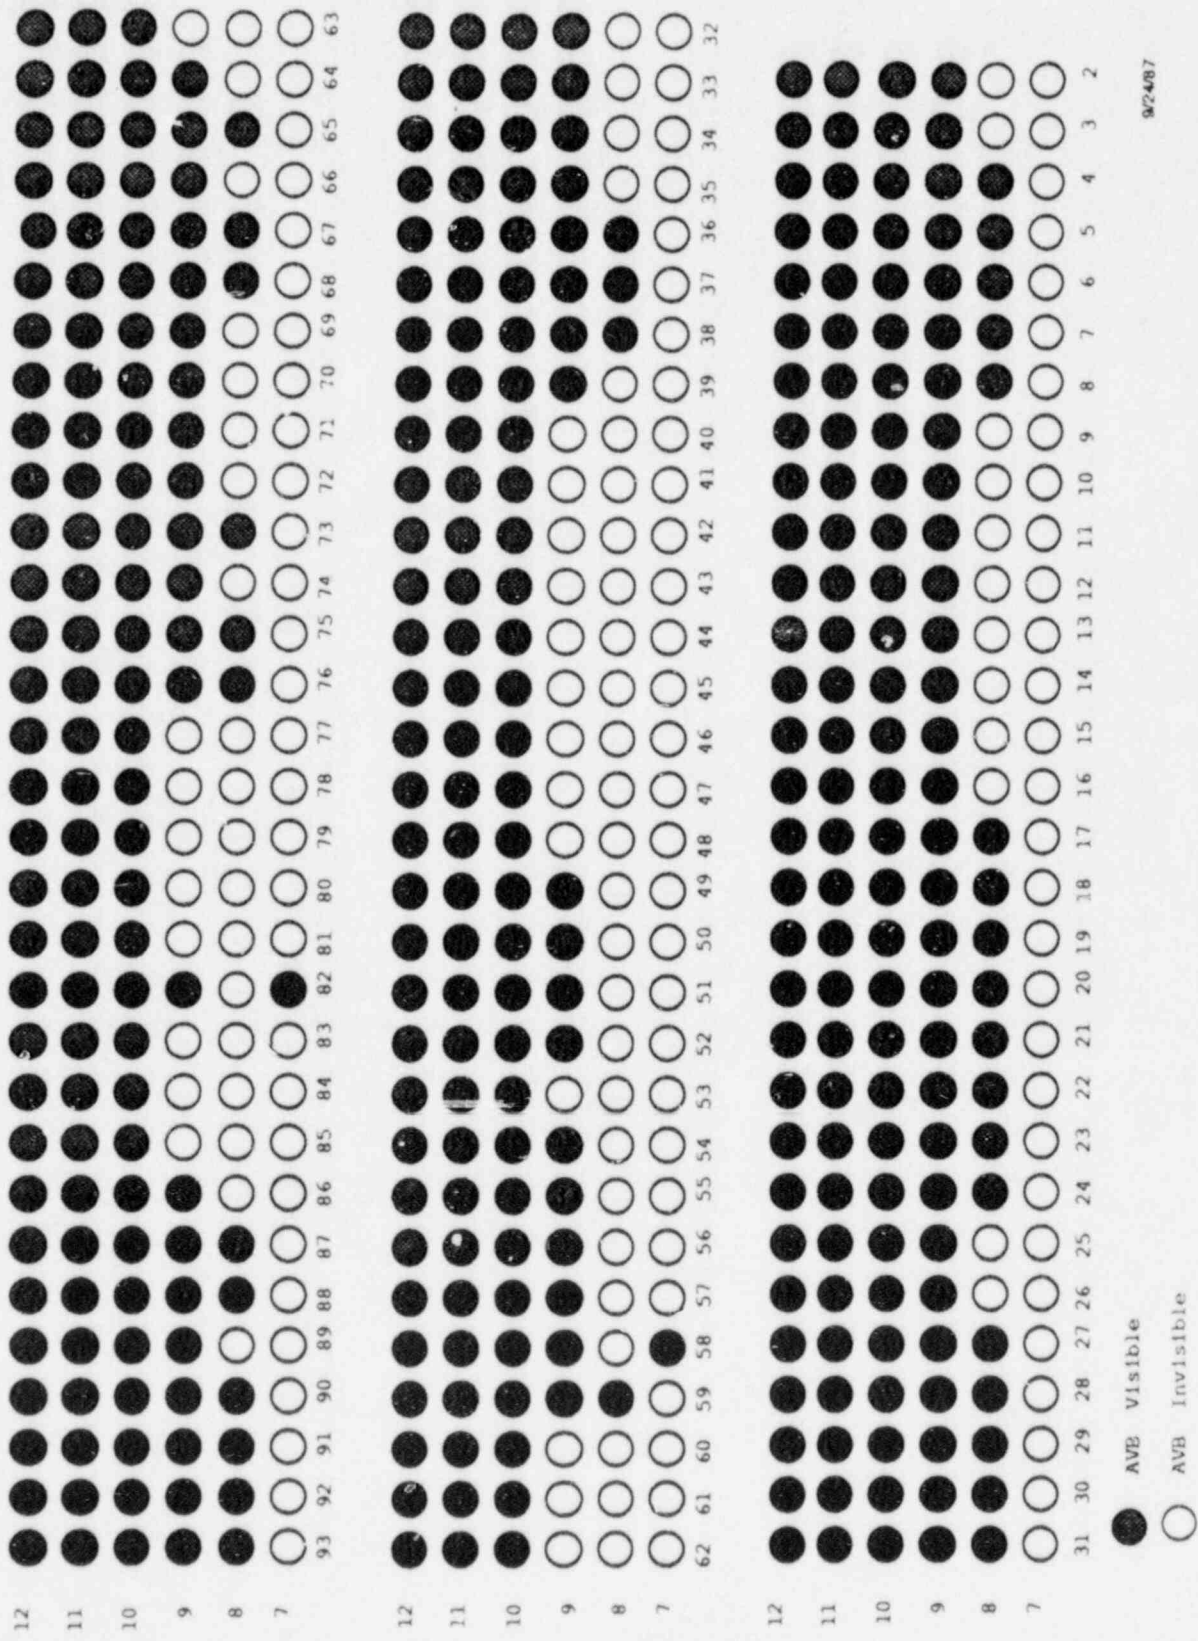
FIGURE 3-2

no AVB eddy current signals were apparent. Initial ECT evaluations of North Anna #2 AVB positions were limited to interpreting whether or not an AVB was "visible" or "invisible". Rows 8 through 12 were examined and "visible" and "invisible" interpretations were made for all tubes. Some anomalies appeared where it is likely that the signals were masked by copper deposits. Figures 3-2 through 3-4 show the "visible" - "invisible" map (without AVBs) in this preliminary stage of data interpretation.

North Anna #2: S/G -A  
AVB Visibility

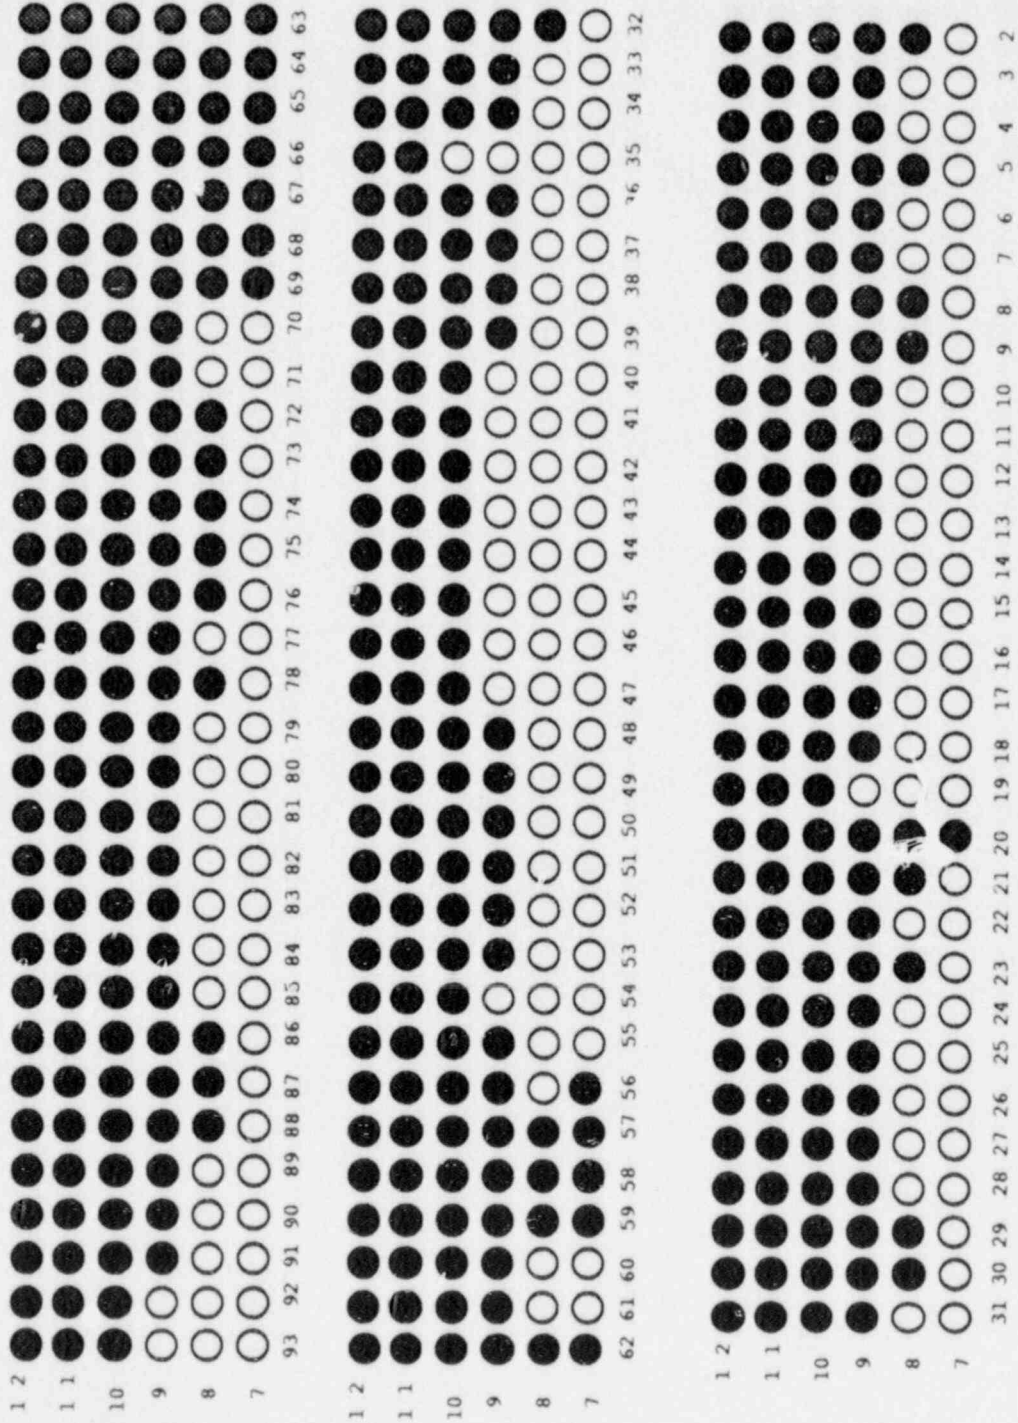
FIGURE 3-3

North Anna - 2: S/G -B  
AVB Visibility

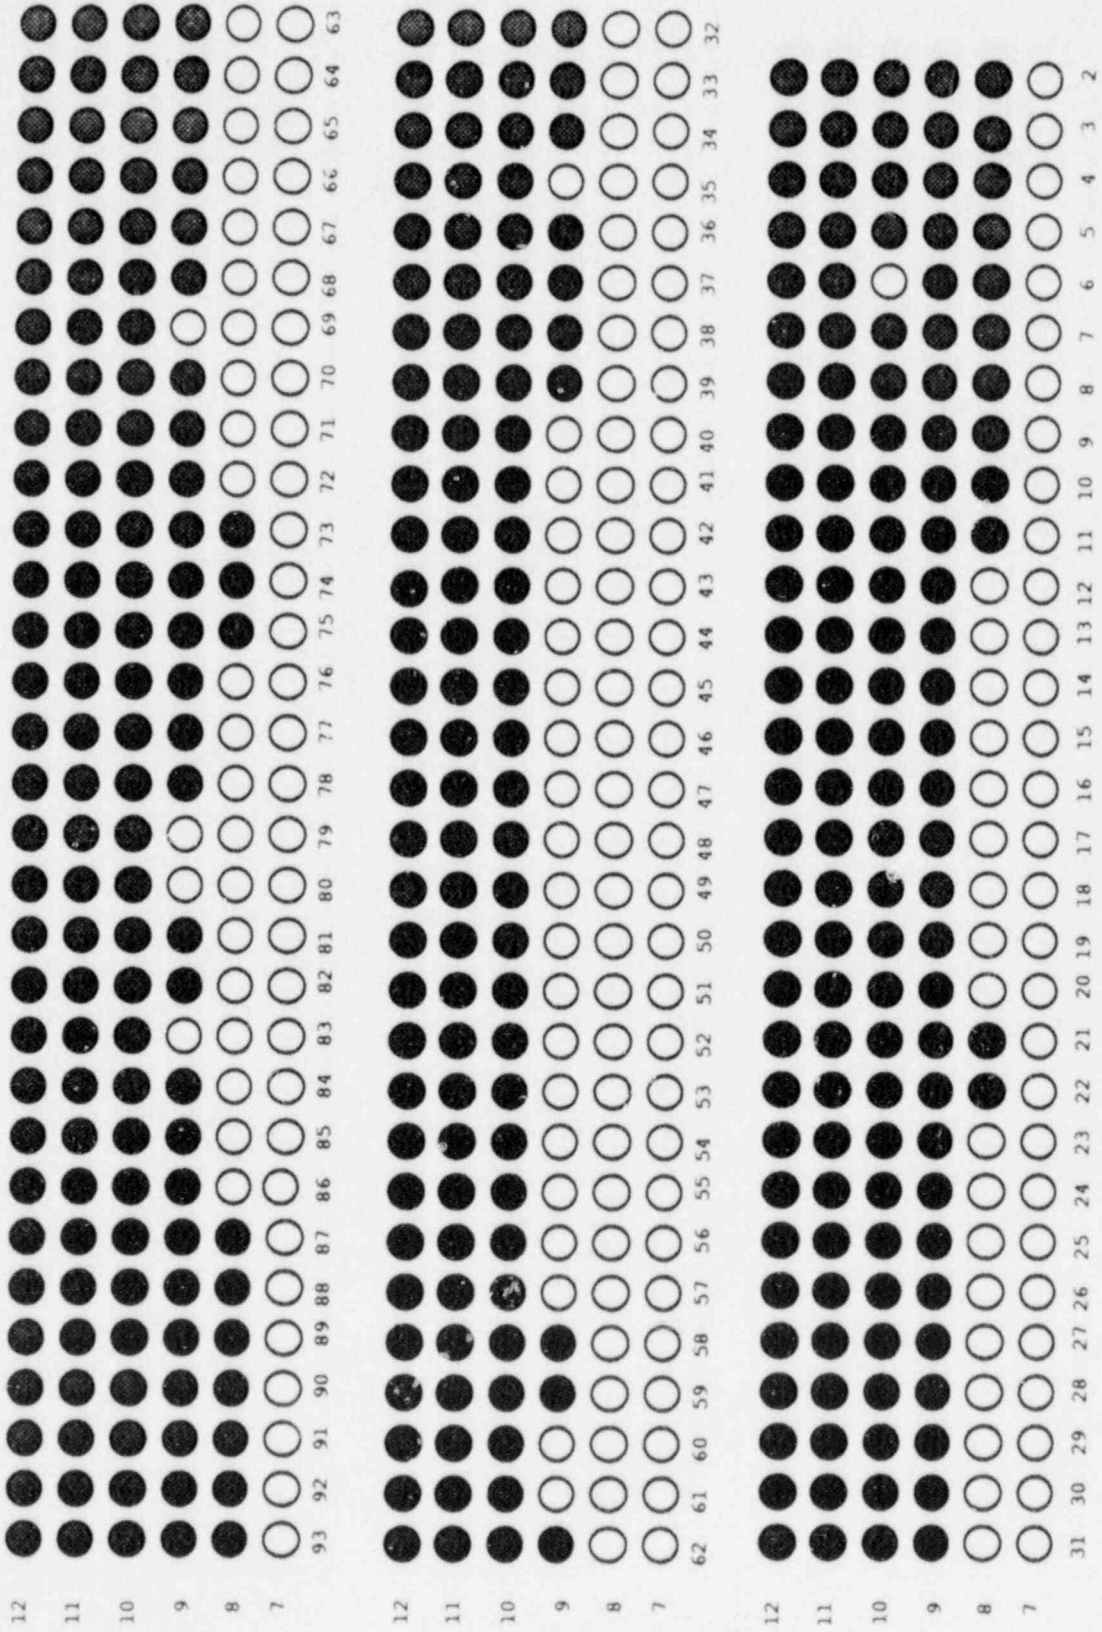
FIGURE 3-4  
 North Anna - 2: S/G-C  
 AVB Visibility

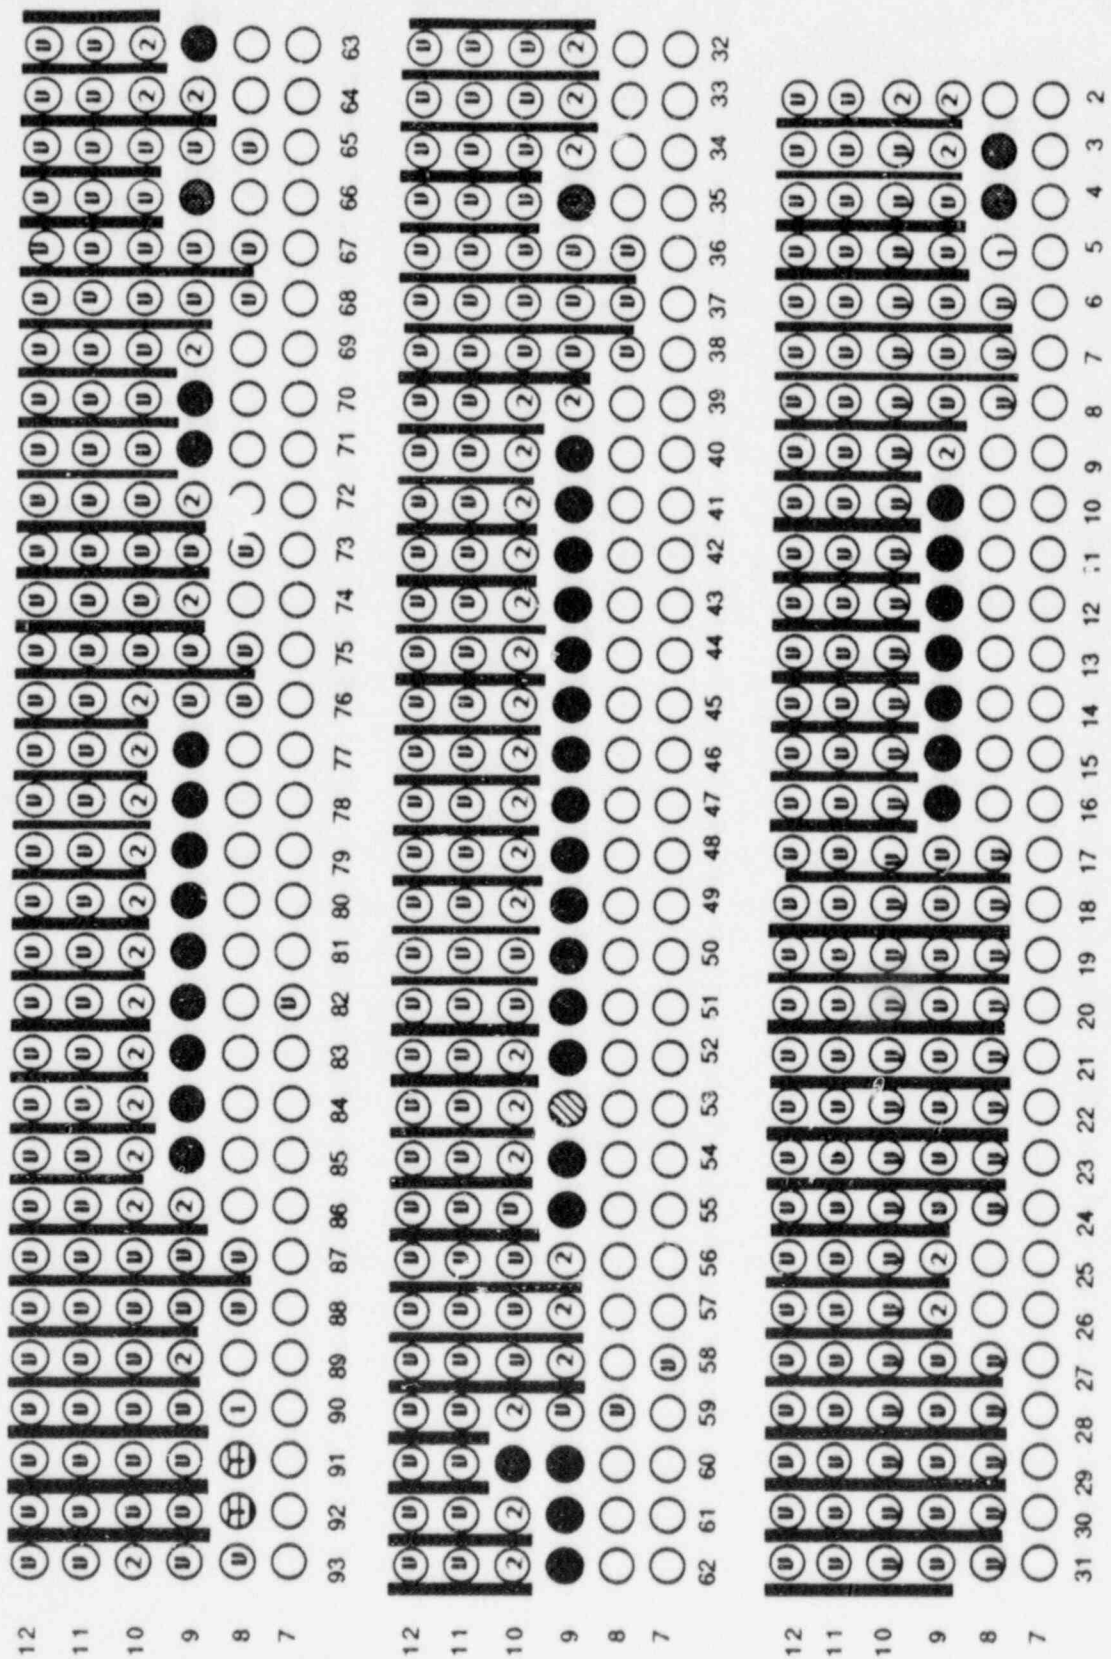
FIGURE 3-5

North Anna #2 (VGB): S/G -A  
 AVB Insertion and Plugging

Figures 3-5 through 3-7 show AVB insertion maps developed according to the above guidelines of the AVB "visible" analysis, "0, 1, or 2 AVB Present" analysis, as well as top tube support plate denting results of preventively plugged tubes.

These criteria are essentially identical with the North Anna #1 tube plugging criteria, except that the acceptability of single-sided support was extended from Row 9 to include all rows in the Unit #2 evaluation. The above criteria led to preventive plugging of all tubes without at least single-sided AVB support in Rows 9 or larger, and Columns 3, 4, 91, and 92 in Row 8. The tubes selected for preventive plugging are also shown in Figures 3-5 through 3-7.

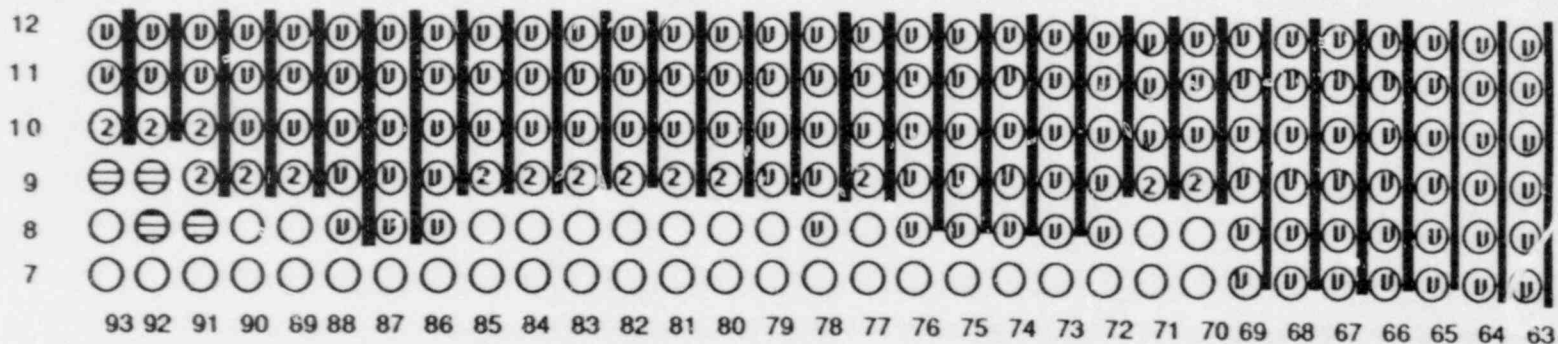
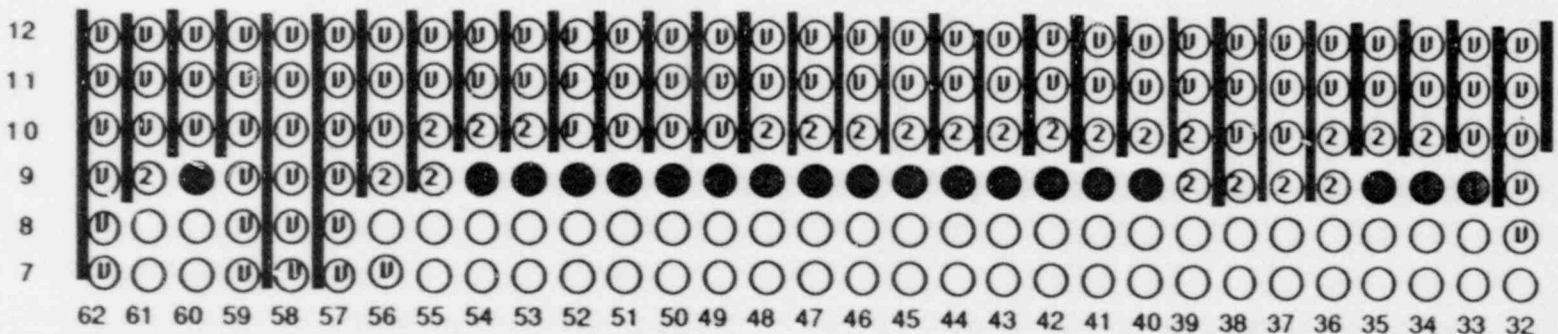
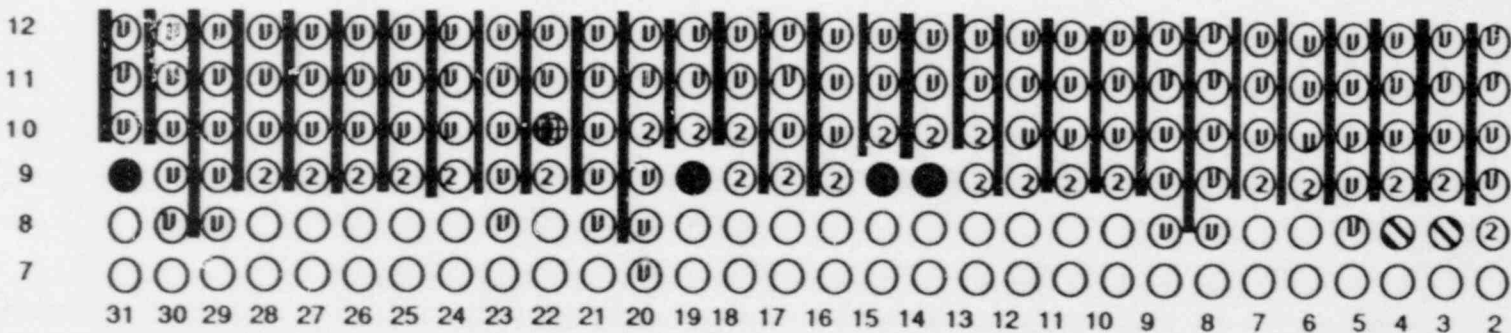
FIGURE 3-6

North Anna #2 (VGB): S/G -B  
 AVB Insertion and Plugging

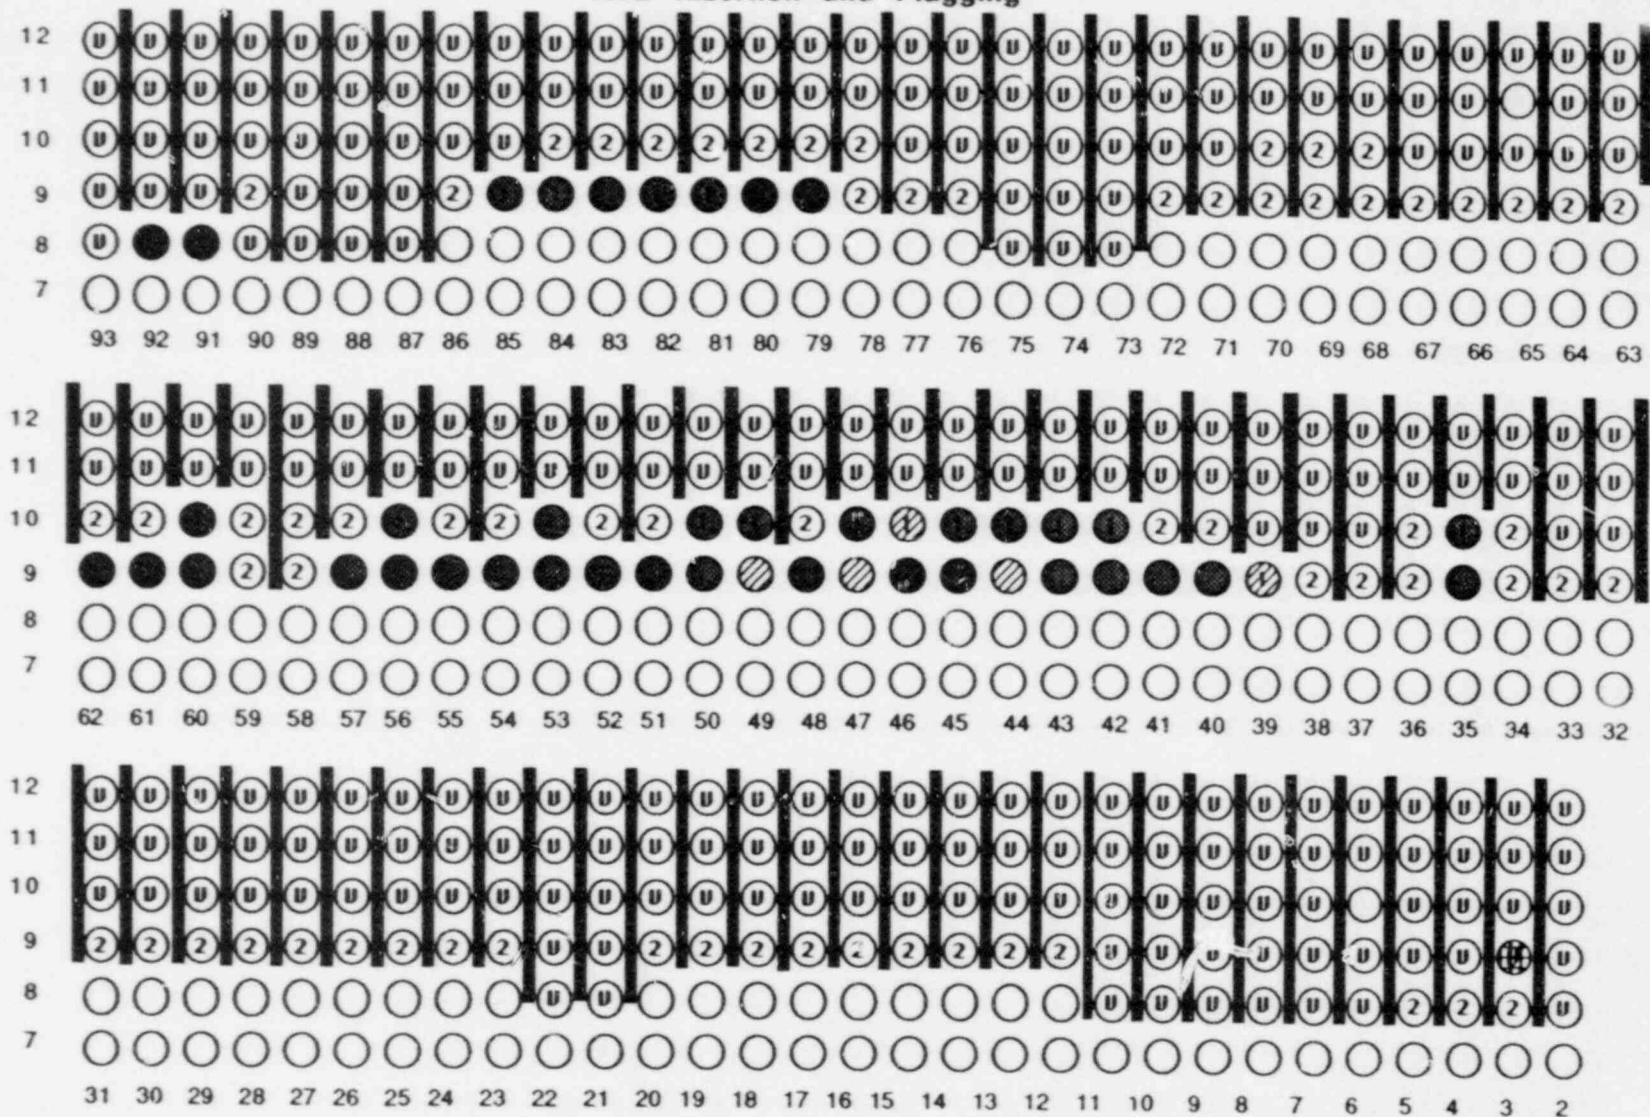
FIGURE 3-7  
 North Anna #2 (VGB): S/G-C  
 AVB Insertion and Plugging

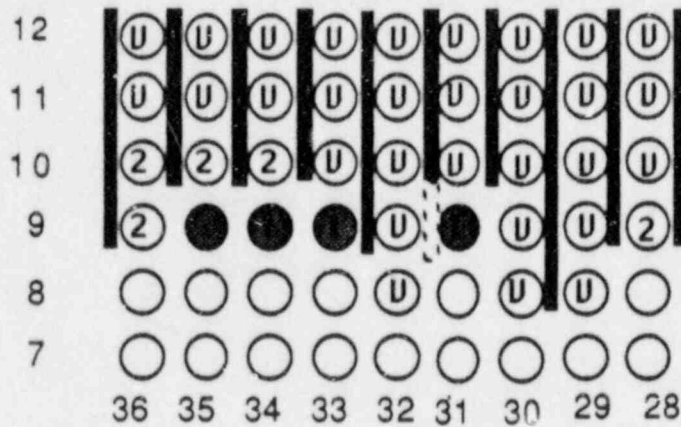
Figure 5-1

An example the second condition be seen in SG-B, Column 32 (See Figure 5-1). R8C32 and R9C32 are reported as "visible". By the second guideline, R9C32 is assumed to be supported, and is shown with single-sided AVB support. Although support is reasonably assumed for R9C32, both adjacent tubes, R9C31 and R9C33 were plugged, since it could not be determined on which side support was provided to R9C32.

North Anna #2 (VGB): S/G -B  
Isolated View of R9C32

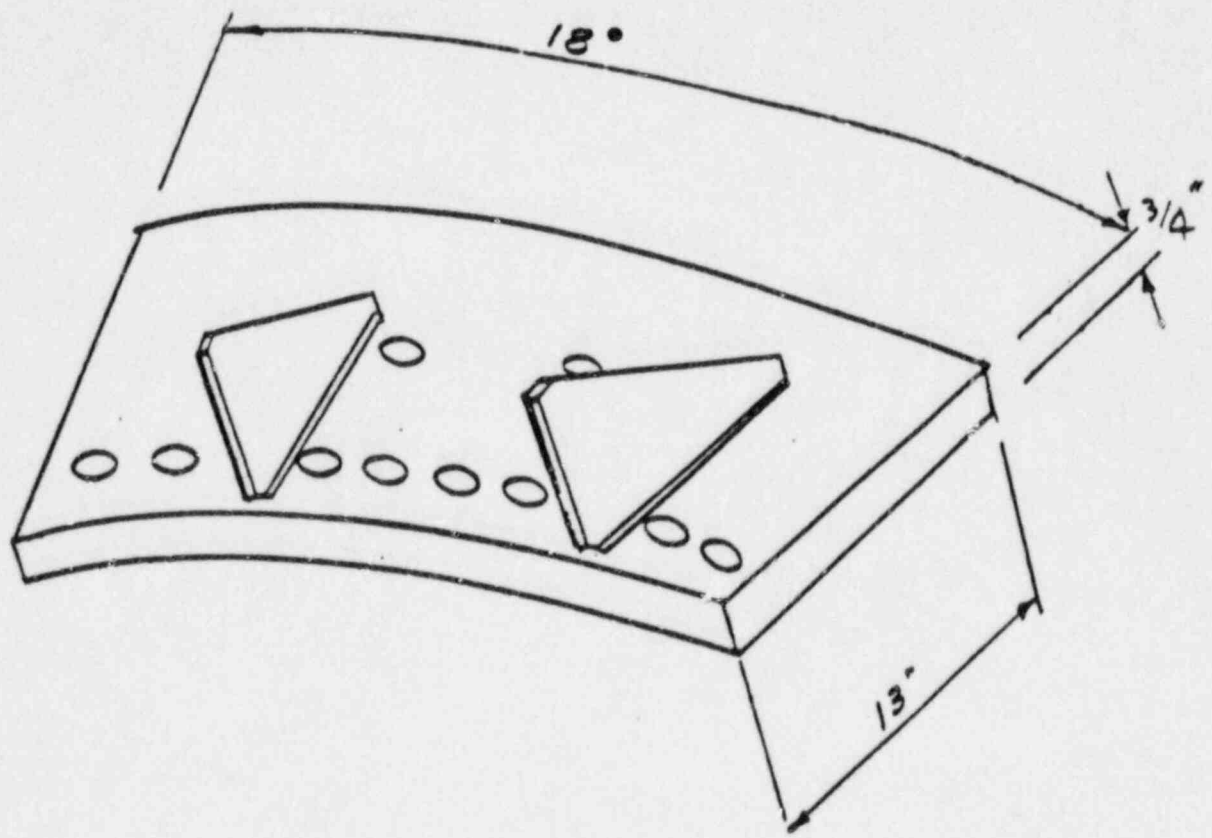
FIGURE 6-1 Typical Downcomer Flow Resistance Plate

The mechanical, structural, and thermal-hydraulic implications of the Downcomer Flow Resistance Plate modification (DFRP) are identical to those of Unit #1 (See Reference 1). Figure 6-1 shows a typical DFRP.
