NRC FOIA REQUEST NUMBER(S) <b>FOIA-88-18</b>	
RESPONSE TYPE	
<input checked="" type="checkbox"/> FINAL	<input type="checkbox"/> PARTIAL
DATE <b>MAR 25 1988</b>	
DOCKET NUMBER(S) (if applicable)

SUBJECT: NOTICE OF VIOLATION (NRC INSPECTION REPORT 50-445/87-27.  
50-446/87-20)

AFW FAN MOTORS AGENDA

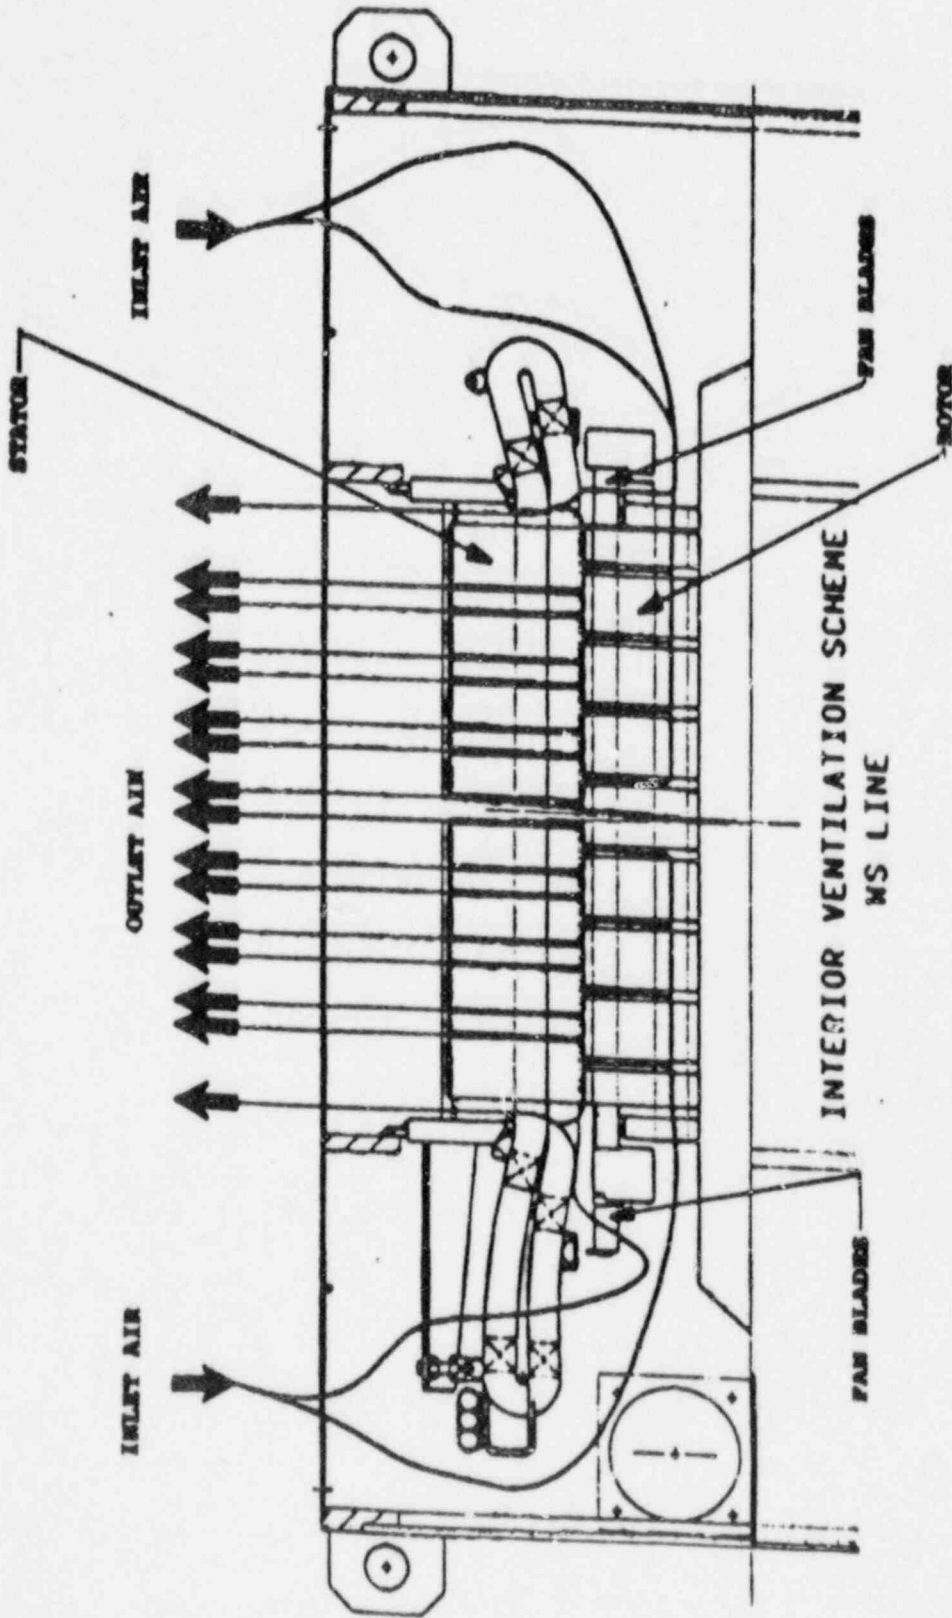
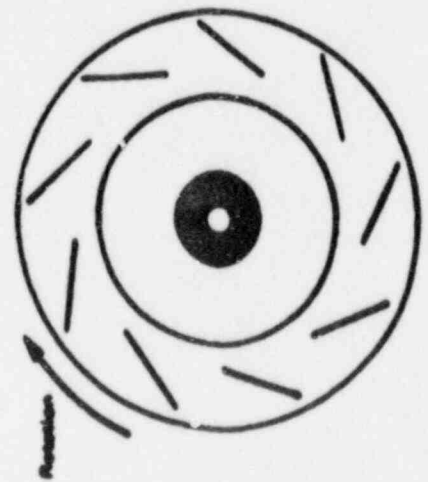
BACKWARD INCLINED (forward curved) FAN  
 INVENTED BY WESTINGHOUSE
