Docket Nos. 50-445/IE Circular 78-18
50-446/IE Circular 78-18

IE Circular 78-18
Date: November 6, 1978
Page 1 of 3

UNDERWRITERS LABORATORY FIRE TEST

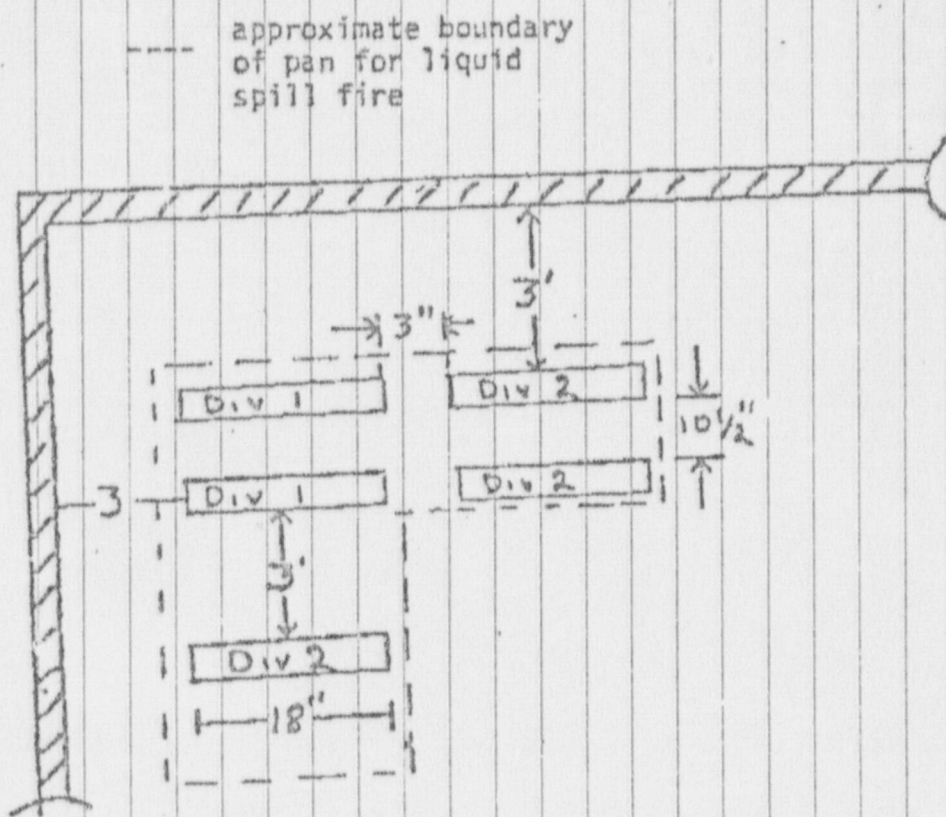
Figure 1

Preliminary information indicates that the flammable liquid or flames penetrated the protective barriers at the bottom of the vertical trays and caused fire damage to the polyvinyl chloride insulation on cables in four of the five trays.

The most probable cause of the fire damage in certain cable trays appears to be related to the absorption or seepage of heptane under the ceramic fiber blanket at the juncture with the floor. Once the heptane entered the interior regions of the cable tray, then ignition apparently occurred via the small opening at the floor or through a vapor/air path within the joints. There is some indication that some cable damage was caused by absorption of heptane on the inside of the barrier (wicking effect) and its ignition which heated a cable tray ladder rung, causing damage to a cable in contact with the rung. The ingress of the heptane into the ceramic fiber needs to be further evaluated since this appears to be the most significant failure mode.

Vertical Tray Corner Test

1. To protect against spills of flammable liquids, barriers or curbs may be needed to prevent entry of the flammable liquid behind fire barriers. A wick effect may also need to be considered in the design of fire barriers.
2. Some small fires may not actuate sprinkler heads. To reduce this possibility in sprinkler systems to be installed, fast response sprinkler heads should be considered (less than approximately 3 minutes in the UL Standard 199 "Automatic Sprinklers for Fire Protection Service").
3. The location of the fire detection devices and the sprinkler heads relative to the fire and components being protected is of great importance. The path of the air movement in the area influences the actuation of such devices and should be considered in the system layout.

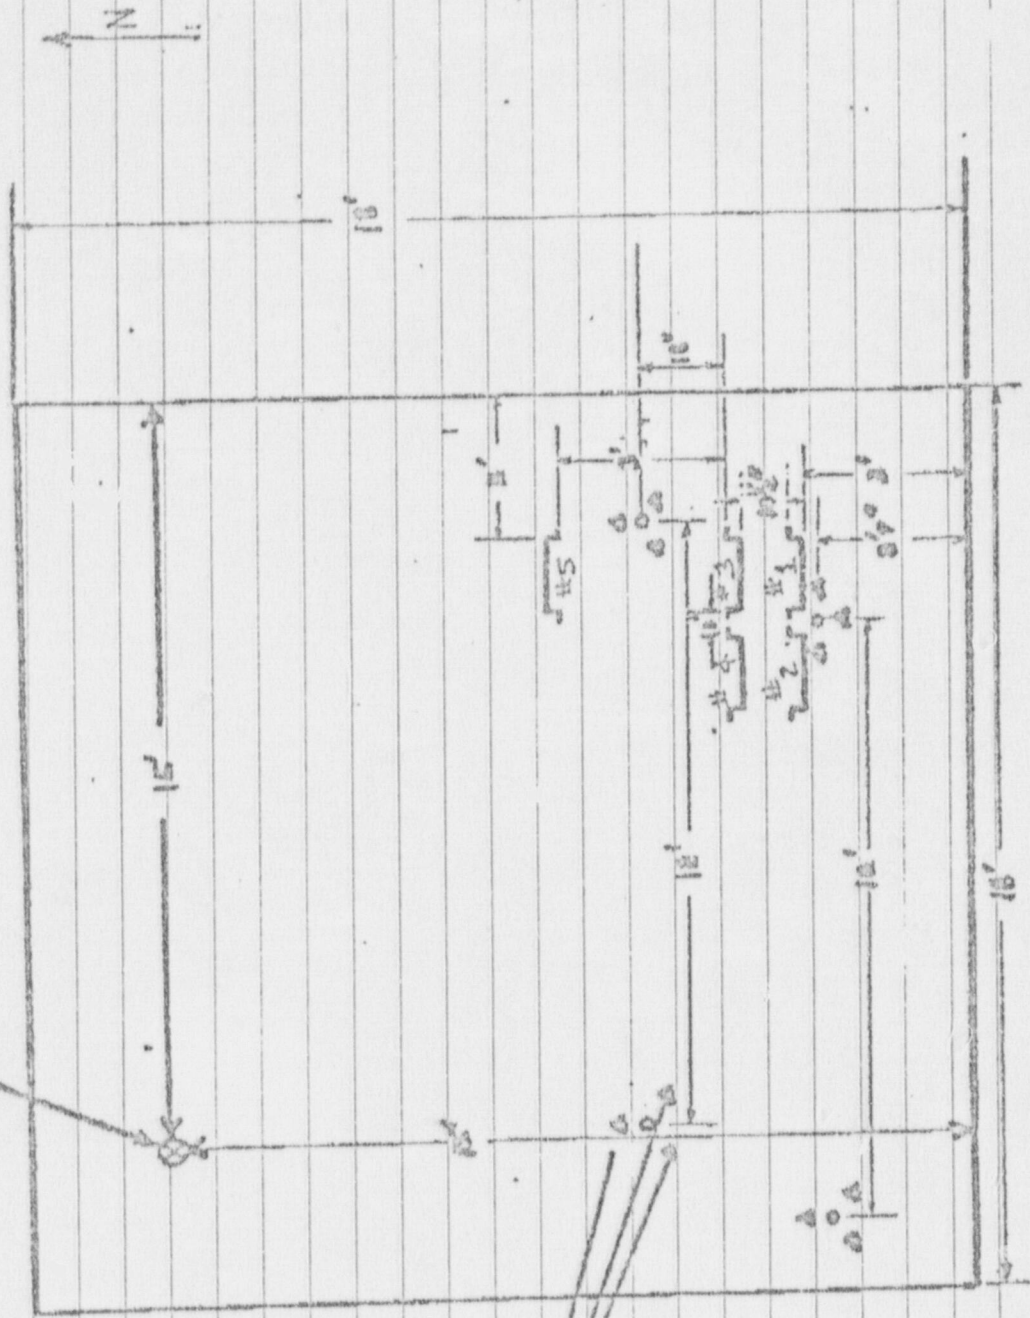
FIGURE 2
TOP VIEW GENERAL

The test was started by igniting the two gallons of heptane that were poured into the floor pan. A fully developed fire occurred almost immediately. The ceiling smoke detector alarmed in about 15 seconds. In about 50-60 seconds, two of the three temperature sensing sprinklers located between the wall and cable trays 1 and 2 activated. The fire between cable trays 1, 2, 3, and 4 appeared most intense, apparently because of a chimney effect between the four trays. The flames between cable trays 3 and 5 did not appear to be so intense. The ceramic fiber blanket absorbed some of the heptane so that after the heptane in the pan burned, most of the flame seemed to come from the bottom outside surface of the ceramic fiber blanket. No additional temperature sensing sprinkler heads at any location activated; thus, the sprinkler water supply was not turned on for any of the three sprinkler locations. The apparent slow response of the third temperature sensing sprinkler is being investigated, since this was not intended to be a slow response sprinkler.
