VPNPD-88-026  
NRC-88-005

January 13, 1988

DOCKET NOS. 50-266 AND 50-301  
SINGLE FAILURE POTENTIAL IN 4160 VOLT SAFEGUARDS SWITCHGEAR  
POINT BEACH NUCLEAR PLANT, UNITS 1 AND 2

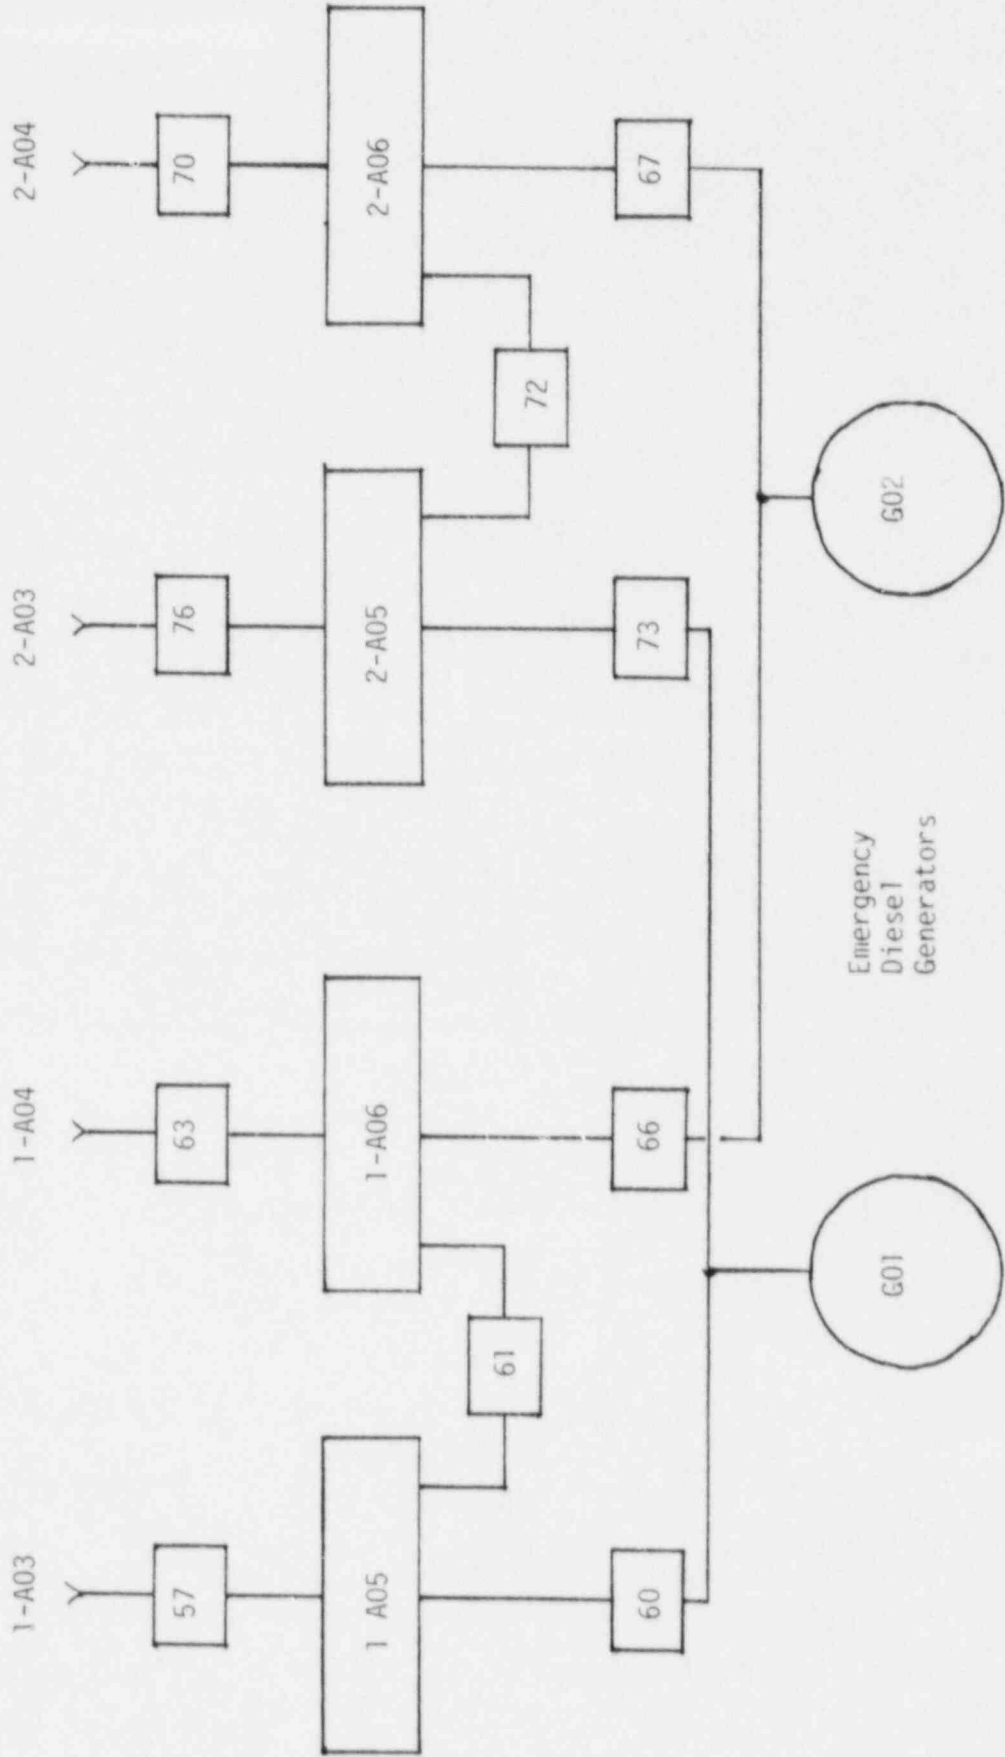
SIMPLIFIED SCHEMATIC OF BUS SECTIONS  
A05 AND A06 NORMAL AND EMERGENCY  
POWER SUPPLIES

Tie breaker 61 provides a means to tie together safeguards busses 1-A05 and 1-A06. These busses supply the 4160 Volt power to Train A and Train B safeguards loads. The tie breaker is provided for use during a unit shutdown to facilitate maintenance on the normal bus supply breakers, 57 and 63. A cell switch associated with tie breaker 61 provides an interlock in the automatic closing circuits for both breakers 60 and 66, preventing automatic closure of those breakers when tie breaker 61 is closed. The purpose of this interlock is to prevent automatic paralleling of both emergency diesel generators following a fast start without synchronization.

We have postulated that a single failure in this cell switch could, in the event of a loss of offsite power, prevent the automatic closure of breakers 60 and 66 and thereby temporarily disable emergency power to both trains of 4160 Volt safeguards equipment. This failure would not, however, prevent the 60 and 66 supply breakers from being closed manually by the control room operator from the unit's control board. The plant Emergency Operation Procedures direct the operators to manually energize the 1-A05 and 1-A06 busses should automatic breaker closure not occur. However, in the event of a design basis loss of coolant accident coincident with a loss of off-site power and this single failure, we cannot assure that operator action would occur in a sufficient time to preclude consequences more severe than analyzed in the safety analysis report. Accordingly, the potential exists for the creation of a substantial safety hazard due to this design deficiency as defined in 10 CFR Part 21.

We are investigating possible modifications to the interlock and indicating circuitry of these tie breakers which would eliminate the potential for this undetected single failure. In the interim, we have implemented administrative controls which will confirm the proper position of the tie breaker 61 and 72 cell switches should operation of either tie breaker be necessary.
