UNITED STATES  
NUCLEAR REGULATORY COMMISSION  
OFFICE OF INSPECTION AND ENFORCEMENT  
WASHINGTON, D. C. 20555

IE Circular 78-18  
Date: November 6, 1978  
Page 1 of 3

UNDERWRITERS LABORATORY FIRE TEST

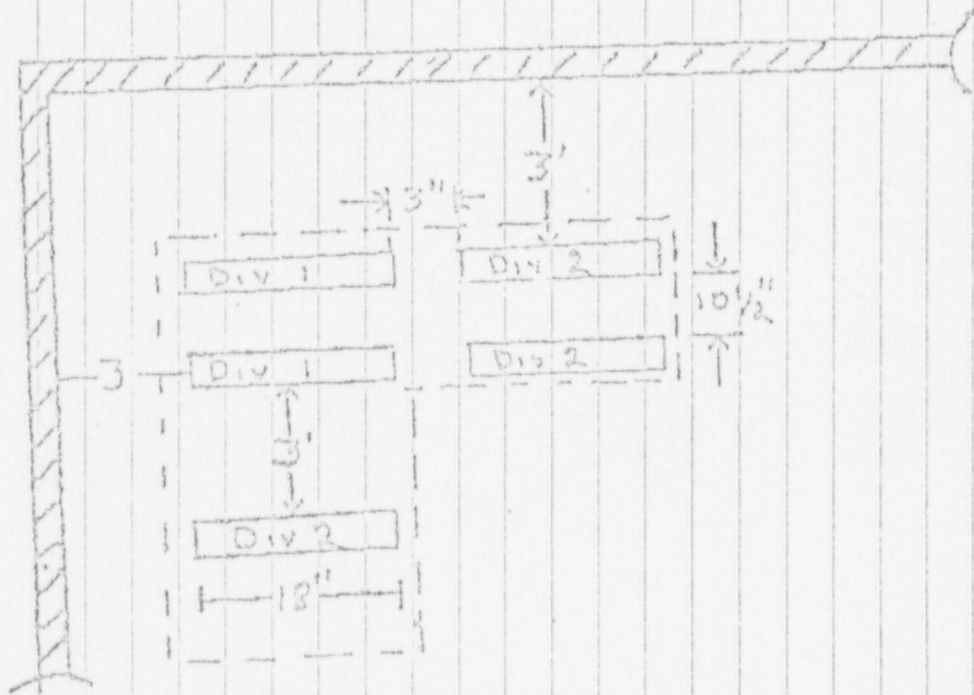
Figure 1

Vertical Tray Corner Test
