LICENSEE EVENT REPORT (LER)

| FACILITY NAME (1)<br>Joseph M. Farley - Unit 1 | DOCKET NUMBER (2)<br>0 5 0 0 0 3 4 8 | PAGE (3)<br>1 OF 0 9 |

TITLE (4)  
Potential Inoperability Of The A Train Charging Pump Due To Gas Accumulation

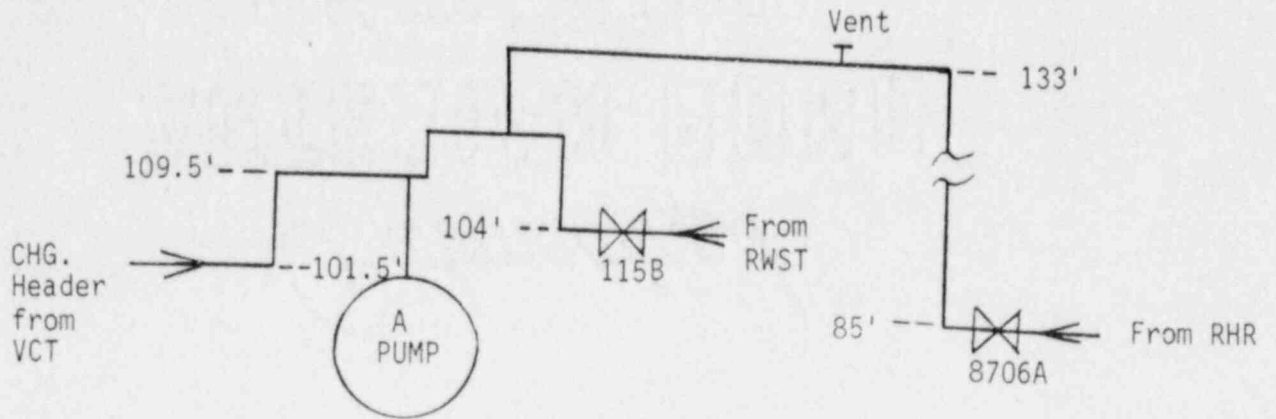
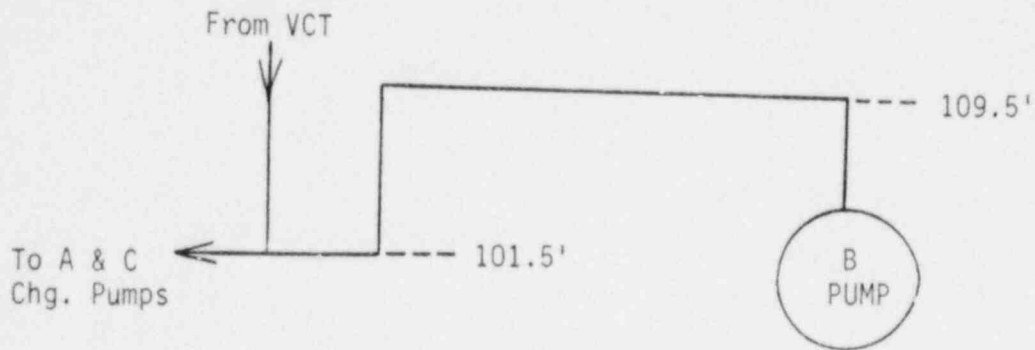
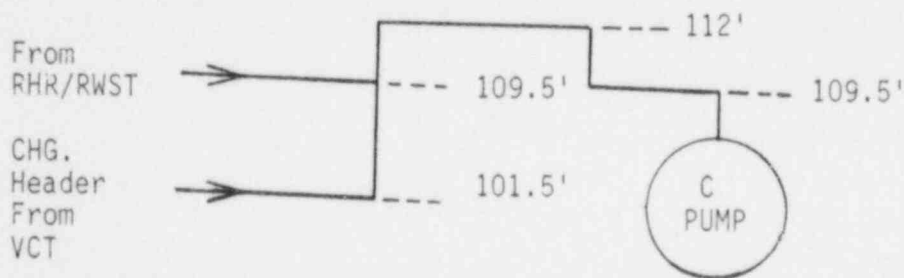
For the Unit 1 A charging pump suction piping, the top of the inverted loop is at 109.5 ft. elevation. The RHR to charging pump suction header is connected to the top of the inverted loop and rises to elevation 133 ft. The vent used to vent the gas is located at this elevation. The Unit 2 A pump suction piping is similar to Unit 1 except the top of the loop is located at 114 ft. elevation. The high point and location of the vent in the RHR to charging pump suction header is at elevation 132.5 ft. Both of these geometries provide the conditions for trapping large amounts of hydrogen gas in the respective RHR to charging pump suction headers.

If hydrogen comes out of solution, it would accumulate in these A charging pump inverted loops. Review of the piping layouts identifies that the section of pipe containing the void is connected via a vertical pipe run to the charging pump suction piping at the top of the inverted loop. It is believed that hydrogen gas was evolving from the fluid and accumulating in the RHR to charging pump suction supply header, since this provided the high point in the system.
