FINAL REPORT
DEFICIENT 312 STAINLESS STEEL BUTTERING
ON FLUED HEAD FITTINGS
FOR PRIMARY CONTAINMENT PENETRATIONS
AT
LIMERICK GENERATING STATION
UNITS 1 AND 2

PHILADELPHIA ELECTRIC COMPANY

NOVEMBER, 1978

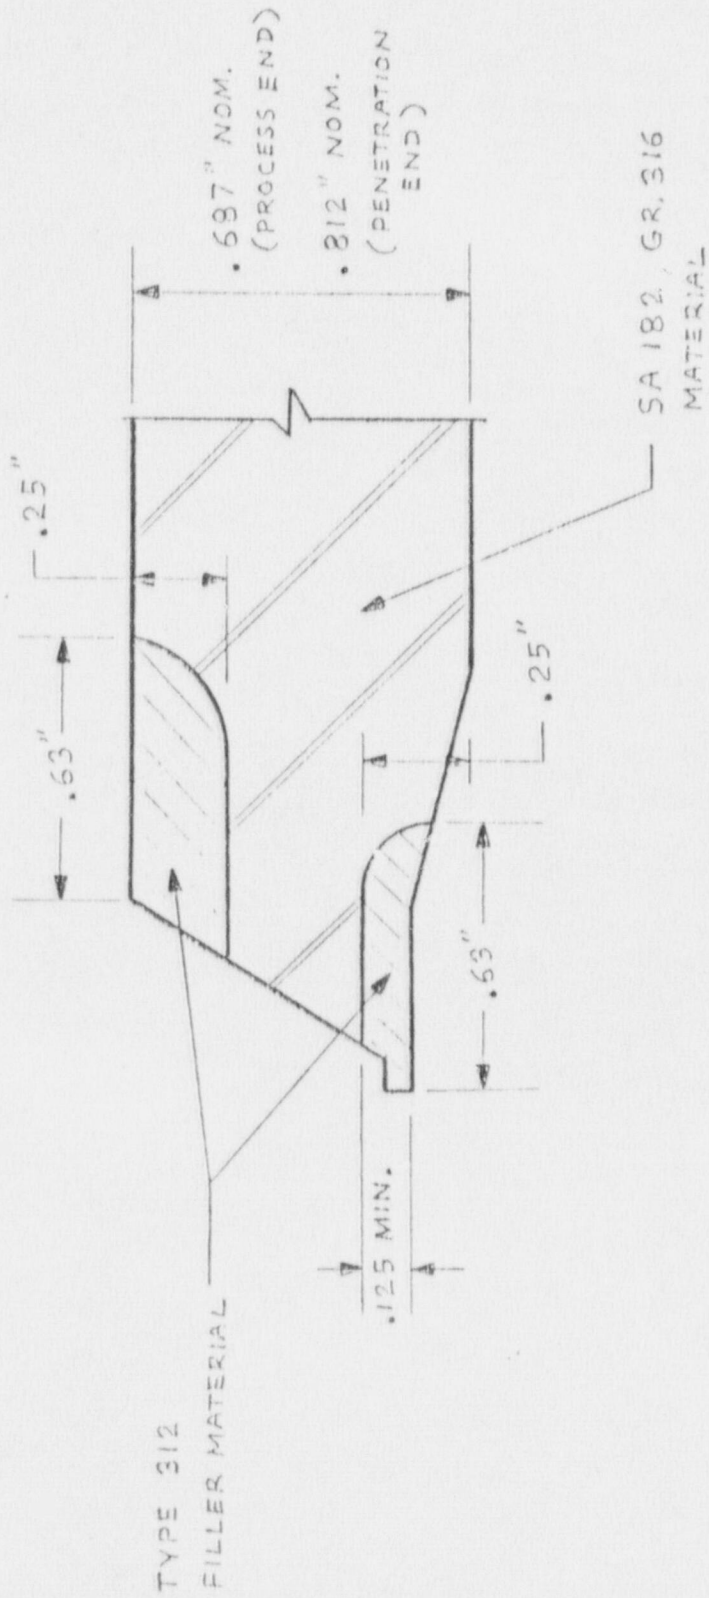
FIGURE 2

In July, 1978, during routine liquid penetrant examination of the field weld on a flued head fitting which had been installed, it was discovered that the OD contained circumferential linear indications in the Type 312 material. Subsequent examinations of the other eleven fittings, one of which is also installed, revealed similar indications. Installation/work holds were placed on all twelve flued heads and in September, 1978 one flued head was returned to the supplier for analysis.

- 2.2.2.1 Circumferential linear indications are present in all twelve fittings.
- 2.2.2.2 While indications are primarily on the OD buttered surfaces, linear indications are also present on the ID buttered surfaces.

- 2.2.2.3 The indications are short (less than 3/4 inch), numerous, and in some cases appear around 360° of the weld end preparations.
- 2.2.2.4 The indications are cracks. The crack width is less at the surface. The largest crack found to date is approximately 3/16" deep and 5/8" long.

- 2.2.2.5 Subsurface cracks exist in the 312 material.
- 2.2.2.6 No defects in the Gr. 316 base material have been found.

4.1.2.1 The 312 filler material used contained 40% ferrite. Filler metal with ferrite in this range has been known to crack through the formation of a brittle phase, possibly sigma. It has not been determined if the cracking was caused by the formation of a brittle sigma phase, however, it is apparent from the cracking that the weld deposit may have been brittle at some time prior to or after heat treatment or may contain areas of low strength ferrite that also could have resulted in cracking.

4.1.2.2 Production problems such as inadequate shielding gas coverage or inadequate control of the interpass temperature may have caused the cracks. Cracks are not present in the workmanship or weld qualification samples which were prepared prior to production welding.

- 4.2.1 The two installed flued head fittings will be removed.
- 4.2.2 Because of the quantity of cracks and the presence of subsurface defects it has been determined that successful repair of the 312 material cannot be assured.

- 4.2.3 Based on an analysis of cost and schedule impact one or more of the following alternatives will be taken:
 - 4.2.3.1 Remove the 312 material, re-machine weld end preparations, and use the Grade 316 flued heads in systems where IGSCC is not considered a significant risk.

- 4.2.3.2 Remove the 312 material and rebutter using 309L material for flued head ends which will be welded to carbon steel pipe and 308L material for flued head ends which will be welded to stainless steel pipe. In addition to the requirements for ultrasonic and liquid penetrant examination which were specified for Type 312 buttering, radiographic examination would also be specified.

- 4.2.3.3 Replacement of the flued heads with a material which would not require weld end preparation buttering.
