LICENSEE EVENT REPORT (LER)

FACILITY NAME (1) Sequoyah, Unit 2	DOCKET NUMBER (2) 0 5 0 0 0 3 2 8 1	PAGE (3) 1 OF 1 0
---------------------------------------	--	----------------------

Ice Buildup In The Flow Passages Of The Ice Condenser Due To Sublimation Which Could Result In Increased Containment Pressures

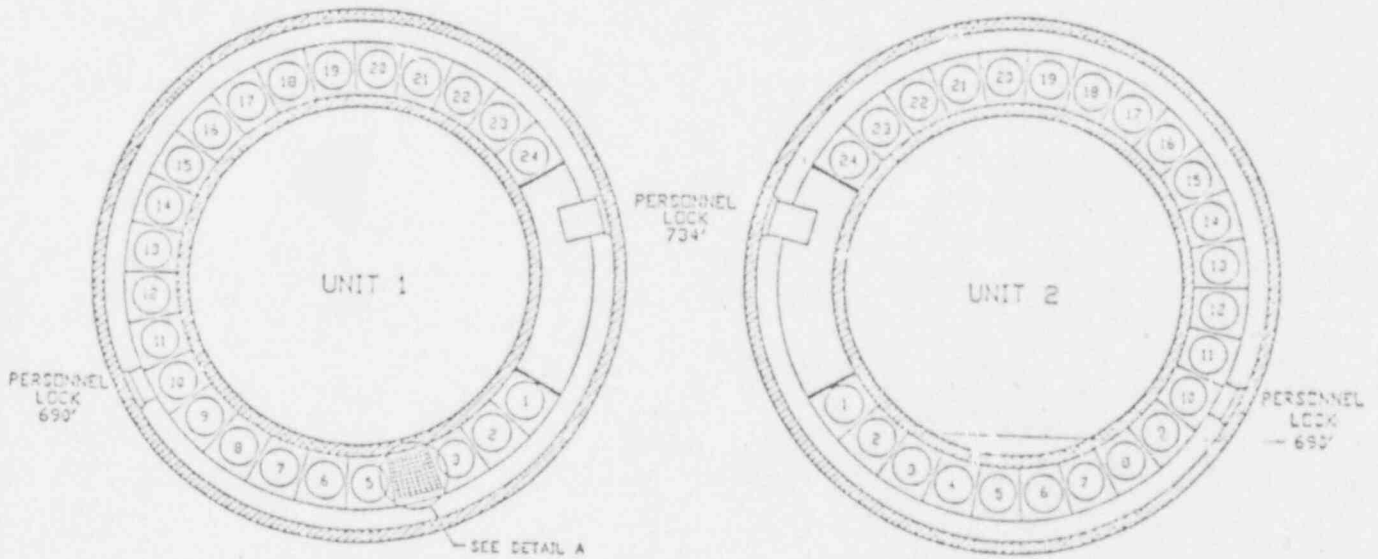
FIGURE 1

On January 19, 1988, with units 1 and 2 in mode 5 (0 percent power, 4 psig, 124 degrees F and 0 percent power, 110 psig, 117 degrees F, respectively), an inspection of the unit 2 ice condenser (EIIIS Code BC) revealed that accumulation of ice or frost in the flow passages represented a degraded condition. Technical Specification (TS) 3.6.5.1 indicates more than one restricted flow passage per ice condenser bay, (24 bays in the ice condenser) is evidence of abnormal degradation of the ice condenser. Figures 1 and 2 are diagrams of the ice condenser and an ice condenser bay, respectively.

## ICE CONDENSER NUMBERING OF BAYS

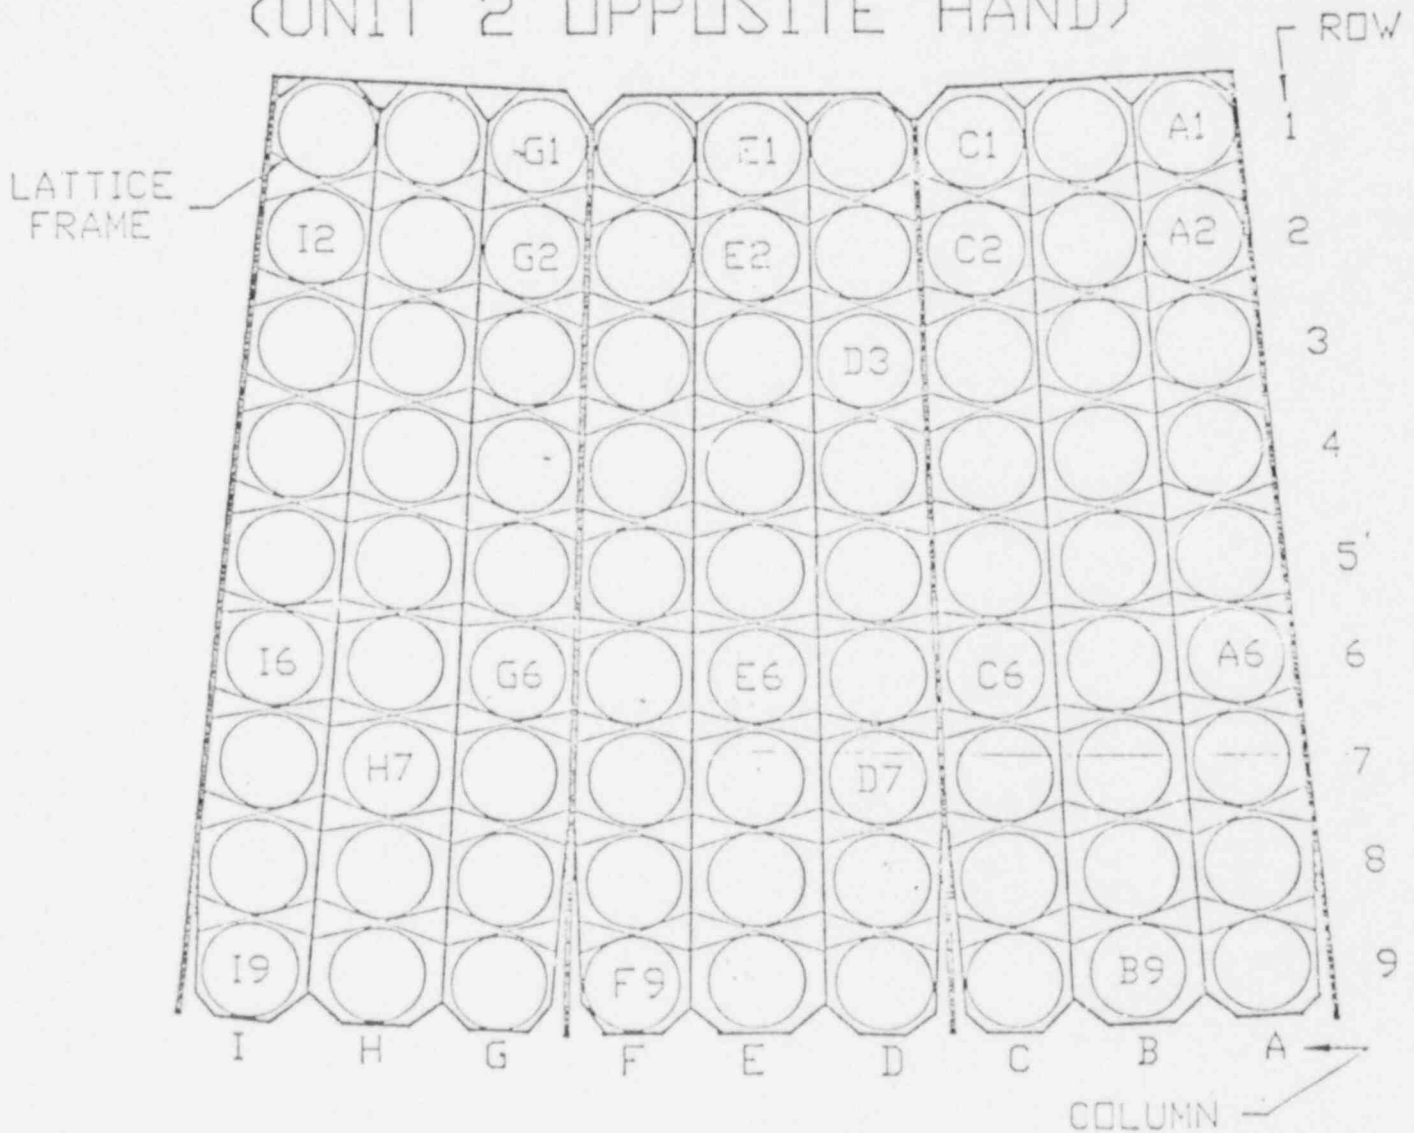
DETAIL A  
FIGURE 2

ICE BASKETS NUMBERING SEQUENCE  
TYPICAL FOR UNIT 1 ICE CONDENSER  
(UNIT 2 OPPOSITE HAND)

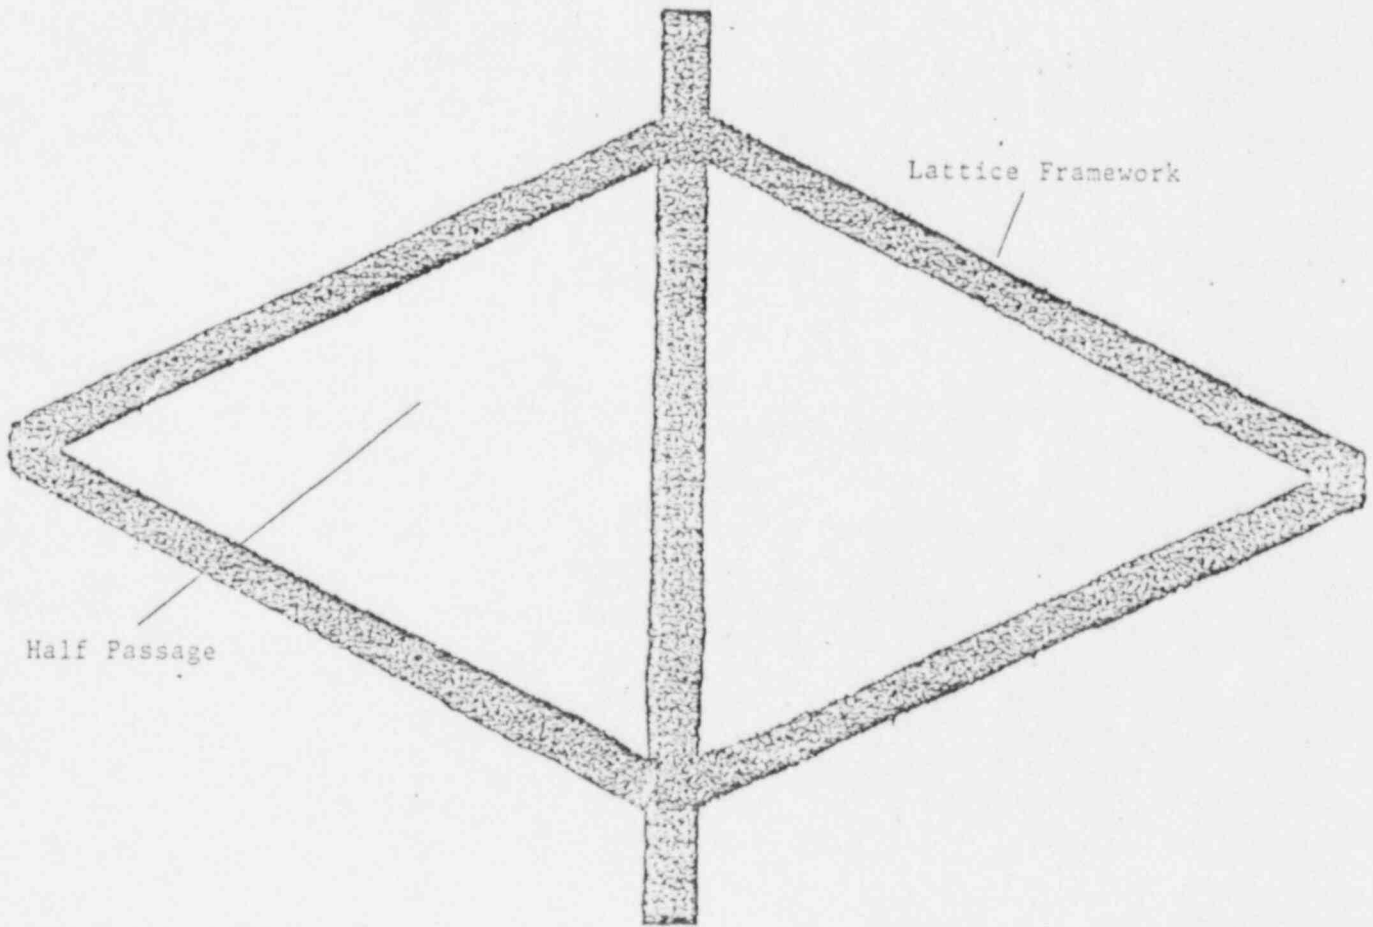
FIGURE 3

At this time, manual chipping and scraping of the ice in the flow passages was started. Parallel to that effort, Westinghouse was contacted to determine the requirements of an operable ice bed. Westinghouse indicated the purpose for maintaining ice/frost free flow passages was to ensure the lower compartments of containment were not overpressurized during the first few seconds of a large break loss of coolant accident (LOCA). Westinghouse also indicated that a computer analysis of the Sequoyah Nuclear Plant (SQN) ice condenser had been run with 15 percent total flow passage blockage. This analysis concluded the pressure from this condition would be within the design limits of containment. Thus, Westinghouse and TVA decided that the ice condenser had evidence of abnormal degradation but was not inoperable. An operable ice condenser consisted of an ice bed with less than 15 percent total flow passage blockage, where a flow passage is as shown in Figure 3.

ICE CONDENSER FLOW PASSAGE  
(AREA INSIDE TRIANGLE)
